Profile/Photo Observation Report

Street:	Old Ridge Rd.	Flow Control:	Not Controlled
City:	Hobart, IN	Year Renewed:	
Location:	Light Highway	Tape/Media #:	
Purpose:	Routine Assessment	Dia/Height:	10"
Use:	Sanitary	Material:	PVC
Drain Area:	NA	Lining:	
Category:	NA		
Comment:

Location Details:		Direction of Survey:	Downstream
US MH:	M-303-068	DS MH:	M-303-064
		Total Length Surveyed (ft):	191.1

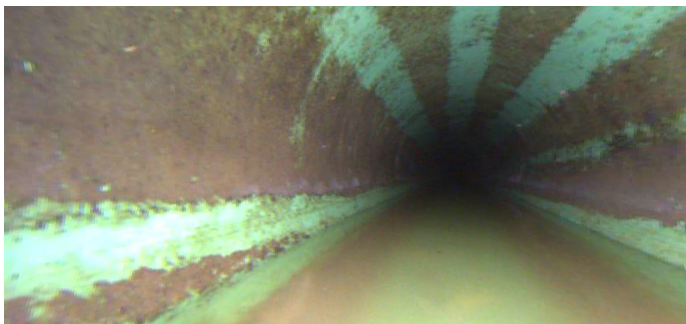
Code: **AMH**
Description: **Manhole**

Distance (ft): **.0**
Structural Grade: **0**
O&M Grade: **0**
Clock Start/From:
Clock To:
1st Value:
2nd Value:
Value Percent:
Continuous Index:
Within 8" of Joint: **NO**
Remarks: **M-303-068**

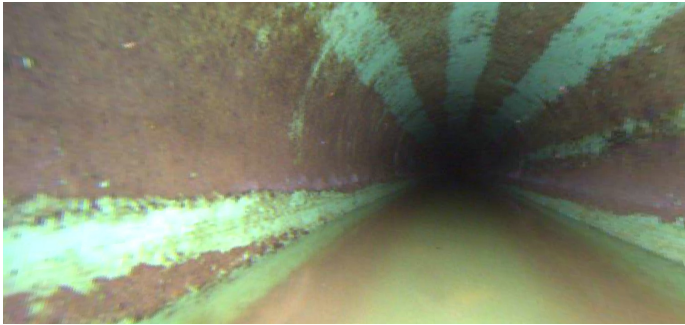
Code:	MWL
Description:	Water Level

Distance (ft):	.0
Structural Grade:	0
O&M Grade:	0
Clock Start/From:	
Clock To:	
1st Value:	
2nd Value:	
Value Percent:	5.000
Continuous Index:	
Within 8" of Joint:	NO
Remarks:

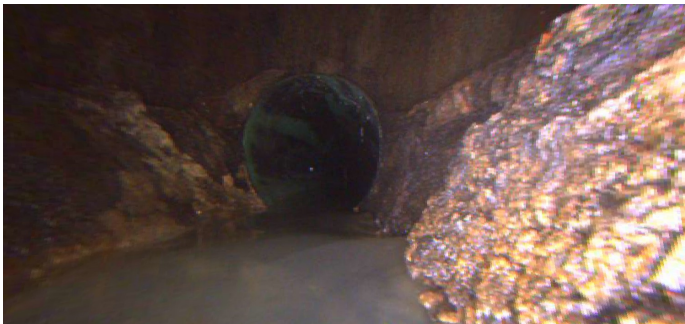
Code:	AMH
Description:	Manhole

Distance (ft):	191.1
Structural Grade:	0
O&M Grade:	0
Clock Start/From:	
Clock To:	
1st Value:	
2nd Value:	
Value Percent:	
Continuous Index:	
Within 8" of Joint:	NO
Remarks:	M-303-064
