Profile/Photo Observation Report

Street:	W OLD RIDGE RD	Flow Control:	Not Controlled
City:	Hobart, IN	Year Renewed:	
Location:	Other	Tape/Media #:	
Purpose:	Not Known	Dia/Height:	12"
Use:	Sanitary	Material:	PVC
Drain Area:	NA	Lining:	
Category:	NA		
Comment:

Location Details:		Direction of Survey:	Downstream
US MH:	M-303-068	DS MH:	M-304-004
		Total Length Surveyed (ft):	268.4

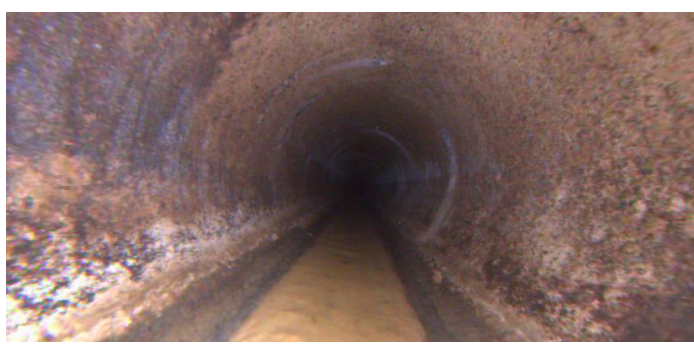
Code: **AMH**
Description: **Manhole**

Distance (ft): **.0**
Structural Grade: **0**
O&M Grade: **0**
Clock Start/From:
Clock To:
1st Value:
2nd Value:
Value Percent:
Continuous Index:
Within 8" of Joint: **NO**
Remarks: **M-303-068**

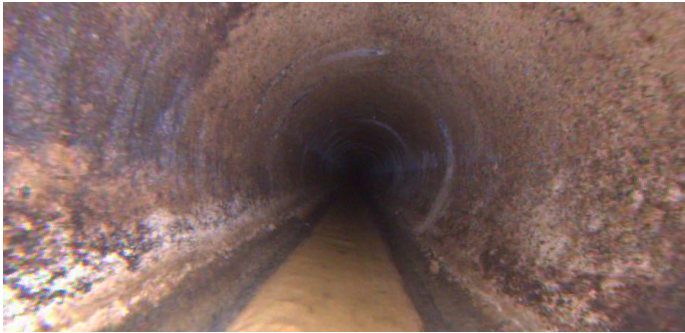
Code:	MWL
Description:	Water Level

Distance (ft):	.0
Structural Grade:	0
O&M Grade:	0
Clock Start/From:	
Clock To:	
1st Value:	
2nd Value:	
Value Percent:	5.000
Continuous Index:	
Within 8" of Joint:	NO
Remarks:

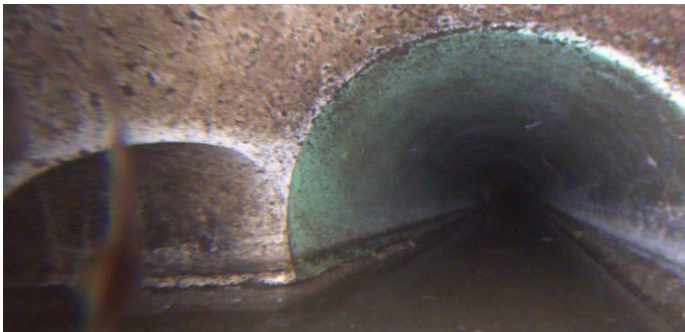
Code:	TFA
Description:	Tap Factory Active

Distance (ft):	261.4
Structural Grade:	0
O&M Grade:	0
Clock Start/From:	9
Clock To:	
1st Value:	4.000
2nd Value:	
Value Percent:	
Continuous Index:	
Within 8" of Joint:	
Remarks:

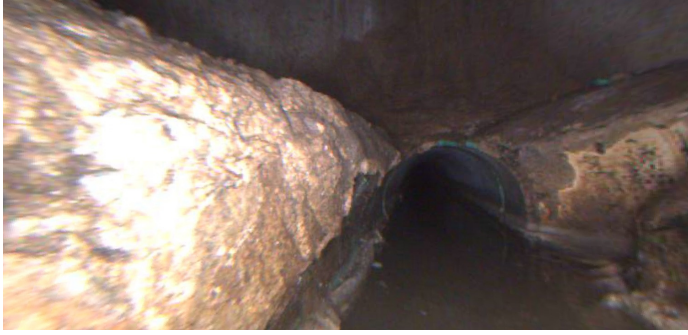
Code:	AMH
Description:	Manhole
Distance (ft):	268.4
Structural Grade:	0
O&M Grade:	0
Clock Start/From:	
Clock To:	
1st Value:	
2nd Value:	
Value Percent:	
Continuous Index:	
Within 8" of Joint:	NO
Remarks:	M-304-004
