Profile/Photo Observation Report

Street:	w old ridge rd	Flow Control:	Not Controlled
City:	Hobart, IN	Year Renewed:	
Location:	Other	Tape/Media #:	
Purpose:	Not Known	Dia/Height:	12"
Use:	Sanitary	Material:	PVC
Drain Area:	NA	Lining:	
Category:	NA		
Comment:

Location Details:		Direction of Survey:	Downstream
US MH:	M-303-068	DS MH:	M-304-004
		Total Length Surveyed (ft):	268.4

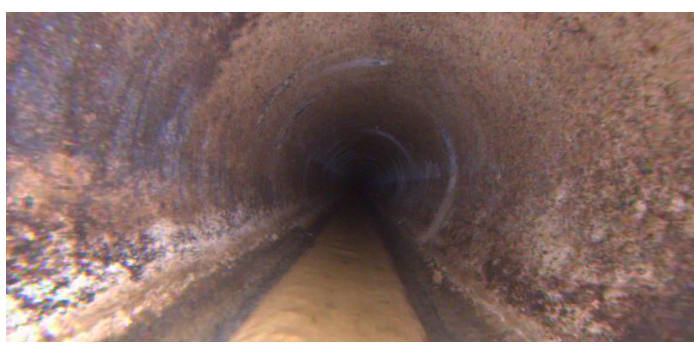
Code: **AMH**
Description: **Manhole**

Distance (ft): **.0**
Structural Grade: **0**
O&M Grade: **0**
Clock Start/From:
Clock To:
1st Value:
2nd Value:
Value Percent:
Continuous Index:
Within 8" of Joint: **NO**
Remarks: **M-303-068**

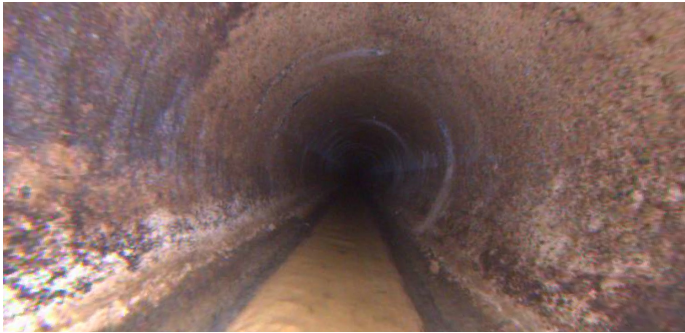
Code:	MWL
Description:	Water Level

Distance (ft):	.0
Structural Grade:	0
O&M Grade:	0
Clock Start/From:	
Clock To:	
1st Value:	
2nd Value:	
Value Percent:	5.000
Continuous Index:	
Within 8" of Joint:	NO
Remarks:

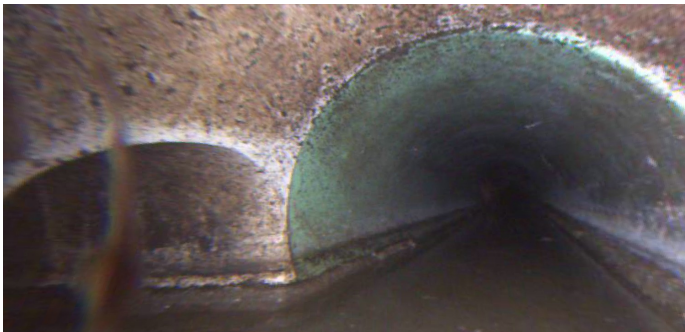
Code:	TFA
Description:	Tap Factory Active

Distance (ft):	261.4
Structural Grade:	0
O&M Grade:	0
Clock Start/From:	9
Clock To:	
1st Value:	4.000
2nd Value:	
Value Percent:	
Continuous Index:	
Within 8" of Joint:	
Remarks:

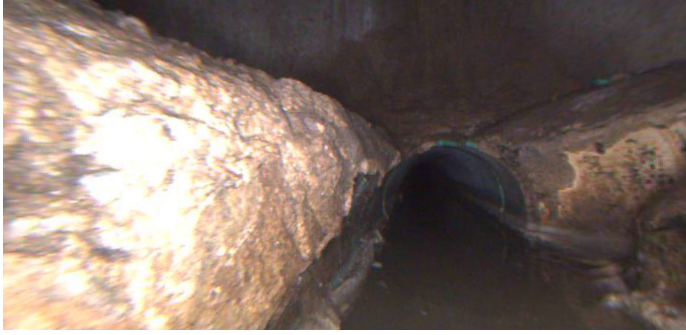
Code:	AMH
Description:	Manhole
Distance (ft):	268.4
Structural Grade:	0
O&M Grade:	0
Clock Start/From:	
Clock To:	
1st Value:	
2nd Value:	
Value Percent:	
Continuous Index:	
Within 8" of Joint:	NO
Remarks:	M-304-004
