Profile/Photo Observation Report

Date:	04/05/2018	Weather:		Coding:	PACP 6.0
Pipe Length (ft):	403.0	Owner:	NA	Pre Clean:	Not Known
P.O.#:		Surveyor:	Jen Costello	PSR:	P-303-070-069
Customer:		Clean Date:	01/01/1900	Shape:	C

Location Details:		Direction of Survey:	Upstream
US MH:	M-303-069	DS MH:	M-303-070
		Total Length Surveyed (ft):	251.6

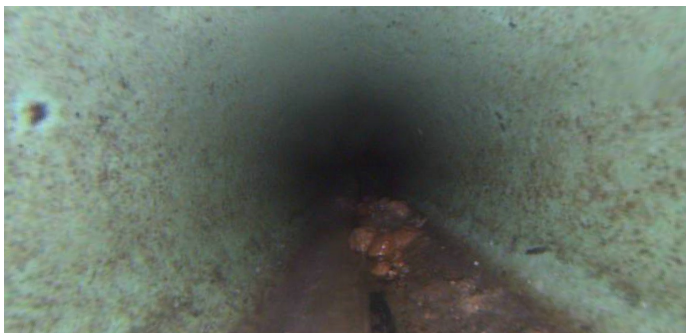
Code: **AMH**
Description: **Manhole**

Distance (ft): **.0**
Structural Grade: **0**
O&M Grade: **0**
Clock Start/From:
Clock To:
1st Value:
2nd Value:
Value Percent:
Continuous Index:
Within 8" of Joint: **NO**
Remarks: **M-303-070**

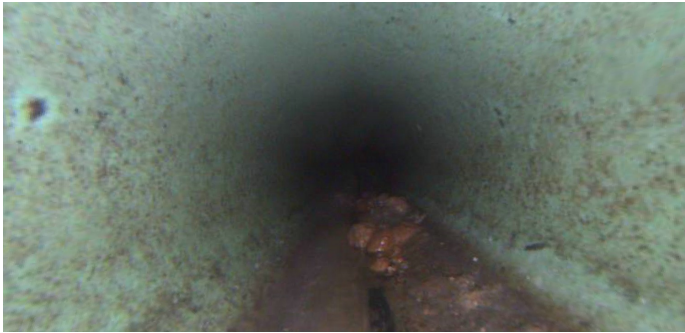
Code:	MWL
Description:	Water Level

Distance (ft):	.0
Structural Grade:	0
O&M Grade:	0
Clock Start/From:	
Clock To:	
1st Value:	
2nd Value:	
Value Percent:	5.000
Continuous Index:	
Within 8" of Joint:	NO
Remarks:

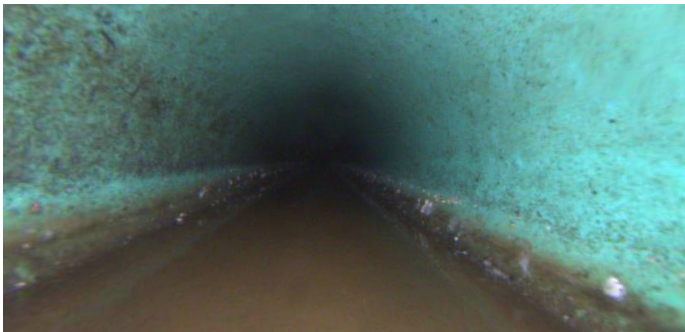
Code:	MWL
Description:	Water Level

Distance (ft):	79.2
Structural Grade:	0
O&M Grade:	0
Clock Start/From:	
Clock To:	
1st Value:	
2nd Value:	
Value Percent:	20.000
Continuous Index:	
Within 8" of Joint:	NO
Remarks:

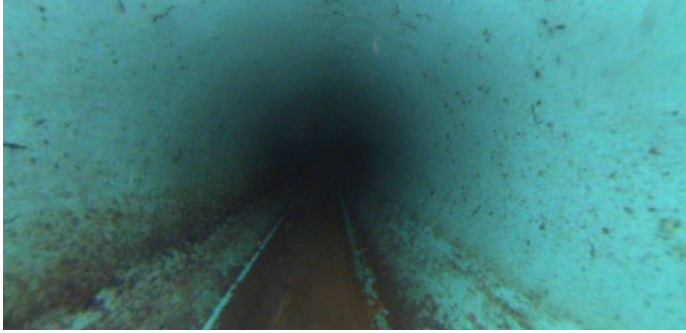
Code: **MWL**
Description: **Water Level**

Distance (ft): **90.7**
Structural Grade: **0**
O&M Grade: **0**
Clock Start/From:
Clock To:
1st Value:
2nd Value:
Value Percent: **5.000**
Continuous Index:
Within 8" of Joint: **NO**
Remarks:

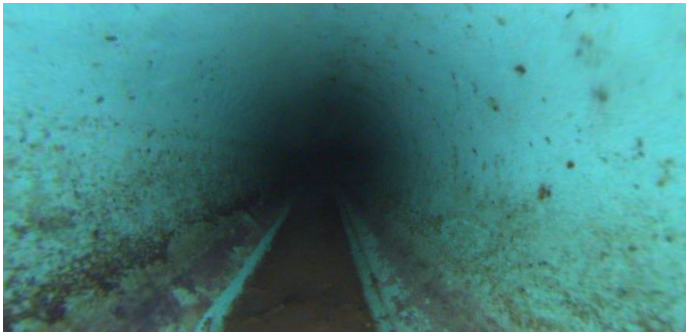
Code: **MSA**
Description: **Abandoned Survey**

Distance (ft): **251.6**
Structural Grade: **0**
O&M Grade: **0**
Clock Start/From:
Clock To:
1st Value:
2nd Value:
Value Percent:
Continuous Index:
Within 8" of Joint: **NO**
Remarks: **DSF**
