Profile/Photo Observation Report

Date:	04/12/2018	Weather:		Coding:	PACP 6.0
Pipe Length (ft):		Owner:	City of Hobart	Pre Clean:	No Pre-Cleaning
P.O.#:	35-1	Surveyor:	M. Pielacha	PSR:	M-303-072-M-303-020
Customer:	City of Hobart	Clean Date:		Shape:	C

Street:	Ridgelawn Drive	Flow Control:	Not Controlled
City:	Hobart, IN	Year Renewed:	
Location:	Light Highway	Tape/Media #:	DEP 35
Purpose:	Routine Assessment	Dia/Height:	6"
Use:	Sanitary	Material:	PVC
Drain Area:		Lining:	
Category:	NA		
Comment:

Location Details:		Direction of Survey:	Downstream
US MH:	M-303-072	DS MH:	M-303-020
		Total Length Surveyed (ft):	55.7

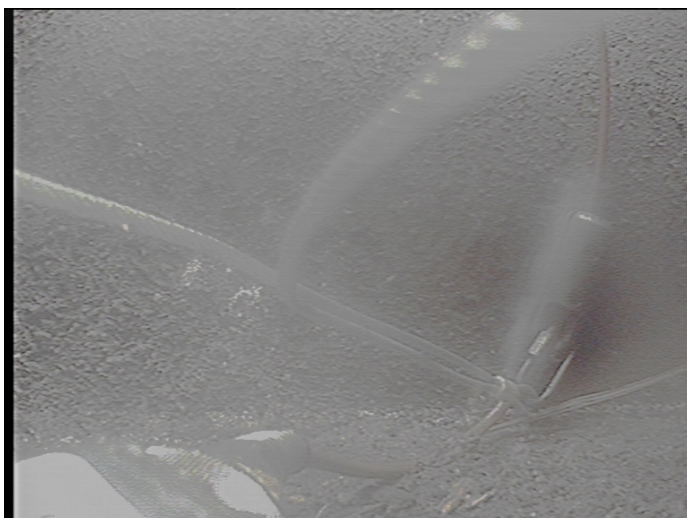
Code: **AMH**
Description: **Manhole**

Distance (ft): **.0**
Structural Grade: **0**
O&M Grade: **0**
Clock Start/From:
Clock To:
1st Value:
2nd Value:
Value Percent:
Continuous Index:
Within 8" of Joint: **NO**
Remarks: **M-303-072**
