Profile/Photo Observation Report

Date:	09/18/2021	Weather:		Coding:	PACP 7.0
Pipe Length (ft):	295.0	Owner:	City of Hobart	Pre Clean:	Light Cleaning
P.O.#:	YES502259	Surveyor:	S. Bucklin	PSR:	P-303-072-020
Customer:	City of Hobart	Clean Date:	08/25/2021	Shape:	C

Street:	Ridgelawn Drive	Flow Control:	Not Controlled
City:	Hobart, IN	Year Renewed:	
Location:	Easement/Right of Way	Tape/Media #:	
Purpose:	Routine Assessment	Dia/Height:	6"
Use:	Sanitary Sewage Pipe	Material:	PVC
Drain Area:		Lining:	None
Category:	NA		
Comment:

Location Details:		Direction of Survey:	Downstream
US MH:	M-303-072	DS MH:	M-303-020
		Total Length Surveyed (ft):	135.4

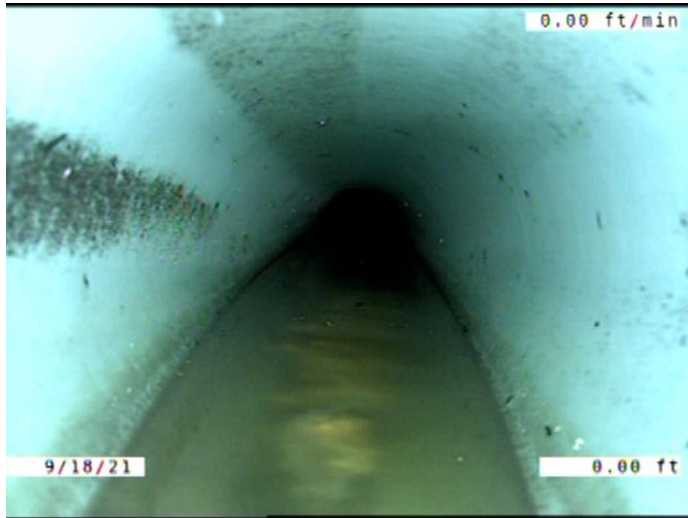
Code:	MWL
Description:	Miscellaneous Water Level
Distance (ft):	.0
Structural Grade:	0
O&M Grade:	0
Clock Start/From:	
Clock To:	
1st Value:	
2nd Value:	
Value Percent:	5.000
Continuous Index:	
Within 8" of Joint:	NO
Remarks:

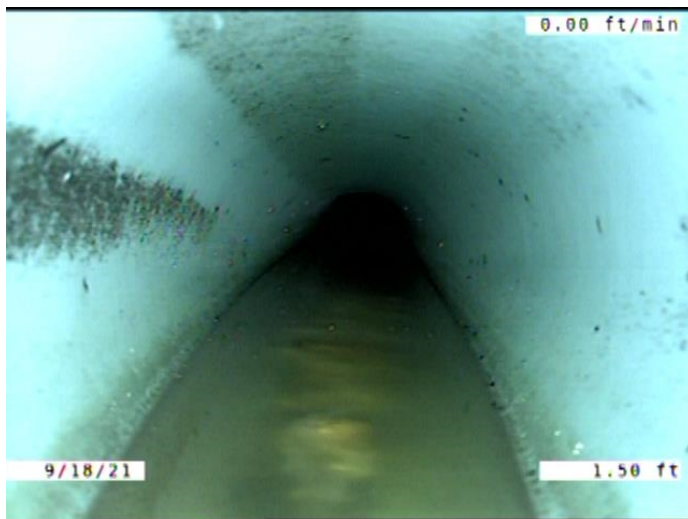
Code:	MGO
Description:	Miscellaneous General Observation
Distance (ft):	1.5
Structural Grade:	0
O&M Grade:	0
Clock Start/From:	
Clock To:	
1st Value:	
2nd Value:	
Value Percent:	
Continuous Index:	
Within 8" of Joint:	NO
Remarks:	DROP INTO THE MANHOLE. HAD TO START IN THE PIPE.

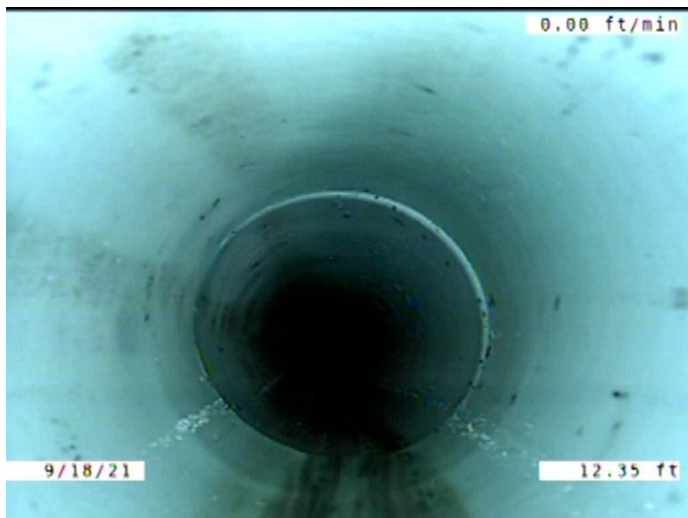
Code: **LD**
Description: **Line Down**

Distance (ft): **12.3**
Structural Grade: **0**
O&M Grade: **1**
Clock Start/From:
Clock To:
1st Value:
2nd Value:
Value Percent: **10.000**
Continuous Index:
Within 8" of Joint: **NO**
Remarks:

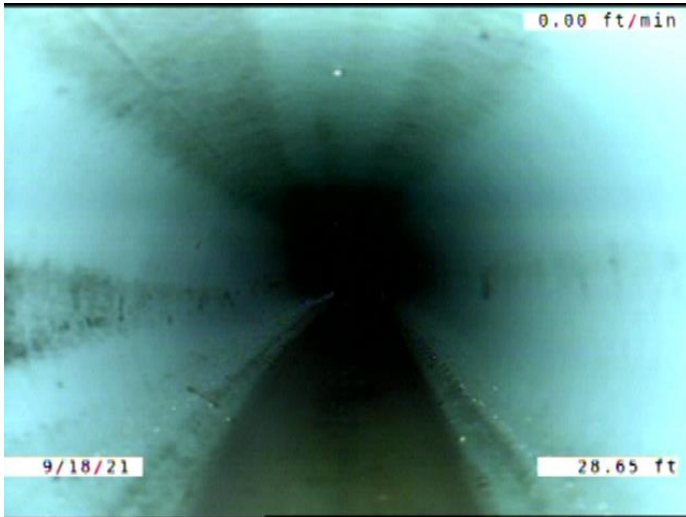
Code: **MWLS**
Description: **Miscellaneous Water Level Sag**

Distance (ft): **28.7**
Structural Grade: **2**
O&M Grade: **0**
Clock Start/From:
Clock To:
1st Value:
2nd Value:
Value Percent: **5.000**
Continuous Index:
Within 8" of Joint: **NO**
Remarks:

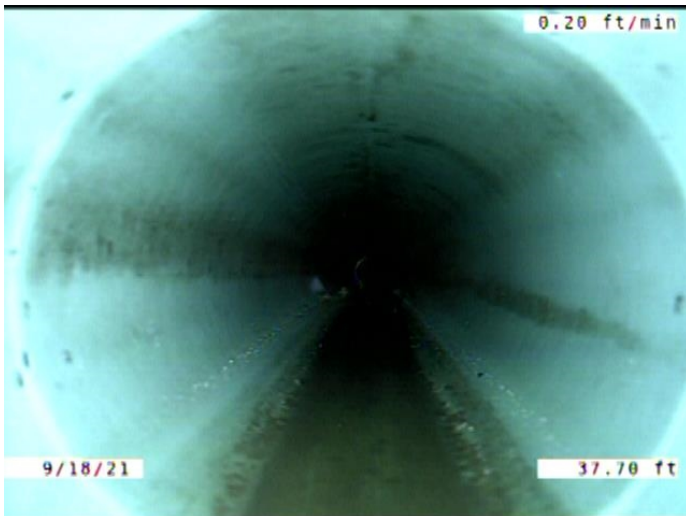
Code: **MWLS**
Description: **Miscellaneous Water Level Sag**

Distance (ft): **37.7**
Structural Grade: **2**
O&M Grade: **0**
Clock Start/From:
Clock To:
1st Value:
2nd Value:
Value Percent: **5.000**
Continuous Index:
Within 8" of Joint: **NO**
Remarks:

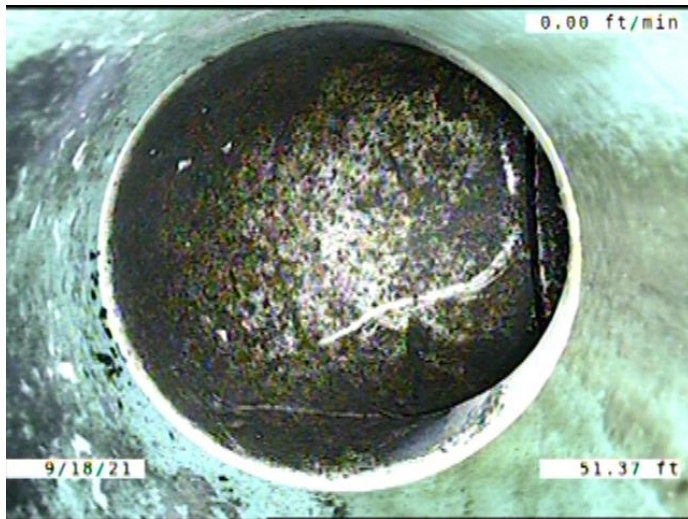
Code: **TF**
 Description: **Tap Factory**

Distance (ft): **51.4**
 Structural Grade: **0**
 O&M Grade: **0**
 Clock Start/From: **12**
 Clock To:
 1st Value: **4.000**
 2nd Value:
 Value Percent:
 Continuous Index:
 Within 8" of Joint: **YES**
 Remarks:

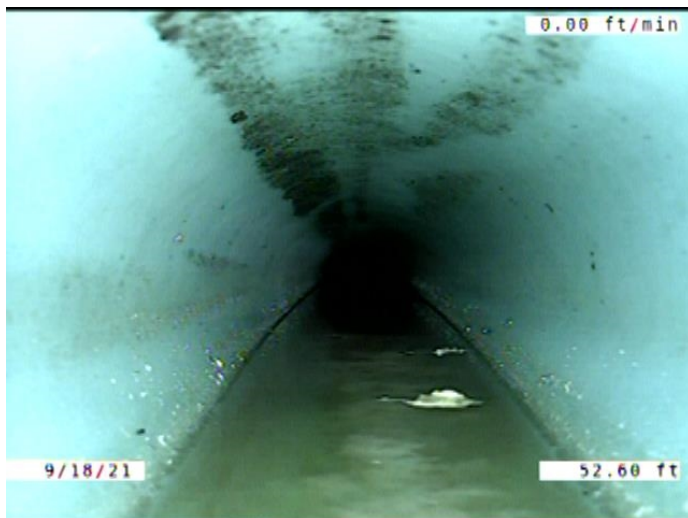
Code: **MWLS**
 Description: **Miscellaneous Water Level Sag**

Distance (ft): **52.6**
 Structural Grade: **2**
 O&M Grade: **0**
 Clock Start/From:
 Clock To:
 1st Value:
 2nd Value:
 Value Percent: **15.000**
 Continuous Index: **S03**
 Within 8" of Joint: **NO**
 Remarks:

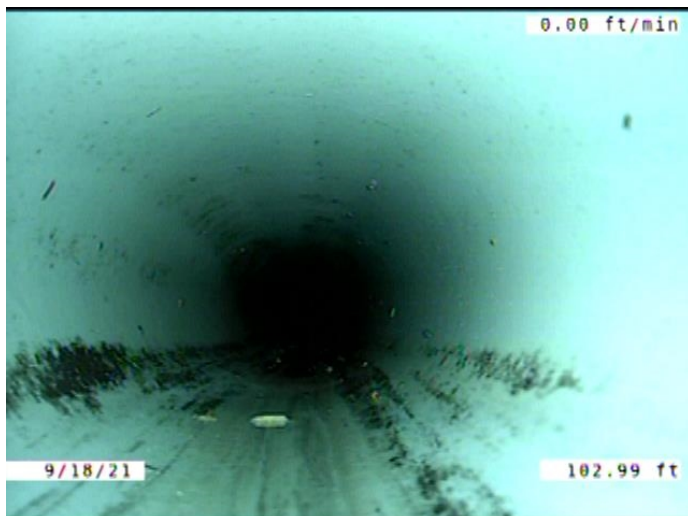
Code: **MWLS**
 Description: **Miscellaneous Water Level Sag**

Distance (ft): **103.0**
 Structural Grade: **2**
 O&M Grade: **0**
 Clock Start/From:
 Clock To:
 1st Value:
 2nd Value:
 Value Percent: **20.000**
 Continuous Index: **F04**
 Within 8" of Joint: **NO**
 Remarks:

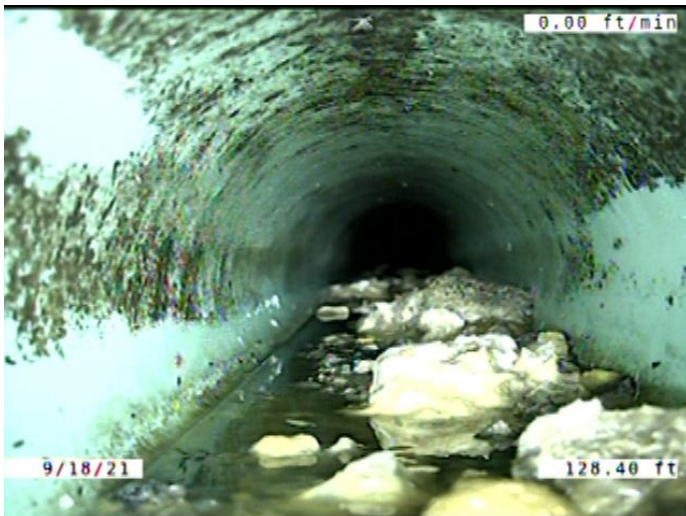
Code: **DSZ**
 Description: **Deposits Settled Other**

Distance (ft): **128.4**
 Structural Grade: **0**
 O&M Grade: **3**
 Clock Start/From: **4**
 Clock To: **8**
 1st Value:
 2nd Value:
 Value Percent: **20.000**
 Continuous Index: **S06**
 Within 8" of Joint: **YES**
 Remarks: **FINE, TP, SEWER DEBRIS**

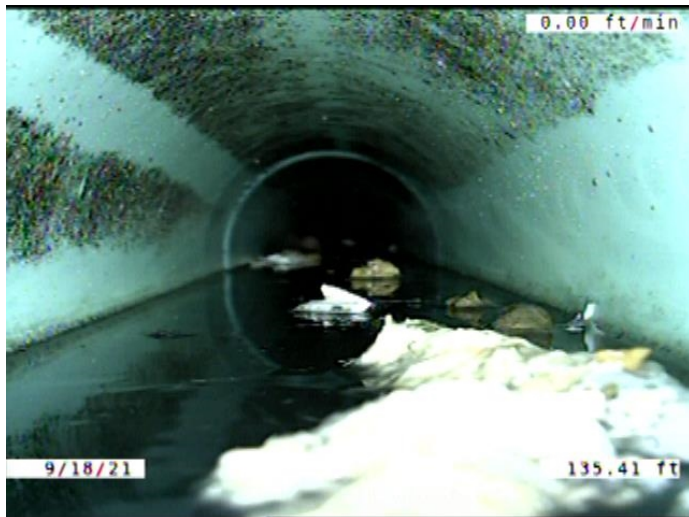
Code: **DSF**
 Description: **Deposits Settled Fine**

Distance (ft): **135.4**
 Structural Grade: **0**
 O&M Grade: **2**
 Clock Start/From: **5**
 Clock To: **7**
 1st Value:
 2nd Value:
 Value Percent: **5.000**
 Continuous Index: **F02**
 Within 8" of Joint: **YES**
 Remarks:

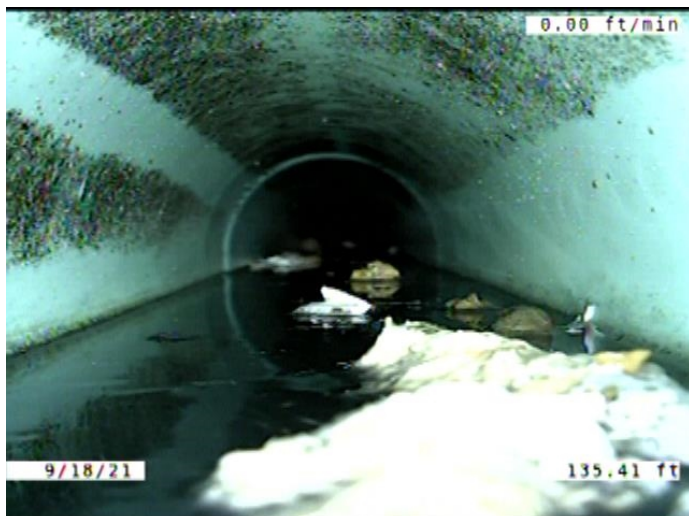
Code: **DSZ**
 Description: **Deposits Settled Other**

Distance (ft): **135.4**
 Structural Grade: **0**
 O&M Grade: **3**
 Clock Start/From: **4**
 Clock To: **8**
 1st Value:
 2nd Value:
 Value Percent: **20.000**
 Continuous Index: **F06**
 Within 8" of Joint: **YES**
 Remarks: **FINE, TP, SEWER DEBRIS**

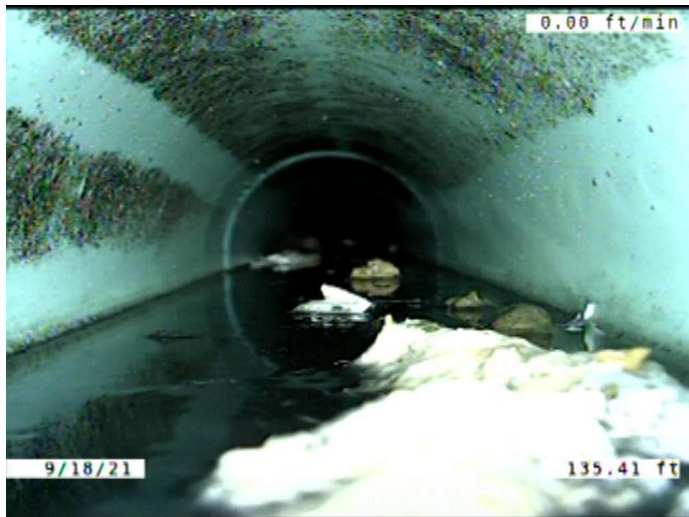
Code: **MWLS**
 Description: **Miscellaneous Water Level Sag**

Distance (ft): **135.4**
 Structural Grade: **2**
 O&M Grade: **0**
 Clock Start/From:
 Clock To:
 1st Value:
 2nd Value:
 Value Percent: **15.000**
 Continuous Index: **F05**
 Within 8" of Joint: **NO**
 Remarks:

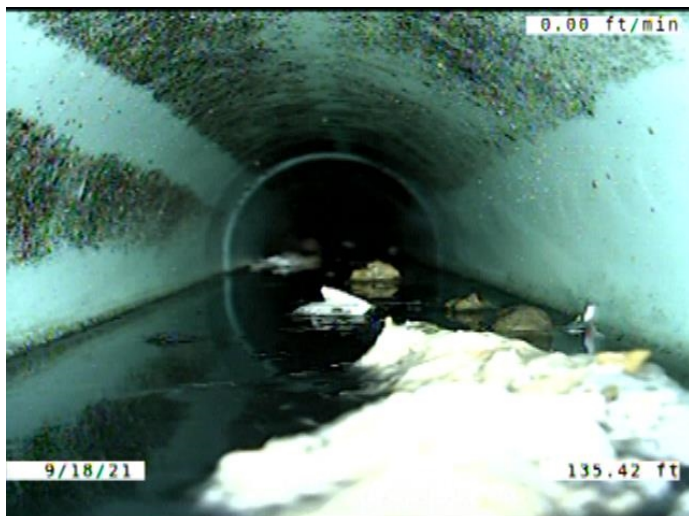
Code: **MSA**
 Description: **Miscellaneous Survey Abandoned**

Distance (ft): **135.4**
 Structural Grade: **0**
 O&M Grade: **0**
 Clock Start/From:
 Clock To:
 1st Value:
 2nd Value:
 Value Percent:
 Continuous Index:
 Within 8" of Joint: **NO**
 Remarks: **CAMERA CANT MAKE IT PAST DEBRIS**
