## Profile/Photo Observation Report

Date:	<b>04/07/2018</b>	Weather:		Coding:	<b>PACP 6.0</b>
Pipe Length (ft):		Owner:	<b>City of Hobart</b>	Pre Clean:	<b>No Pre-Cleaning</b>
P.O.#:	<b>7-1</b>	Surveyor:	<b>M. Pielacha</b>	PSR:	<b>M-303-073-M-303-021</b>
Customer:	<b>City of Hobart</b>	Clean Date:		Shape:	<b>C</b>

Street:	<b>Ridgelawn Drive</b>	Flow Control:	<b>Not Controlled</b>
City:	<b>Hobart, IN</b>	Year Renewed:	
Location:	<b>Light Highway</b>	Tape/Media #:	<b>DEP 7</b>
Purpose:	<b>Routine Assessment</b>	Dia/Height:	<b>18"</b>
Use:	<b>Sanitary</b>	Material:	<b>VCP</b>
Drain Area:		Lining:

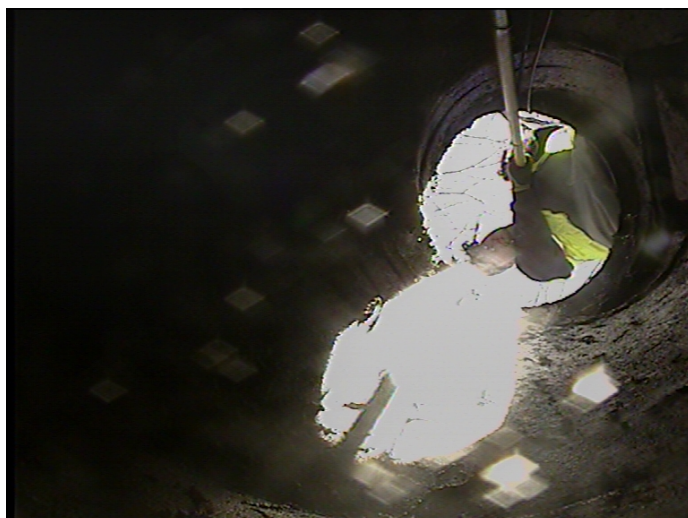
Code: **AMH**  
Description: **Manhole**

Distance (ft): **.0**  
Structural Grade: **0**  
O&M Grade: **0**  
Clock Start/From:  
Clock To:  
1st Value:  
2nd Value:  
Value Percent:  
Continuous Index:  
Within 8" of Joint: **NO**  
Remarks: **M-303-073**

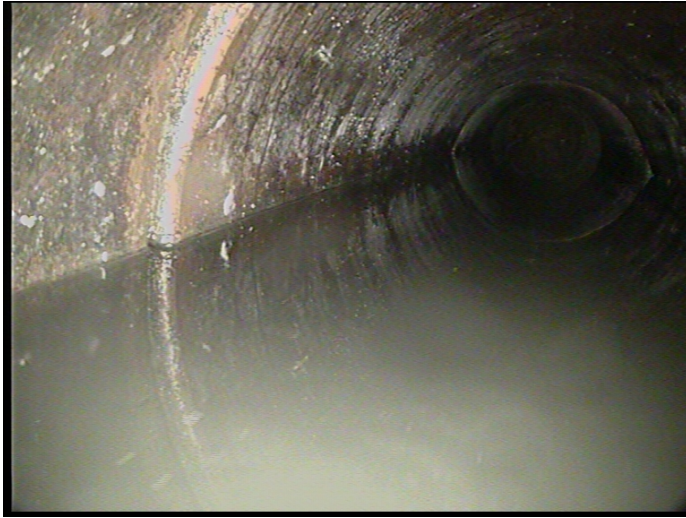
Code: **MWL**  
Description: **Water Level**

Distance (ft): **.0**  
Structural Grade: **0**  
O&M Grade: **0**  
Clock Start/From:  
Clock To:  
1st Value:  
2nd Value:  
Value Percent: **25.000**  
Continuous Index:  
Within 8" of Joint: **NO**  
Remarks:
