## Profile/Photo Observation Report

Date:	<b>01/25/2025</b>	Weather:		Coding:	<b>PACP 7.0</b>
Pipe Length (ft):	<b>355.0</b>	Owner:	<b>City of Hobart</b>	Pre Clean:	<b>Heavy Cleaning</b>
P.O.#:	<b>YES502259</b>	Surveyor:	<b>Steven Bucklin</b>	PSR:	<b>P-303-021-073</b>
Customer:	<b>City of Hobart</b>	Clean Date:	<b>10/06/2024</b>	Shape:	<b>C</b>

Street:	<b>Ridgelawn Drive</b>	Flow Control:	<b>Not Controlled</b>
City:	<b>Hobart, IN</b>	Year Renewed:	
Location:	<b>Local rural streets with light traffic, t</b>	Tape/Media #:	
Purpose:	<b>Sewer System Evaluation Survey (SS</b>	Dia/Height:	<b>18"</b>
Use:	<b>Sanitary Sewage Pipe</b>	Material:	<b>VCP</b>
Drain Area:		Lining:	<b>None</b>
Category:	<b>NA</b>		
Comment:			
Location Details:		Direction of Survey:	<b>Downstream</b>
US MH:	<b>M-303-021</b>	DS MH:	<b>M-303-073</b>
		Total Length Surveyed (ft):	<b>353.9</b>

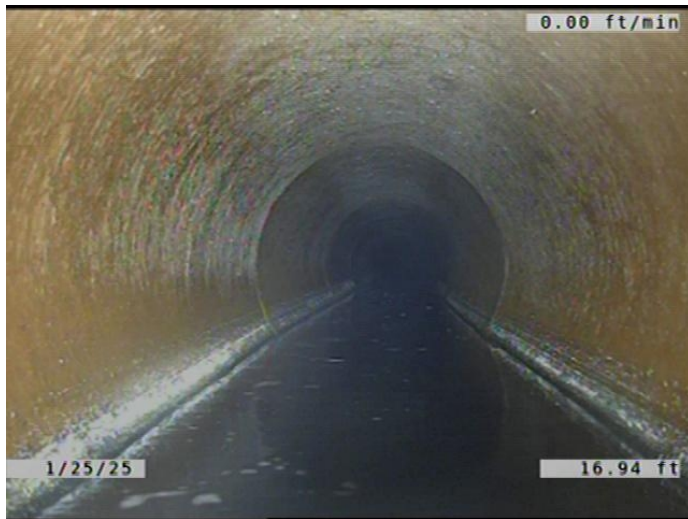
Code: **LR**  
Description: **Line Right**

Distance (ft): **16.9**  
Structural Grade: **0**  
O&M Grade: **1**  
Clock Start/From:  
Clock To:  
1st Value:  
2nd Value:  
Value Percent: **5.000**  
Continuous Index:  
Within 8" of Joint: **NO**  
Remarks:

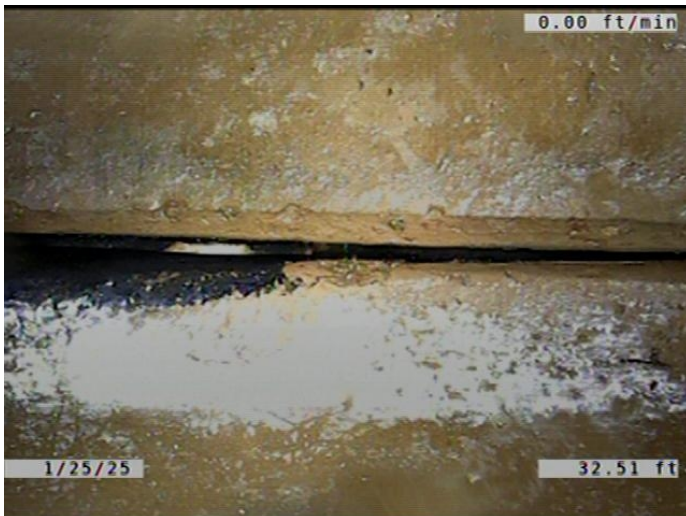
Code: **IDJ**  
Description: **Infiltration Dripper Joint**

Distance (ft): **32.5**  
Structural Grade: **0**  
O&M Grade: **3**  
Clock Start/From: **11**  
Clock To:  
1st Value:  
2nd Value:  
Value Percent:  
Continuous Index:  
Within 8" of Joint: **YES**  
Remarks:

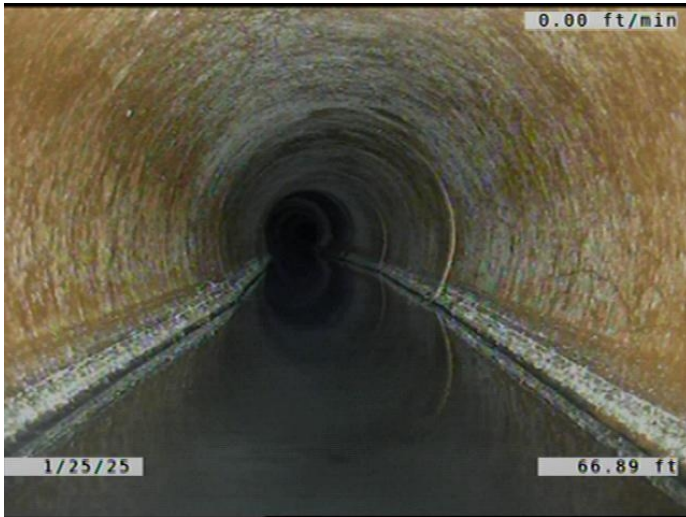
Code: **LL**  
Description: **Line Left**

Distance (ft): **66.9**  
Structural Grade: **0**  
O&M Grade: **1**  
Clock Start/From:  
Clock To:  
1st Value:  
2nd Value:  
Value Percent: **5.000**  
Continuous Index: **S02**  
Within 8" of Joint: **NO**  
Remarks:

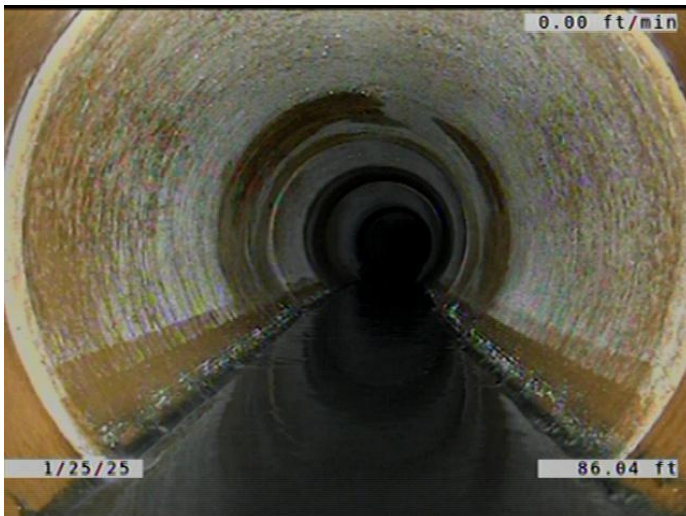
Code: **LL**  
Description: **Line Left**

Distance (ft): **86.0**  
Structural Grade: **0**  
O&M Grade: **1**  
Clock Start/From:  
Clock To:  
1st Value:  
2nd Value:  
Value Percent: **5.000**  
Continuous Index: **F02**  
Within 8" of Joint: **NO**  
Remarks:

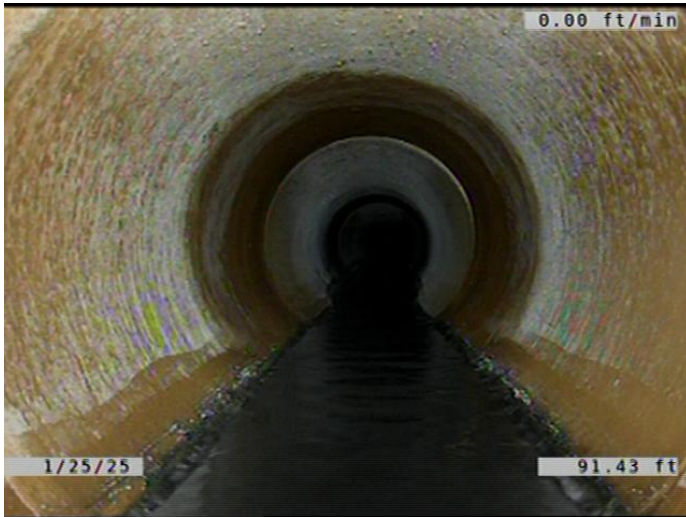
Code: **LR**  
Description: **Line Right**

Distance (ft): **91.4**  
Structural Grade: **0**  
O&M Grade: **1**  
Clock Start/From:  
Clock To:  
1st Value:  
2nd Value:  
Value Percent: **5.000**  
Continuous Index:  
Within 8" of Joint: **NO**  
Remarks:

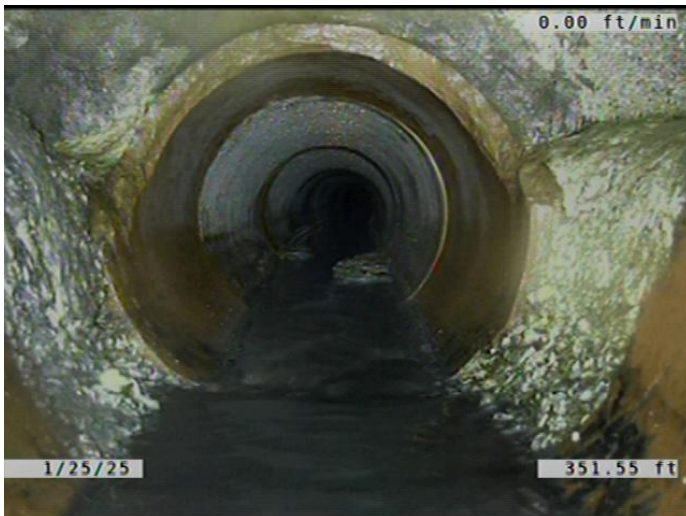
Code: **DAE**  
 Description: **Deposits Attached Encrustation**

Distance (ft): **351.6**  
 Structural Grade: **0**  
 O&M Grade: **2**  
 Clock Start/From: **8**  
 Clock To: **4**  
 1st Value:  
 2nd Value:  
 Value Percent: **5.000**  
 Continuous Index: **F01**  
 Within 8" of Joint: **YES**  
 Remarks:
