## Profile/Photo Observation Report

Street:	<b>Old Ridge Road</b>	Flow Control:	<b>Not Controlled</b>
City:	<b>Hobart, IN</b>	Year Renewed:	
Location:	<b>Light Highway</b>	Tape/Media #:	<b>DEP 15</b>
Purpose:	<b>Routine Assessment</b>	Dia/Height:	<b>18"</b>
Use:	<b>Sanitary</b>	Material:	<b>VCP</b>
Drain Area:		Lining:

US MH: **M-304-001** DS MH: **M-404-035** Total Length Surveyed (ft): **161.6**

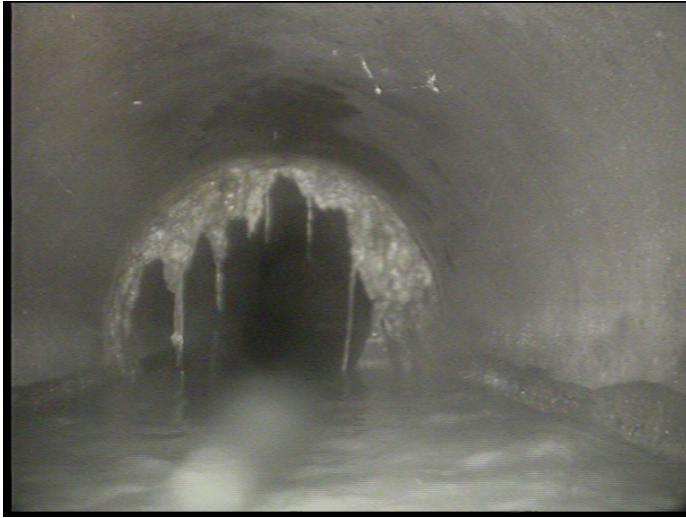
Code:	AMH
Description:	Manhole
Distance (ft):	.0
Structural Grade:	0
O&M Grade:	0
Clock Start/From:	
Clock To:	
1st Value:	
2nd Value:	
Value Percent:	
Continuous Index:	
Within 8" of Joint:	NO
Remarks:	M-304-001
