Profile/Photo Observation Report

Date:	04/07/2018	Weather:		Coding:	PACP 6.0
Pipe Length (ft):		Owner:	City of Hobart	Pre Clean:	No Pre-Cleaning
P.O.#:	14-1	Surveyor:	M. Pielacha	PSR:	M-304-002-M-304-001
Customer:	City of Hobart	Clean Date:		Shape:	C

Street:	Old Ridge Road	Flow Control:	Not Controlled
City:	Hobart, IN	Year Renewed:	
Location:	Light Highway	Tape/Media #:	DEP 14
Purpose:	Routine Assessment	Dia/Height:	18"
Use:	Sanitary	Material:	VCP
Drain Area:		Lining:	
Category:	NA		
Comment:			
Location Details:		Direction of Survey:	Upstream
US MH:	M-304-002	DS MH:	M-304-001
		Total Length Surveyed (ft):	327.4

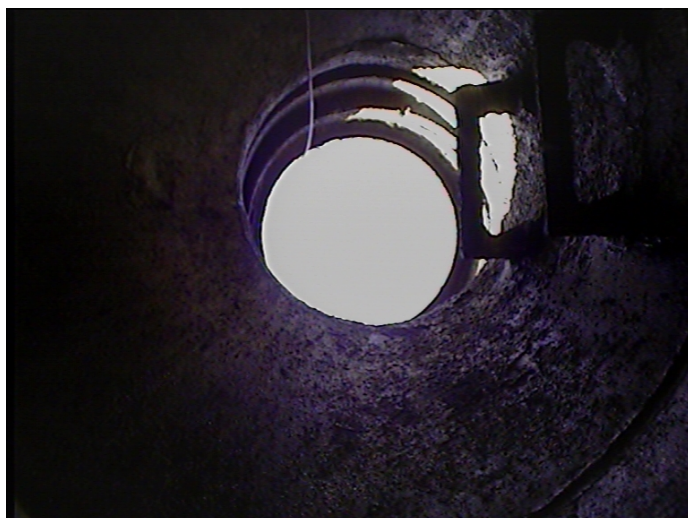
Code: **AMH**
Description: **Manhole**

Distance (ft): **.0**
Structural Grade: **0**
O&M Grade: **0**
Clock Start/From:
Clock To:
1st Value:
2nd Value:
Value Percent:
Continuous Index:
Within 8" of Joint: **NO**
Remarks: **M-304-001**

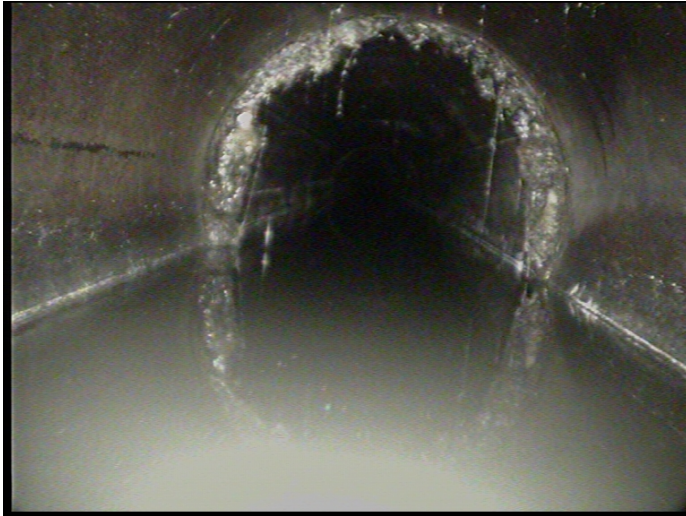
Code: **MWL**
Description: **Water Level**

Distance (ft): **.0**
Structural Grade: **0**
O&M Grade: **0**
Clock Start/From:
Clock To:
1st Value:
2nd Value:
Value Percent: **15.000**
Continuous Index:
Within 8" of Joint: **NO**
Remarks:

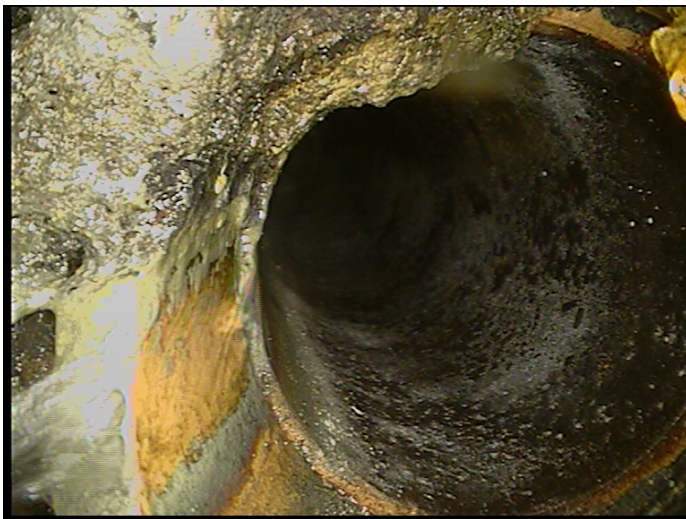
Code: **TBA**
Description: **Tap Break-in Active**

Distance (ft): **130.0**
Structural Grade: **0**
O&M Grade: **0**
Clock Start/From: **9**
Clock To:
1st Value: **4.000**
2nd Value:
Value Percent:
Continuous Index:
Within 8" of Joint: **NO**
Remarks:

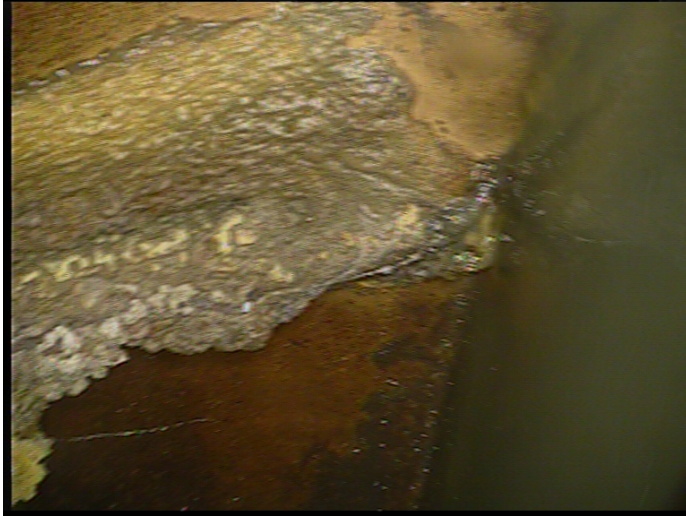
Code: **DAE**
Description: **Deposits Attached Encrustation**

Distance (ft): **236.0**
Structural Grade: **0**
O&M Grade: **2**
Clock Start/From: **7**
Clock To: **5**
1st Value:
2nd Value:
Value Percent: **5.000**
Continuous Index:
Within 8" of Joint: **YES**
Remarks:

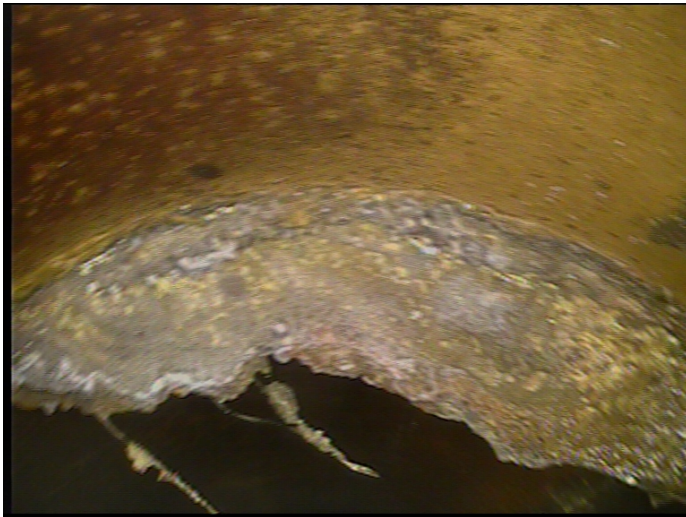
Code: **DAE**
Description: **Deposits Attached Encrustation**

Distance (ft): **285.8**
Structural Grade: **0**
O&M Grade: **2**
Clock Start/From: **7**
Clock To: **5**
1st Value:
2nd Value:
Value Percent: **10.000**
Continuous Index:
Within 8" of Joint: **YES**
Remarks:

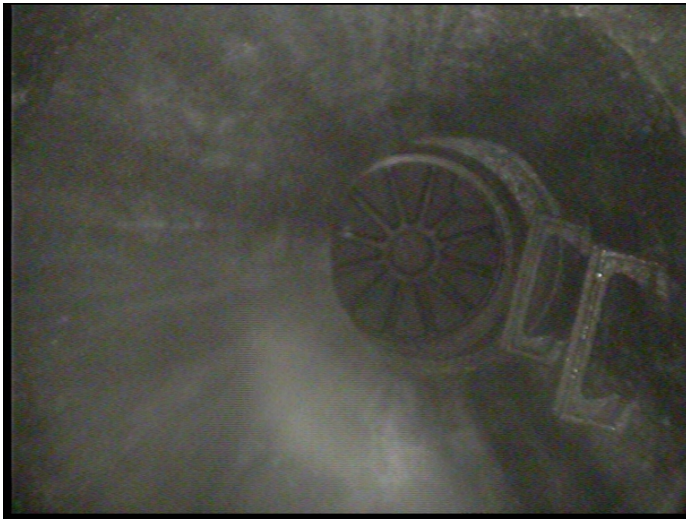
Code:	AMH
Description:	Manhole
Distance (ft):	327.4
Structural Grade:	0
O&M Grade:	0
Clock Start/From:	
Clock To:	
1st Value:	
2nd Value:	
Value Percent:	
Continuous Index:	
Within 8" of Joint:	NO
Remarks:	M-304-002
