Profile/Photo Observation Report

Date:	04/07/2018	Weather:		Coding:	PACP 6.0
Pipe Length (ft):		Owner:	City of Hobart	Pre Clean:	No Pre-Cleaning
P.O.#:	14-1	Surveyor:	M. Pielacha	PSR:	M-304-002-M-304-001
Customer:	City of Hobart	Clean Date:		Shape:	C

Street:	Old Ridge Road	Flow Control:	Not Controlled
City:	Hobart, IN	Year Renewed:	
Location:	Light Highway	Tape/Media #:	DEP 14
Purpose:	Routine Assessment	Dia/Height:	18"
Use:	Sanitary	Material:	VCP
Drain Area:		Lining:	
Category:	NA		
Comment:			
Location Details:		Direction of Survey:	Upstream
US MH:	M-304-002	DS MH:	M-304-001
		Total Length Surveyed (ft):	327.4

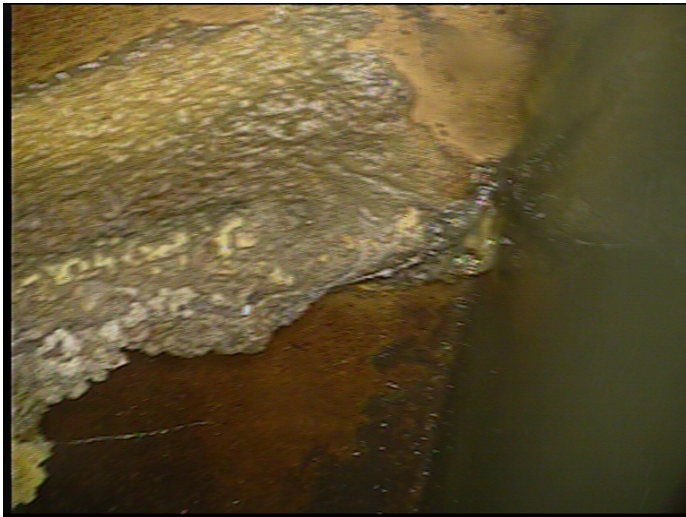
Code:	DAE
Description:	Deposits Attached Encrustation
Distance (ft):	236.0
Structural Grade:	0
O&M Grade:	2
Clock Start/From:	7
Clock To:	5
1st Value:	
2nd Value:	
Value Percent:	5.000
Continuous Index:	
Within 8" of Joint:	YES
Remarks:

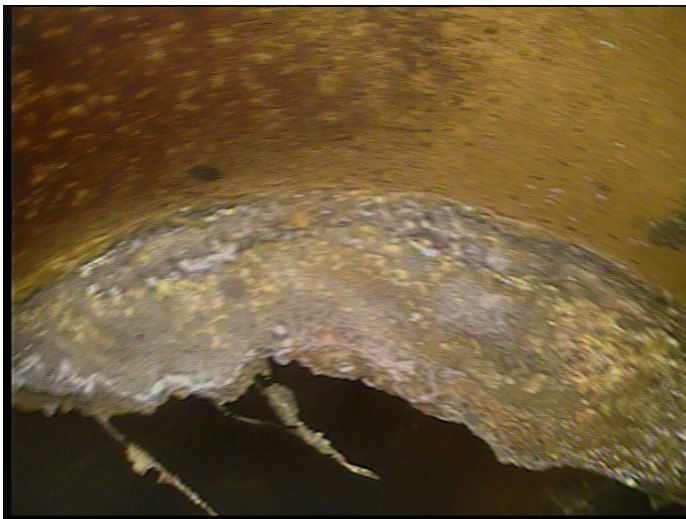
Code:	DAE
Description:	Deposits Attached Encrustation
Distance (ft):	285.8
Structural Grade:	0
O&M Grade:	2
Clock Start/From:	7
Clock To:	5
1st Value:	
2nd Value:	
Value Percent:	10.000
Continuous Index:	
Within 8" of Joint:	YES
Remarks:
