Profile/Photo Observation Report

Street:	W OLD RIDGE RD	Flow Control:	Not Controlled
City:	Hobart, IN	Year Renewed:	
Location:	Light Highway	Tape/Media #:	
Purpose:	Routine Assessment	Dia/Height:	12"
Use:	Sanitary	Material:	PVC
Drain Area:	NA	Lining:	
Category:	NA		
Comment:

Location Details:		Direction of Survey:	Downstream
US MH:	M-304-004	DS MH:	M-304-001
		Total Length Surveyed (ft):	45.7

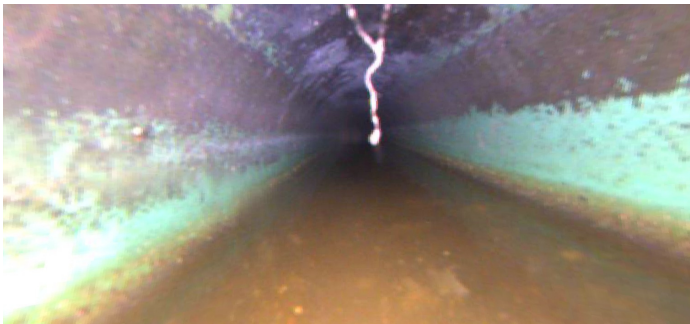
Code: AMH

Description: Manhole

Distance (ft): .0

Remarks: M-304-004

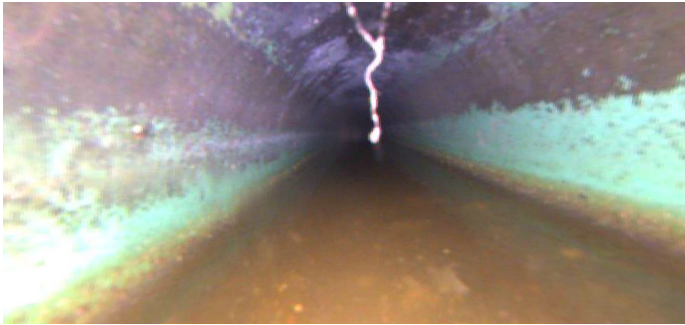
Code:	MWL
Description:	Water Level

Distance (ft):	.0
Structural Grade:	0
O&M Grade:	0
Clock Start/From:	
Clock To:	
1st Value:	
2nd Value:	
Value Percent:	5.000
Continuous Index:	
Within 8" of Joint:	NO
Remarks:

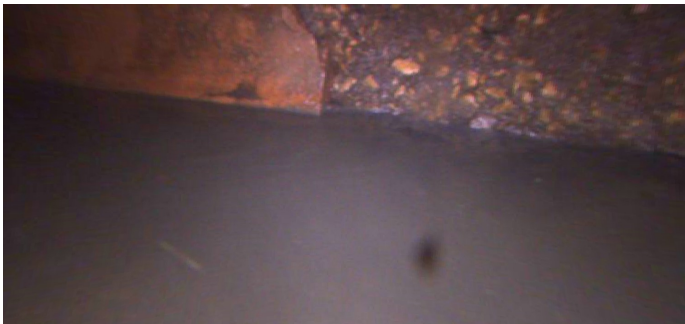
Code:	AMH
Description:	Manhole

Distance (ft):	45.7
Structural Grade:	0
O&M Grade:	0
Clock Start/From:	
Clock To:	
1st Value:	
2nd Value:	
Value Percent:	
Continuous Index:	
Within 8" of Joint:	NO
Remarks:	M-304-001
