## Profile/Photo Observation Report

Street:	<b>Old Ridge Rd.</b>	Flow Control:	<b>Not Controlled</b>
City:	<b>Hobart, IN</b>	Year Renewed:	
Location:	<b>Light Highway</b>	Tape/Media #:	
Purpose:	<b>Routine Assessment</b>	Dia/Height:	<b>12"</b>
Use:	<b>Sanitary</b>	Material:	<b>PVC</b>
Drain Area:	<b>NA</b>	Lining:	
Category:	<b>NA</b>		
Comment:

Location Details:		Direction of Survey:	<b>Downstream</b>
US MH:	<b>M-304-004</b>	DS MH:	<b>M-304-001</b>
		Total Length Surveyed (ft):	<b>45.7</b>

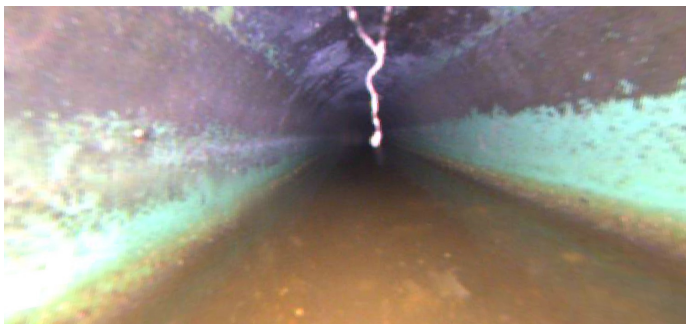
Code: **AMH**  
Description: **Manhole**

Distance (ft): **.0**  
Structural Grade: **0**  
O&M Grade: **0**  
Clock Start/From:  
Clock To:  
1st Value:  
2nd Value:  
Value Percent:  
Continuous Index:  
Within 8" of Joint: **NO**  
Remarks: **M-304-004**

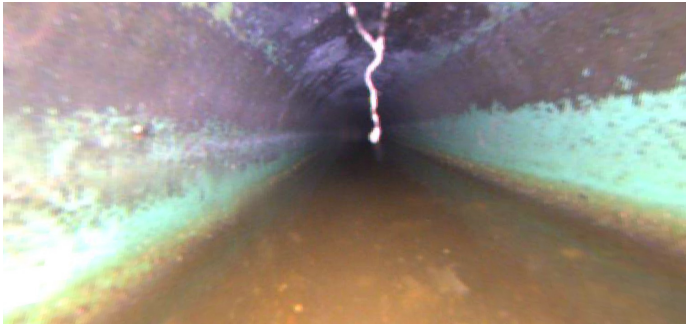
Code:	<b>MWL</b>
Description:	<b>Water Level</b>

Distance (ft):	<b>.0</b>
Structural Grade:	<b>0</b>
O&M Grade:	<b>0</b>
Clock Start/From:	
Clock To:	
1st Value:	
2nd Value:	
Value Percent:	<b>5.000</b>
Continuous Index:	
Within 8" of Joint:	<b>NO</b>
Remarks:

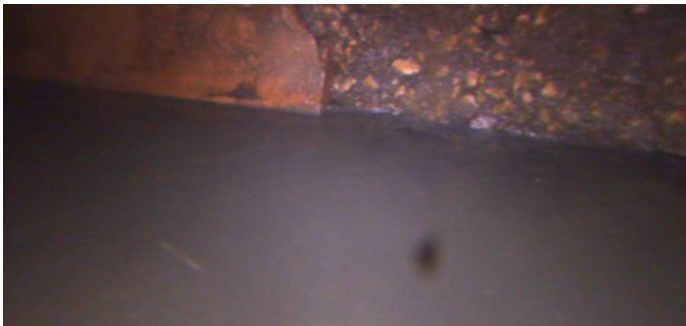
Code:	<b>AMH</b>
Description:	<b>Manhole</b>

Distance (ft):	<b>45.7</b>
Structural Grade:	<b>0</b>
O&M Grade:	<b>0</b>
Clock Start/From:	
Clock To:	
1st Value:	
2nd Value:	
Value Percent:	
Continuous Index:	
Within 8" of Joint:	<b>NO</b>
Remarks:	<b>M-304-001</b>
