Profile/Photo Observation Report

Street:	FOXCROFT STREET	Flow Control:	Not Controlled
City:	Hobart, IN	Year Renewed:	
Location:	Yard	Tape/Media #:	
Purpose:	Routine Assessment	Dia/Height:	10"
Use:	Sanitary	Material:	PVC
Drain Area:	NA	Lining:	Cured in Place
Category:	NA		
Comment:

Location Details:		Direction of Survey:	Downstream
US MH:	M-305-001	DS MH:	M-405-031
		Total Length Surveyed (ft):	16.1

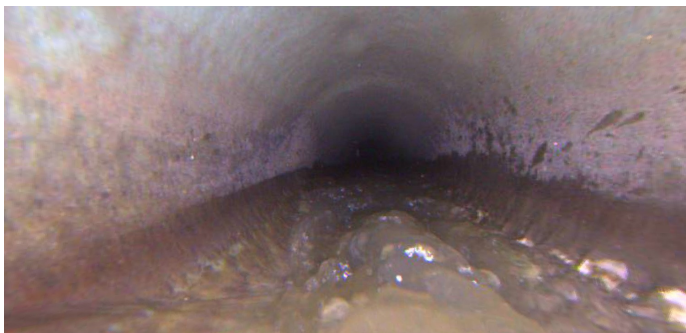
Code: **AMH**
Description: **Manhole**

Distance (ft): **.0**
Structural Grade: **0**
O&M Grade: **0**
Clock Start/From:
Clock To:
1st Value:
2nd Value:
Value Percent:
Continuous Index:
Within 8" of Joint: **NO**
Remarks: **M-305-001**

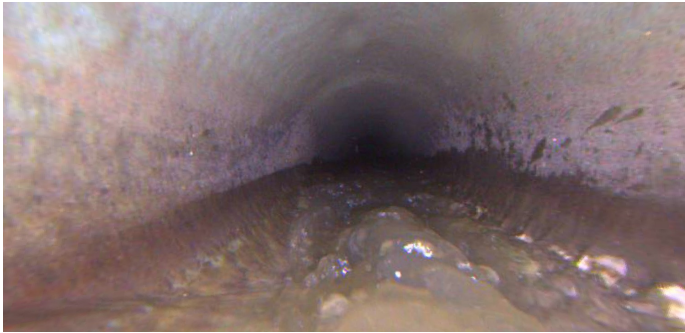
Code:	MWL
Description:	Water Level

Distance (ft):	.0
Structural Grade:	0
O&M Grade:	0
Clock Start/From:	
Clock To:	
1st Value:	
2nd Value:	
Value Percent:	10.000
Continuous Index:	
Within 8" of Joint:	NO
Remarks:

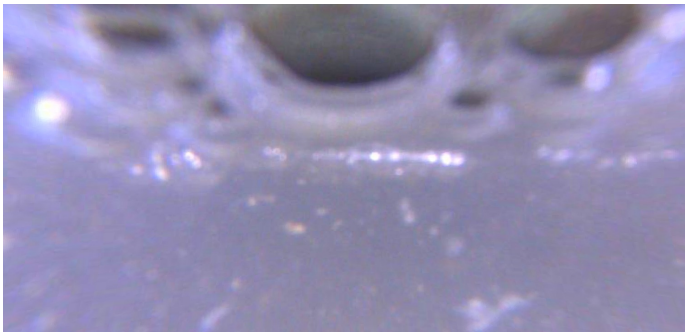
Code:	MWL
Description:	Water Level

Distance (ft):	8.5
Structural Grade:	0
O&M Grade:	0
Clock Start/From:	
Clock To:	
1st Value:	
2nd Value:	
Value Percent:	50.000
Continuous Index:	
Within 8" of Joint:	NO
Remarks:

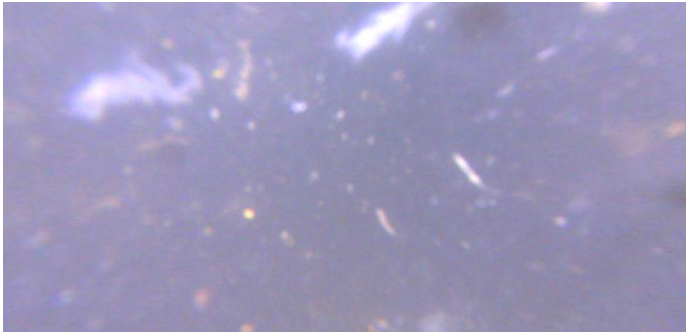
Code: **MSA**
Description: **Abandoned Survey**

Distance (ft): **16.1**
Structural Grade: **0**
O&M Grade: **0**
Clock Start/From:
Clock To:
1st Value:
2nd Value:
Value Percent:
Continuous Index:
Within 8" of Joint: **NO**
Remarks: **mcu**

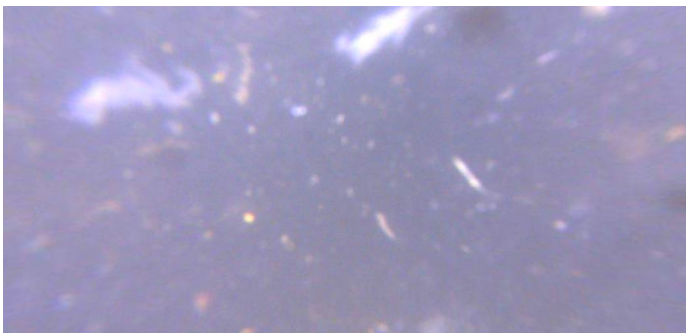
Code: **MCU**
Description: **Camera Underwater**

Distance (ft): **16.1**
Structural Grade: **0**
O&M Grade: **4**
Clock Start/From:
Clock To:
1st Value:
2nd Value:
Value Percent:
Continuous Index:
Within 8" of Joint: **NO**
Remarks:
