Profile/Photo Observation Report

Street:	ALLEY WALNUT LN & W 49TH AVE	Flow Control:	Not Controlled
City:	Hobart, IN	Year Renewed:	
Location:	Yard	Tape/Media #:	
Purpose:	Routine Assessment	Dia/Height:	10"
Use:	Sanitary	Material:	XXX
Drain Area:	NA	Lining:	Cured in Place
Category:	NA		
Comment:

Location Details:		Direction of Survey:	Upstream
US MH:	M-305-008	DS MH:	M-305-007
		Total Length Surveyed (ft):	269.5

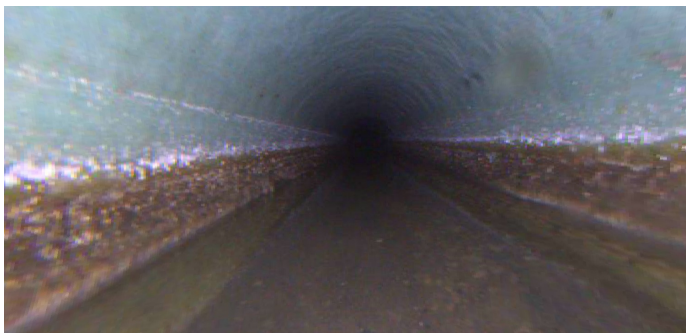
Code: **AMH**
Description: **Manhole**

Distance (ft): **.0**
Structural Grade: **0**
O&M Grade: **0**
Clock Start/From:
Clock To:
1st Value:
2nd Value:
Value Percent:
Continuous Index:
Within 8" of Joint: **NO**
Remarks: **M-305-007**

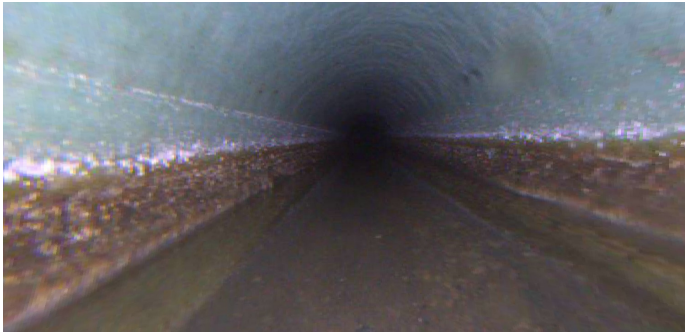
Code:	MWL
Description:	Water Level

Distance (ft):	.0
Structural Grade:	0
O&M Grade:	0
Clock Start/From:	
Clock To:	
1st Value:	
2nd Value:	
Value Percent:	5.000
Continuous Index:	
Within 8" of Joint:	NO
Remarks:

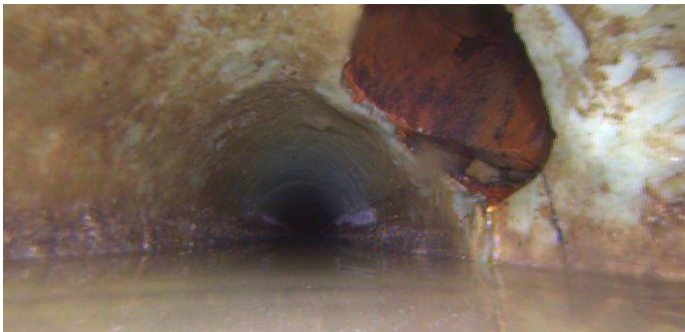
Code:	TB
Description:	Tap Break-in

Distance (ft):	7.4
Structural Grade:	0
O&M Grade:	0
Clock Start/From:	1
Clock To:	
1st Value:	6.000
2nd Value:	
Value Percent:	
Continuous Index:	
Within 8" of Joint:	
Remarks:

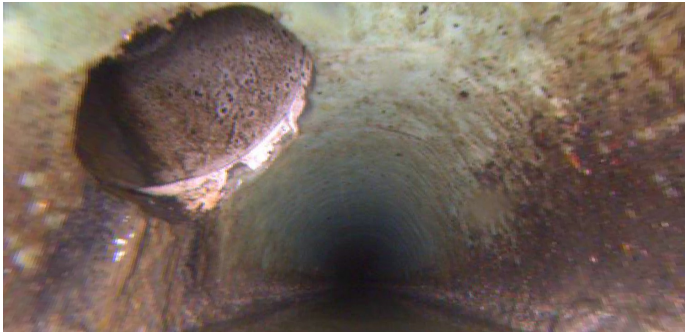
Code: **TB**
Description: **Tap Break-in**

Distance (ft): **16.8**
Structural Grade: **0**
O&M Grade: **0**
Clock Start/From: **11**
Clock To:
1st Value: **4.000**
2nd Value:
Value Percent:
Continuous Index:
Within 8" of Joint:
Remarks:

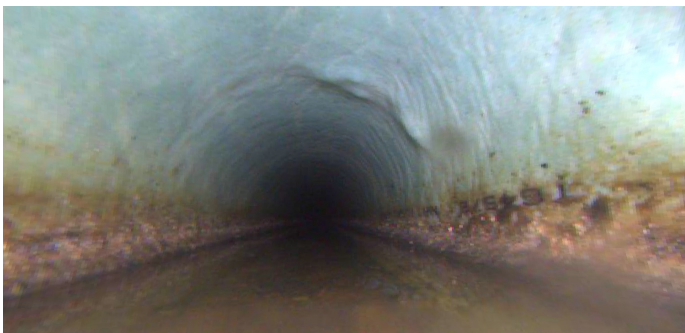
Code: **LFBU**
Description: **Lining Failure Bulges**

Distance (ft): **23.1**
Structural Grade: **0**
O&M Grade: **0**
Clock Start/From: **12**
Clock To: **2**
1st Value:
2nd Value:
Value Percent:
Continuous Index:
Within 8" of Joint: **NO**
Remarks:

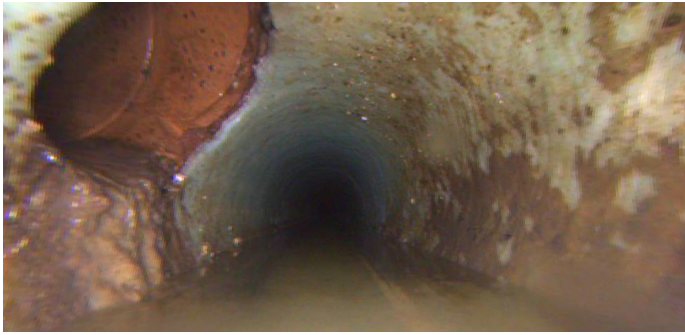
Code: **TB**
Description: **Tap Break-in**

Distance (ft): **86.7**
Structural Grade: **0**
O&M Grade: **0**
Clock Start/From: **10**
Clock To:
1st Value: **6.000**
2nd Value:
Value Percent:
Continuous Index:
Within 8" of Joint:
Remarks:

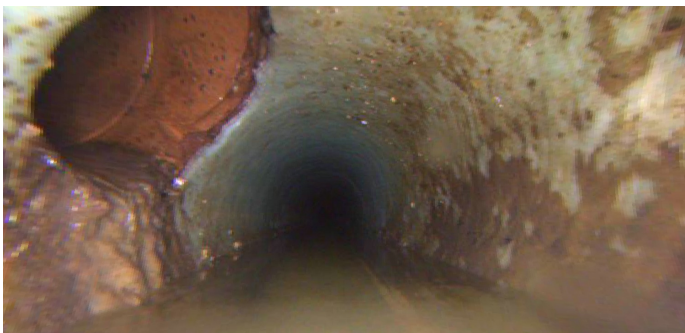
Code: **DAGS**
Description: **Deposits Attached Grease**

Distance (ft): **86.7**
Structural Grade: **0**
O&M Grade: **2**
Clock Start/From: **7**
Clock To: **9**
1st Value:
2nd Value:
Value Percent: **5.000**
Continuous Index:
Within 8" of Joint: **NO**
Remarks:

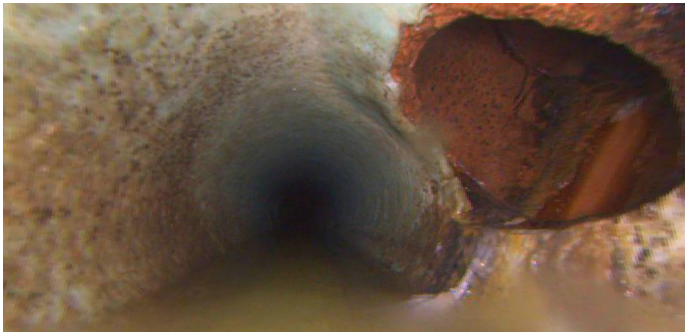
Code: **TB**
Description: **Tap Break-in**

Distance (ft): **156.1**
Structural Grade: **0**
O&M Grade: **0**
Clock Start/From: **2**
Clock To:
1st Value: **6.000**
2nd Value:
Value Percent:
Continuous Index:
Within 8" of Joint:
Remarks:

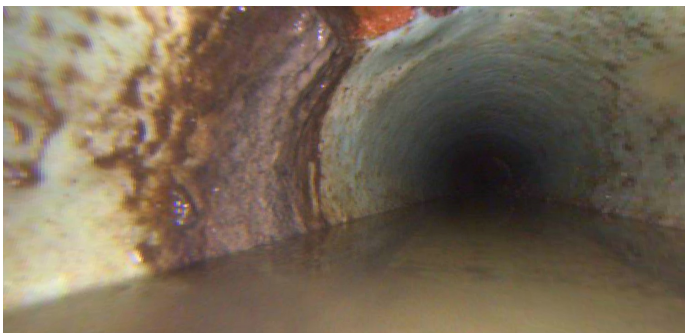
Code: **DAGS**
Description: **Deposits Attached Grease**

Distance (ft): **226.1**
Structural Grade: **0**
O&M Grade: **2**
Clock Start/From: **8**
Clock To: **11**
1st Value:
2nd Value:
Value Percent: **5.000**
Continuous Index:
Within 8" of Joint: **NO**
Remarks:

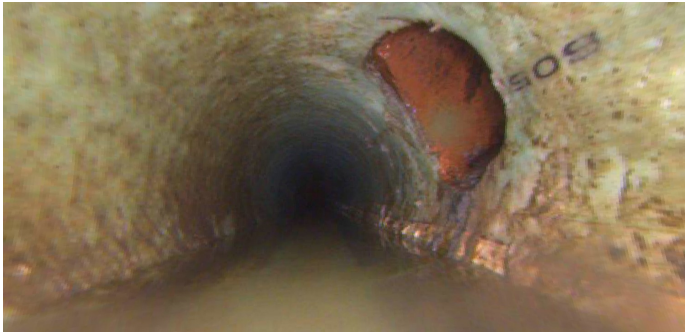
Code: **TB**
Description: **Tap Break-in**

Distance (ft): **230.6**
Structural Grade: **0**
O&M Grade: **0**
Clock Start/From: **2**
Clock To:
1st Value: **4.000**
2nd Value:
Value Percent:
Continuous Index:
Within 8" of Joint:
Remarks:
