Profile/Photo Observation Report

Street:	FOXCROFT STREET	Flow Control:	Not Controlled
City:	Hobart, IN	Year Renewed:	
Location:	Yard	Tape/Media #:	
Purpose:	Routine Assessment	Dia/Height:	10"
Use:	Sanitary	Material:	XXX
Drain Area:	NA	Lining:	Cured in Place
Category:	NA		
Comment:

Location Details:		Direction of Survey:	Upstream
US MH:	M-305-008	DS MH:	M-305-007
		Total Length Surveyed (ft):	269.5

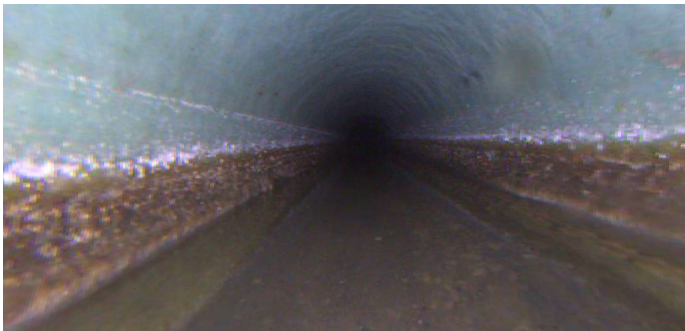
Code: **AMH**
Description: **Manhole**

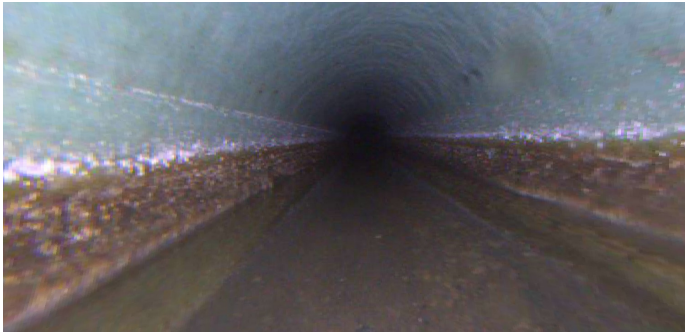
Code:	MWL
Description:	Water Level

Distance (ft):	.0
Structural Grade:	0
O&M Grade:	0
Clock Start/From:	
Clock To:	
1st Value:	
2nd Value:	
Value Percent:	5.000
Continuous Index:	
Within 8" of Joint:	NO
Remarks:

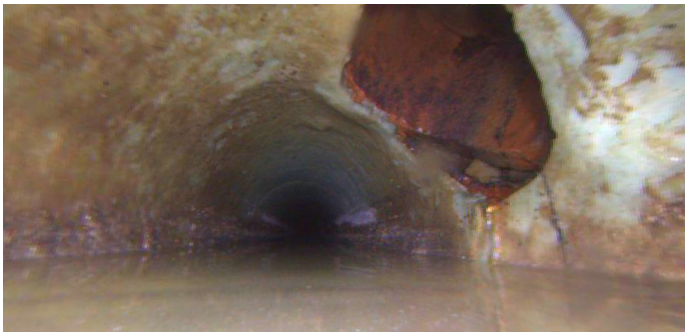
Code:	TB
Description:	Tap Break-in

Distance (ft):	7.4
Structural Grade:	0
O&M Grade:	0
Clock Start/From:	1
Clock To:	
1st Value:	6.000
2nd Value:	
Value Percent:	
Continuous Index:	
Within 8" of Joint:	
Remarks:

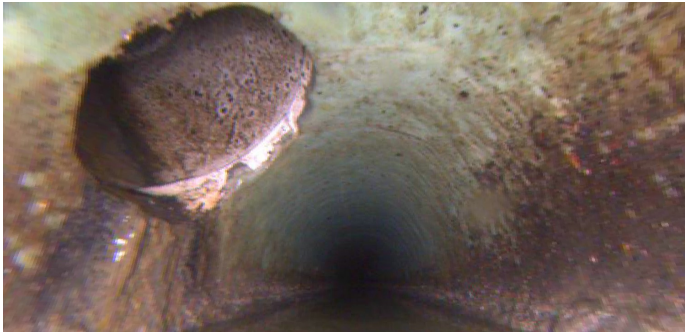
Code: **TB**
Description: **Tap Break-in**

Distance (ft): **16.8**
Structural Grade: **0**
O&M Grade: **0**
Clock Start/From: **11**
Clock To:
1st Value: **4.000**
2nd Value:
Value Percent:
Continuous Index:
Within 8" of Joint:
Remarks:

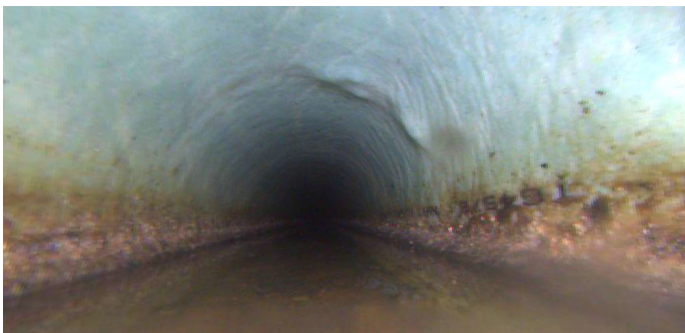
Code: **LFBU**
Description: **Lining Failure Bulges**

Distance (ft): **23.1**
Structural Grade: **0**
O&M Grade: **0**
Clock Start/From: **12**
Clock To: **2**
1st Value:
2nd Value:
Value Percent:
Continuous Index:
Within 8" of Joint: **NO**
Remarks:

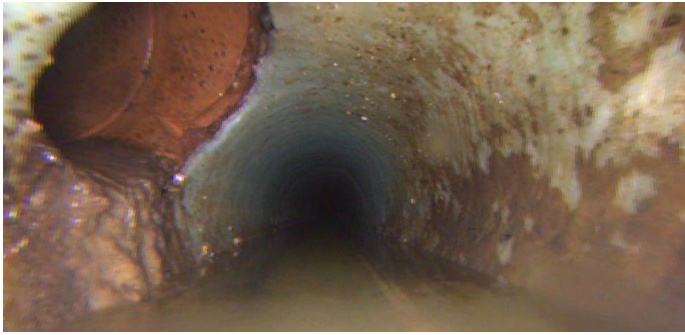
Code: **TB**
Description: **Tap Break-in**

Distance (ft): **86.7**
Structural Grade: **0**
O&M Grade: **0**
Clock Start/From: **10**
Clock To:
1st Value: **6.000**
2nd Value:
Value Percent:
Continuous Index:
Within 8" of Joint:
Remarks:

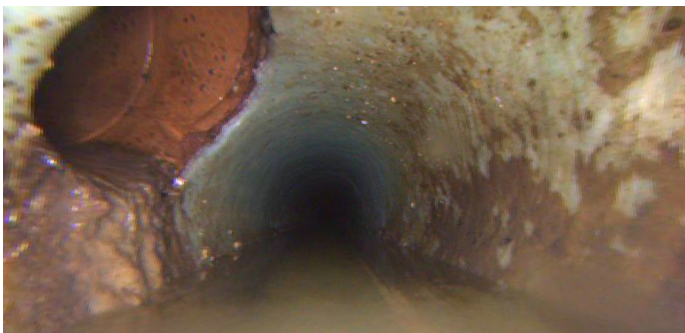
Code: **DAGS**
Description: **Deposits Attached Grease**

Distance (ft): **86.7**
Structural Grade: **0**
O&M Grade: **2**
Clock Start/From: **7**
Clock To: **9**
1st Value:
2nd Value:
Value Percent: **5.000**
Continuous Index:
Within 8" of Joint: **NO**
Remarks:

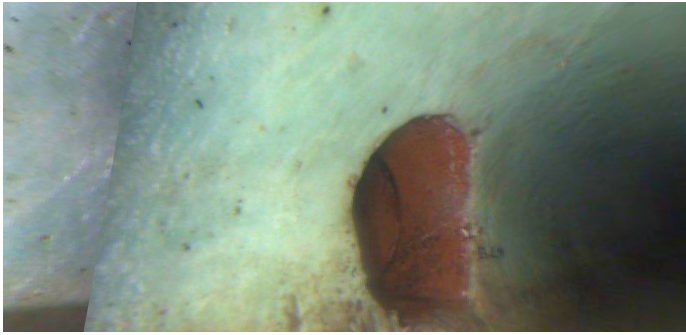
Code: **TB**
Description: **Tap Break-in**

Distance (ft): **98.5**
Structural Grade: **0**
O&M Grade: **0**
Clock Start/From: **3**
Clock To:
1st Value: **4.000**
2nd Value:
Value Percent:
Continuous Index:
Within 8" of Joint:
Remarks:

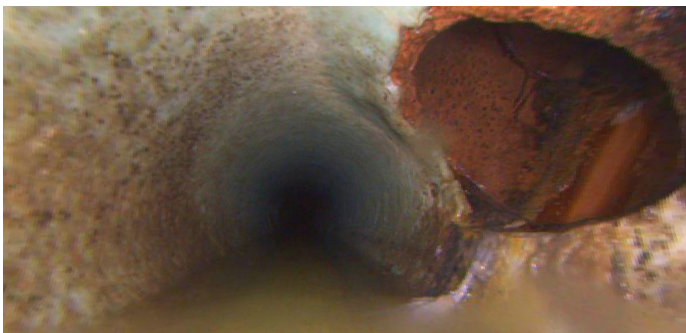
Code: **TB**
Description: **Tap Break-in**

Distance (ft): **156.1**
Structural Grade: **0**
O&M Grade: **0**
Clock Start/From: **2**
Clock To:
1st Value: **6.000**
2nd Value:
Value Percent:
Continuous Index:
Within 8" of Joint:
Remarks:

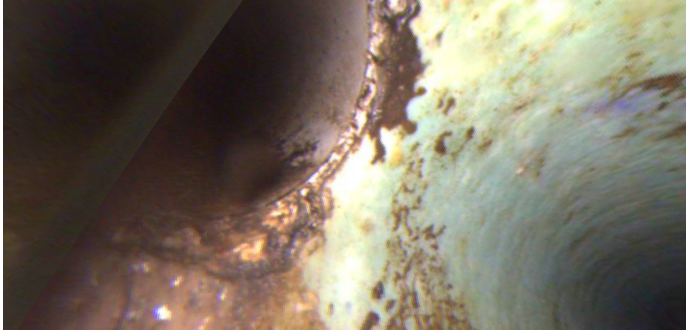
Code: **TB**
Description: **Tap Break-in**

Distance (ft): **184.8**
Structural Grade: **0**
O&M Grade: **0**
Clock Start/From: **10**
Clock To:
1st Value: **6.000**
2nd Value:
Value Percent:
Continuous Index:
Within 8" of Joint:
Remarks:

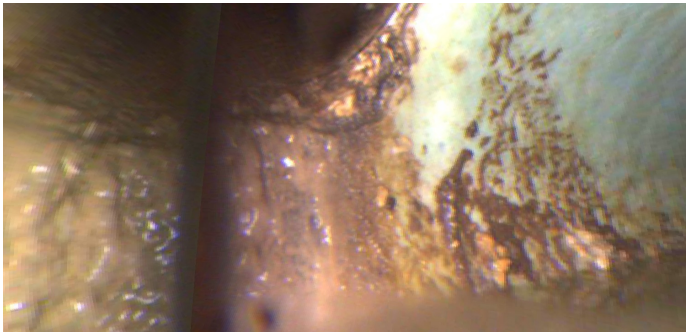
Code: **DAGS**
Description: **Deposits Attached Grease**

Distance (ft): **184.8**
Structural Grade: **0**
O&M Grade: **2**
Clock Start/From: **8**
Clock To: **9**
1st Value:
2nd Value:
Value Percent: **5.000**
Continuous Index:
Within 8" of Joint: **NO**
Remarks:

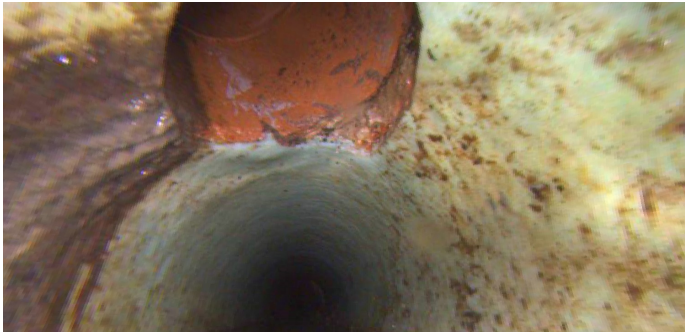
Code: **TB**
Description: **Tap Break-in**

Distance (ft): **226.1**
Structural Grade: **0**
O&M Grade: **0**
Clock Start/From: **12**
Clock To:
1st Value: **4.000**
2nd Value:
Value Percent:
Continuous Index:
Within 8" of Joint:
Remarks:

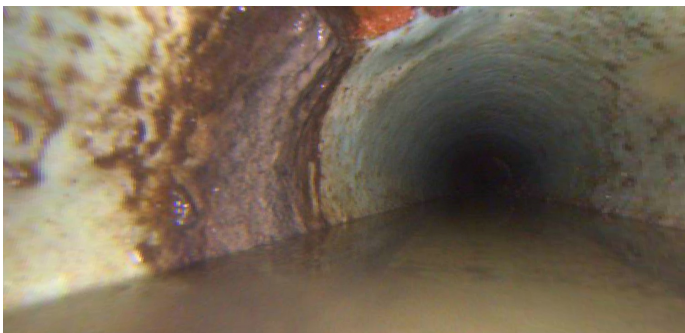
Code: **DAGS**
Description: **Deposits Attached Grease**

Distance (ft): **226.1**
Structural Grade: **0**
O&M Grade: **2**
Clock Start/From: **8**
Clock To: **11**
1st Value:
2nd Value:
Value Percent: **5.000**
Continuous Index:
Within 8" of Joint: **NO**
Remarks:

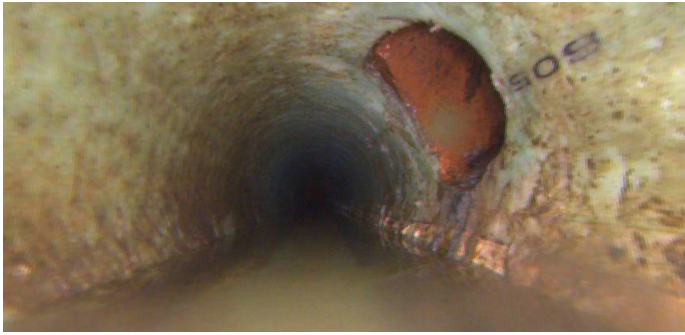
Code: **TB**
Description: **Tap Break-in**

Distance (ft): **230.6**
Structural Grade: **0**
O&M Grade: **0**
Clock Start/From: **2**
Clock To:
1st Value: **4.000**
2nd Value:
Value Percent:
Continuous Index:
Within 8" of Joint:
Remarks:

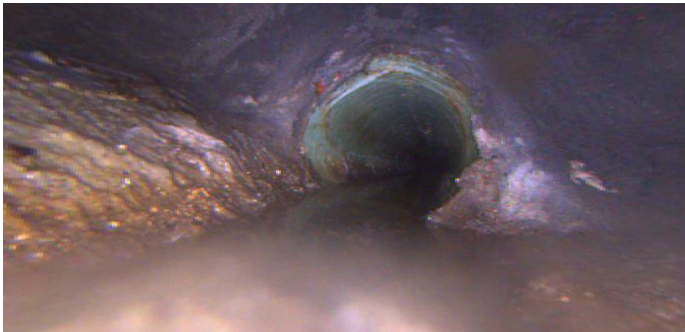
Code: **AMH**
Description: **Manhole**

Distance (ft): **269.5**
Structural Grade: **0**
O&M Grade: **0**
Clock Start/From:
Clock To:
1st Value:
2nd Value:
Value Percent:
Continuous Index:
Within 8" of Joint: **NO**
Remarks: **M-305-008**
