Profile/Photo Observation Report

Date:	04/19/2018	Weather:		Coding:	PACP 6.0
Pipe Length (ft):	229.8	Owner:	NA	Pre Clean:	No Pre-Cleaning
P.O.#:		Surveyor:	Byrd Fitzgerald	PSR:	P-305-010-009
Customer:		Clean Date:	01/01/1900	Shape:	C

Street:	OFF W 49TH AVE	Flow Control:	Not Controlled
City:	Hobart, IN	Year Renewed:	
Location:	Yard	Tape/Media #:	
Purpose:	Routine Assessment	Dia/Height:	10"
Use:	Sanitary	Material:	XXX
Drain Area:	NA	Lining:	Cured in Place
Category:	NA		
Comment:	P_C at 224 ft in the O_C		
Location Details:		Direction of Survey:	Upstream
US MH:	M-305-010	DS MH:	M-305-009
		Total Length Surveyed (ft):	224.9

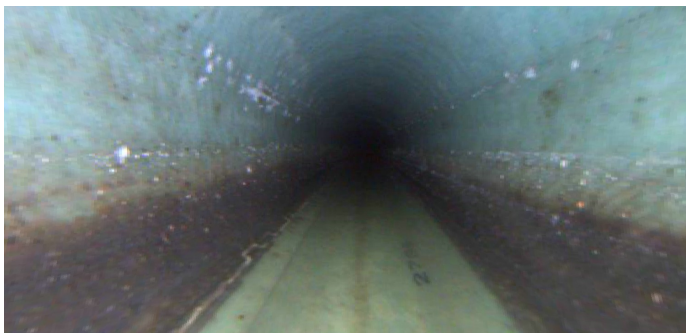
Code: **AMH**
Description: **Manhole**

Distance (ft): **.0**
Structural Grade: **0**
O&M Grade: **0**
Clock Start/From:
Clock To:
1st Value:
2nd Value:
Value Percent:
Continuous Index:
Within 8" of Joint: **NO**
Remarks: **M-305-009**

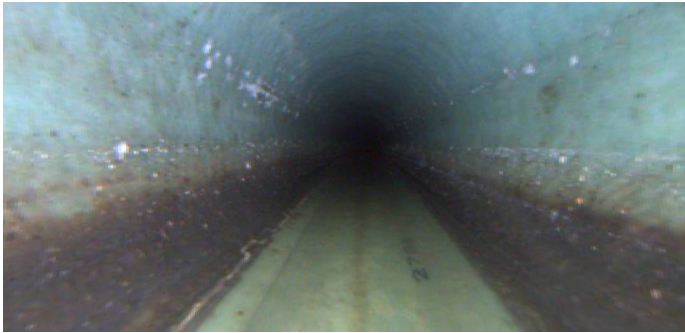
Code:	MWL
Description:	Water Level

Distance (ft):	.0
Structural Grade:	0
O&M Grade:	0
Clock Start/From:	
Clock To:	
1st Value:	
2nd Value:	
Value Percent:	5.000
Continuous Index:	
Within 8" of Joint:	NO
Remarks:

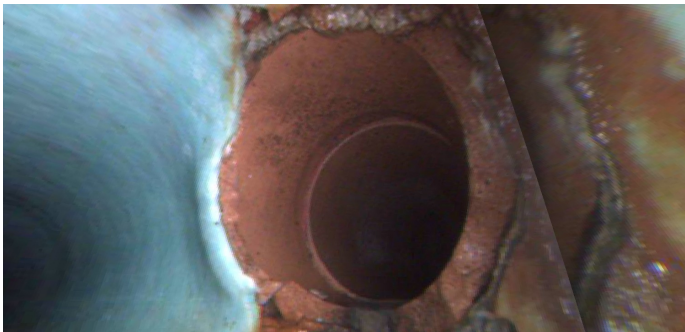
Code:	TB
Description:	Tap Break-in

Distance (ft):	56.2
Structural Grade:	0
O&M Grade:	0
Clock Start/From:	2
Clock To:	
1st Value:	4.000
2nd Value:	
Value Percent:	
Continuous Index:	
Within 8" of Joint:	
Remarks:

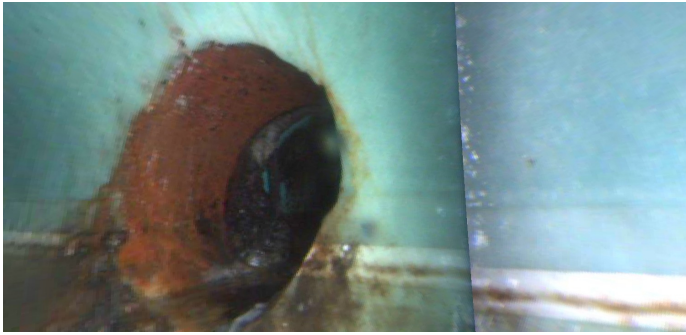
Code: **TB**
Description: **Tap Break-in**

Distance (ft): **65.0**
Structural Grade: **0**
O&M Grade: **0**
Clock Start/From: **9**
Clock To:
1st Value: **4.000**
2nd Value:
Value Percent:
Continuous Index:
Within 8" of Joint:
Remarks:

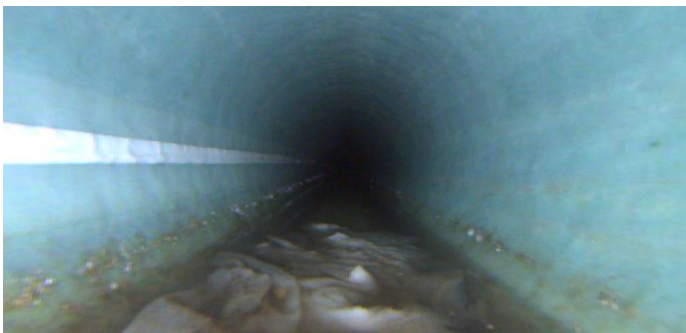
Code: **DSZ**
Description: **Deposits Settled Other**

Distance (ft): **78.1**
Structural Grade: **0**
O&M Grade: **2**
Clock Start/From: **6**
Clock To:
1st Value:
2nd Value:
Value Percent: **5.000**
Continuous Index:
Within 8" of Joint: **NO**
Remarks: **tissue**

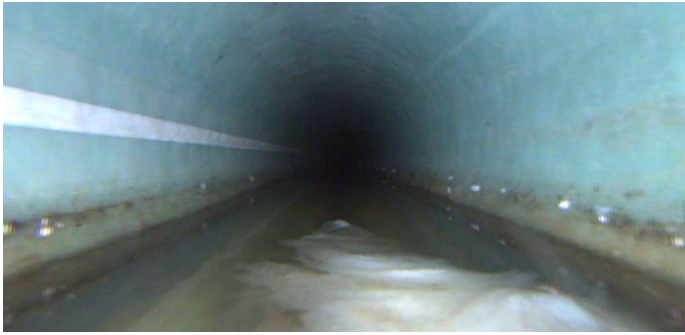
Code: **DSZ**
Description: **Deposits Settled Other**

Distance (ft): **89.5**
Structural Grade: **0**
O&M Grade: **2**
Clock Start/From: **6**
Clock To:
1st Value:
2nd Value:
Value Percent: **5.000**
Continuous Index: **S01**
Within 8" of Joint: **NO**
Remarks: **tissue**

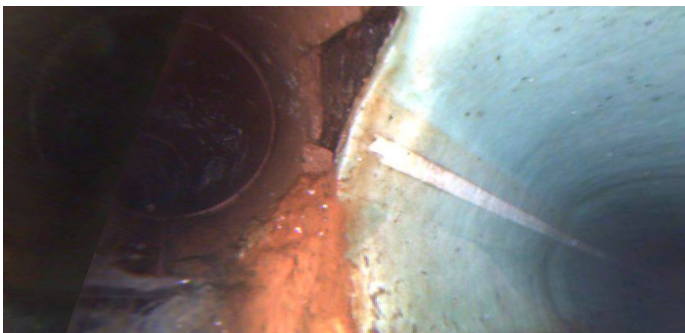
Code: **TB**
Description: **Tap Break-in**

Distance (ft): **152.2**
Structural Grade: **0**
O&M Grade: **0**
Clock Start/From: **10**
Clock To:
1st Value: **4.000**
2nd Value:
Value Percent:
Continuous Index:
Within 8" of Joint:
Remarks:

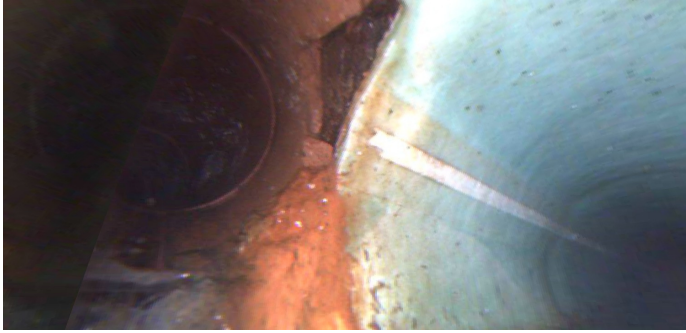
Code: **DAE**
Description: **Deposits Attached Encrustation**

Distance (ft): **152.2**
Structural Grade: **0**
O&M Grade: **2**
Clock Start/From: **9**
Clock To:
1st Value:
2nd Value:
Value Percent: **5.000**
Continuous Index:
Within 8" of Joint: **NO**
Remarks:

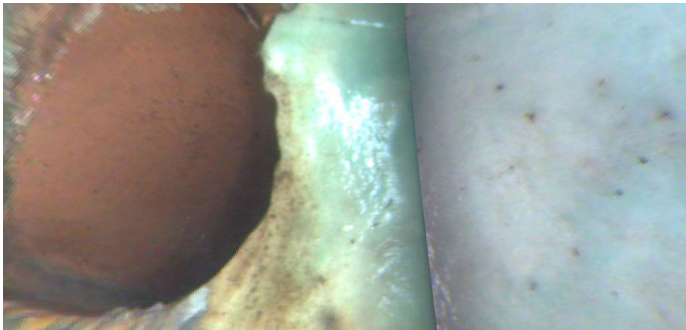
Code: **TB**
Description: **Tap Break-in**

Distance (ft): **220.2**
Structural Grade: **0**
O&M Grade: **0**
Clock Start/From: **10**
Clock To:
1st Value: **4.000**
2nd Value:
Value Percent:
Continuous Index:
Within 8" of Joint:
Remarks:

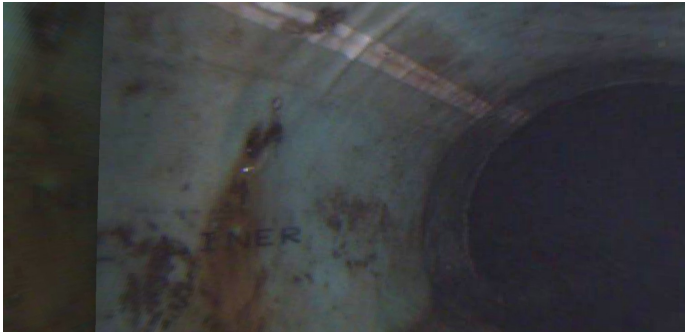
Code: **H**
Description: **Hole**

Distance (ft): **221.4**
Structural Grade: **3**
O&M Grade: **0**
Clock Start/From: **10**
Clock To:
1st Value:
2nd Value:
Value Percent:
Continuous Index:
Within 8" of Joint:
Remarks: **pin hole**

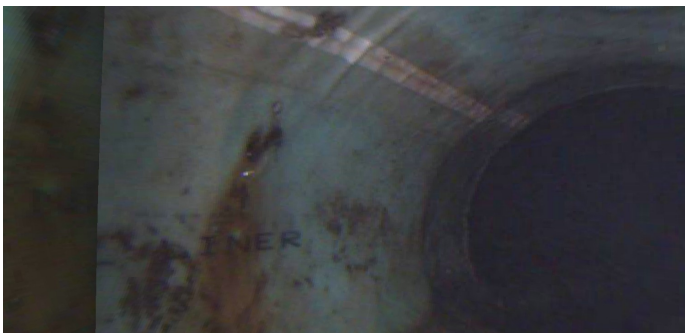
Code: **IS**
Description: **Infil Stain**

Distance (ft): **221.4**
Structural Grade: **0**
O&M Grade: **0**
Clock Start/From: **7**
Clock To: **10**
1st Value:
2nd Value:
Value Percent:
Continuous Index:
Within 8" of Joint:
Remarks:

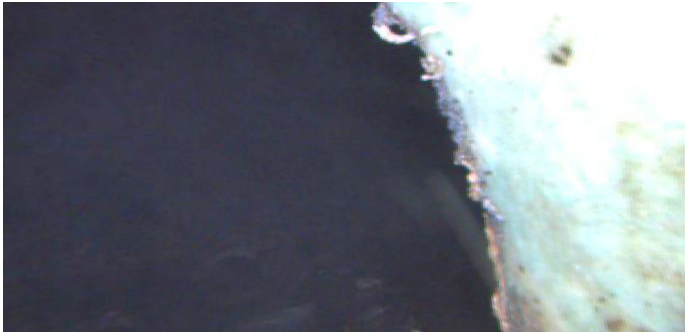
Code: **DSZ**
Description: **Deposits Settled Other**

Distance (ft): **222.2**
Structural Grade: **0**
O&M Grade: **2**
Clock Start/From: **6**
Clock To:
1st Value:
2nd Value:
Value Percent: **5.000**
Continuous Index: **F01**
Within 8" of Joint: **NO**
Remarks: **tissue**

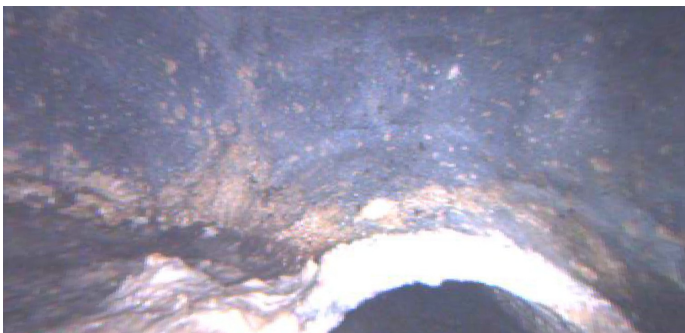
Code: **AMH**
Description: **Manhole**

Distance (ft): **224.9**
Structural Grade: **0**
O&M Grade: **0**
Clock Start/From:
Clock To:
1st Value:
2nd Value:
Value Percent:
Continuous Index:
Within 8" of Joint: **NO**
Remarks: **M-305-010**
