Profile/Photo Observation Report

Date:	04/19/2018	Weather:		Coding:	PACP 6.0
Pipe Length (ft):	229.8	Owner:	NA	Pre Clean:	No Pre-Cleaning
P.O.#:		Surveyor:	Byrd Fitzgerald	PSR:	P-305-010-009
Customer:		Clean Date:	01/01/1900	Shape:	C

Street:	FOXCROFT STREET	Flow Control:	Not Controlled
City:	Hobart, IN	Year Renewed:	
Location:	Yard	Tape/Media #:	
Purpose:	Routine Assessment	Dia/Height:	10"
Use:	Sanitary	Material:	XXX
Drain Area:	NA	Lining:	Cured in Place
Category:	NA		
Comment:	P_C at 224 ft in the O_C		
Location Details:		Direction of Survey:	Upstream
US MH:	M-305-010	DS MH:	M-305-009
		Total Length Surveyed (ft):	224.9

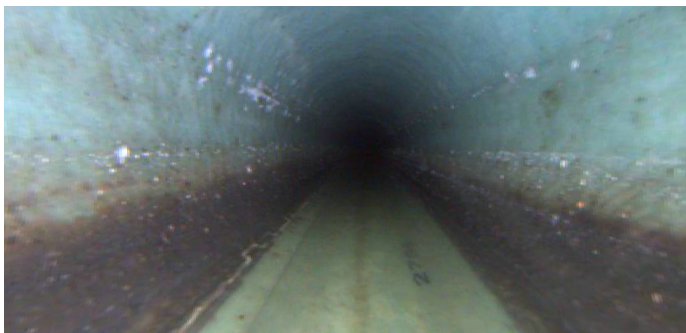
Code: **AMH**
Description: **Manhole**

Distance (ft): **.0**
Structural Grade: **0**
O&M Grade: **0**
Clock Start/From:
Clock To:
1st Value:
2nd Value:
Value Percent:
Continuous Index:
Within 8" of Joint: **NO**
Remarks: **M-305-009**

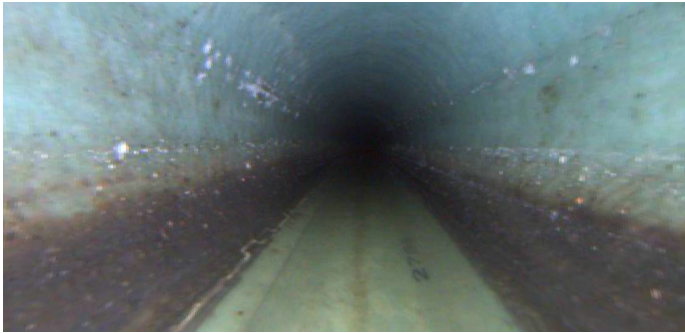
Code:	MWL
Description:	Water Level

Distance (ft):	.0
Structural Grade:	0
O&M Grade:	0
Clock Start/From:	
Clock To:	
1st Value:	
2nd Value:	
Value Percent:	5.000
Continuous Index:	
Within 8" of Joint:	NO
Remarks:

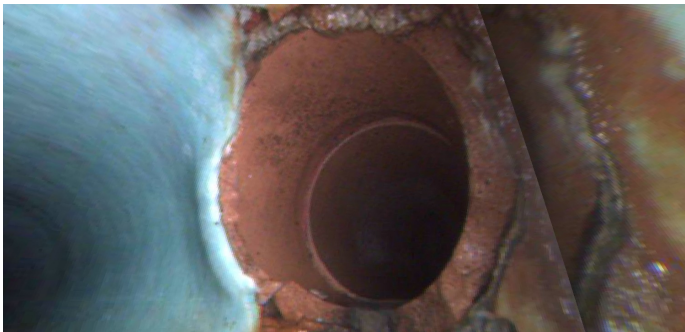
Code:	TB
Description:	Tap Break-in

Distance (ft):	56.2
Structural Grade:	0
O&M Grade:	0
Clock Start/From:	2
Clock To:	
1st Value:	4.000
2nd Value:	
Value Percent:	
Continuous Index:	
Within 8" of Joint:	
Remarks:

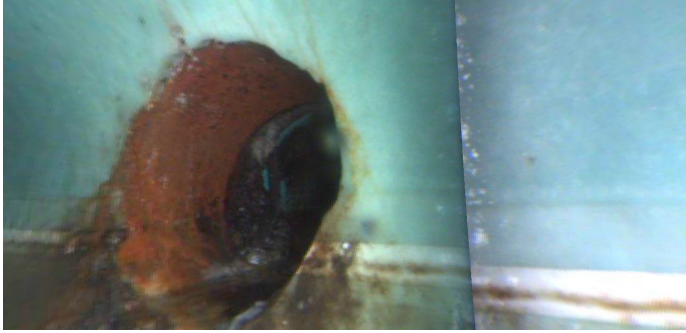
Code: **TB**
Description: **Tap Break-in**

Distance (ft): **65.0**
Structural Grade: **0**
O&M Grade: **0**
Clock Start/From: **9**
Clock To:
1st Value: **4.000**
2nd Value:
Value Percent:
Continuous Index:
Within 8" of Joint:
Remarks:

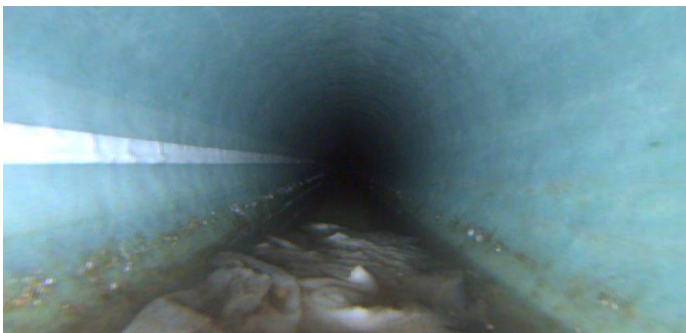
Code: **DSZ**
Description: **Deposits Settled Other**

Distance (ft): **78.1**
Structural Grade: **0**
O&M Grade: **2**
Clock Start/From: **6**
Clock To:
1st Value:
2nd Value:
Value Percent: **5.000**
Continuous Index:
Within 8" of Joint: **NO**
Remarks: **tissue**

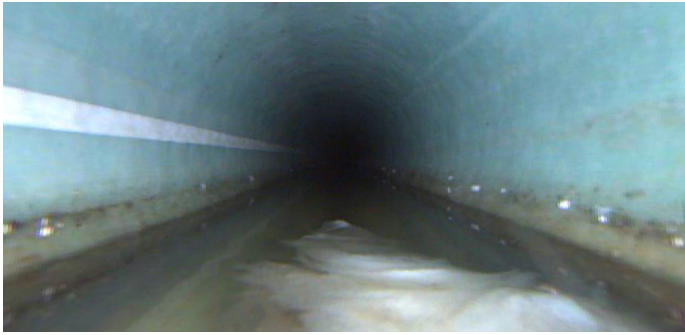
Code: **DSZ**
Description: **Deposits Settled Other**

Distance (ft): **89.5**
Structural Grade: **0**
O&M Grade: **2**
Clock Start/From: **6**
Clock To:
1st Value:
2nd Value:
Value Percent: **5.000**
Continuous Index: **S01**
Within 8" of Joint: **NO**
Remarks: **tissue**

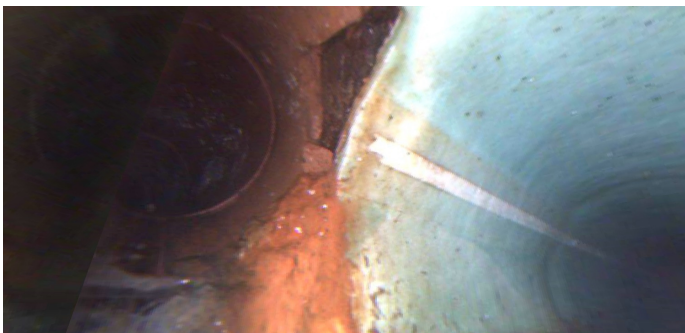
Code: **TB**
Description: **Tap Break-in**

Distance (ft): **152.2**
Structural Grade: **0**
O&M Grade: **0**
Clock Start/From: **10**
Clock To:
1st Value: **4.000**
2nd Value:
Value Percent:
Continuous Index:
Within 8" of Joint:
Remarks:

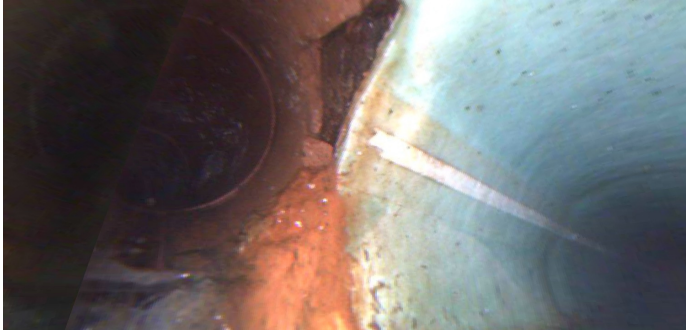
Code: **DAE**
Description: **Deposits Attached Encrustation**

Distance (ft): **152.2**
Structural Grade: **0**
O&M Grade: **2**
Clock Start/From: **9**
Clock To:
1st Value:
2nd Value:
Value Percent: **5.000**
Continuous Index:
Within 8" of Joint: **NO**
Remarks:

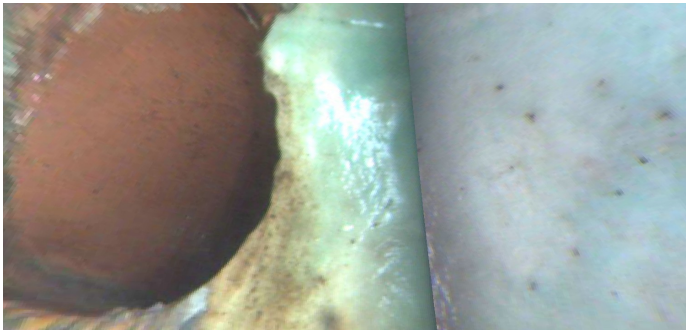
Code: **TB**
Description: **Tap Break-in**

Distance (ft): **220.2**
Structural Grade: **0**
O&M Grade: **0**
Clock Start/From: **10**
Clock To:
1st Value: **4.000**
2nd Value:
Value Percent:
Continuous Index:
Within 8" of Joint:
Remarks:

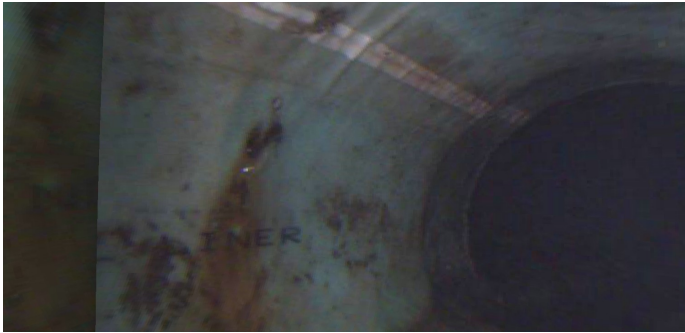
Code: **H**
Description: **Hole**

Distance (ft): **221.4**
Structural Grade: **3**
O&M Grade: **0**
Clock Start/From: **10**
Clock To:
1st Value:
2nd Value:
Value Percent:
Continuous Index:
Within 8" of Joint:
Remarks: **pin hole**

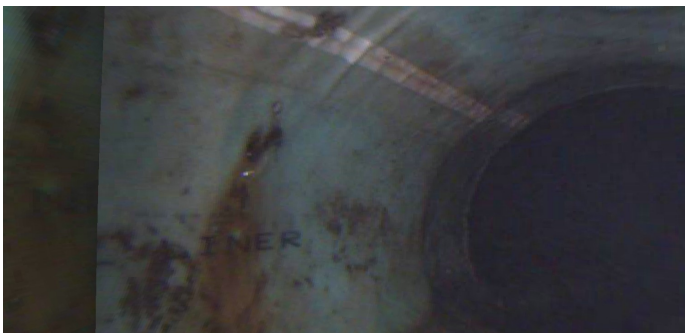
Code: **IS**
Description: **Infil Stain**

Distance (ft): **221.4**
Structural Grade: **0**
O&M Grade: **0**
Clock Start/From: **7**
Clock To: **10**
1st Value:
2nd Value:
Value Percent:
Continuous Index:
Within 8" of Joint:
Remarks:

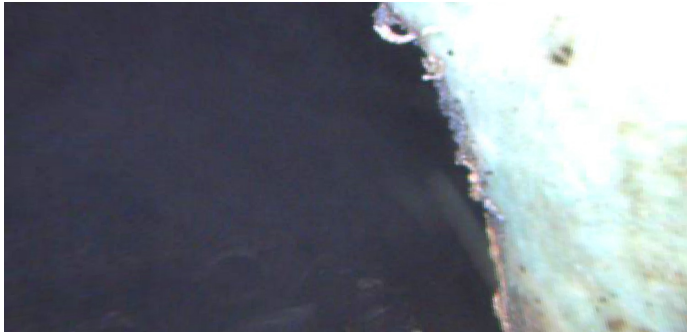
Code: **DSZ**
Description: **Deposits Settled Other**

Distance (ft): **222.2**
Structural Grade: **0**
O&M Grade: **2**
Clock Start/From: **6**
Clock To:
1st Value:
2nd Value:
Value Percent: **5.000**
Continuous Index: **F01**
Within 8" of Joint: **NO**
Remarks: **tissue**

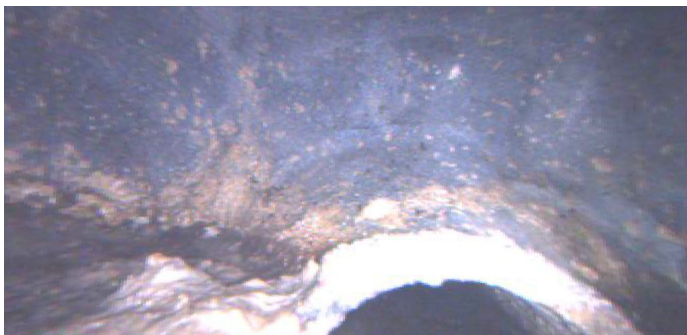
Code: **AMH**
Description: **Manhole**

Distance (ft): **224.9**
Structural Grade: **0**
O&M Grade: **0**
Clock Start/From:
Clock To:
1st Value:
2nd Value:
Value Percent:
Continuous Index:
Within 8" of Joint: **NO**
Remarks: **M-305-010**
