Profile/Photo Observation Report

Street:	ALLEY BETWEEN WALNUT LN & CRO	Flow Control:	Not Controlled
City:	Hobart, IN	Year Renewed:	
Location:	Yard	Tape/Media #:	
Purpose:	Routine Assessment	Dia/Height:	10"
Use:	Sanitary	Material:	XXX
Drain Area:	NA	Lining:	Cured in Place
Category:	NA		
Comment:

Location Details:		Direction of Survey:	Downstream
US MH:	M-305-018	DS MH:	M-305-017
		Total Length Surveyed (ft):	283.5

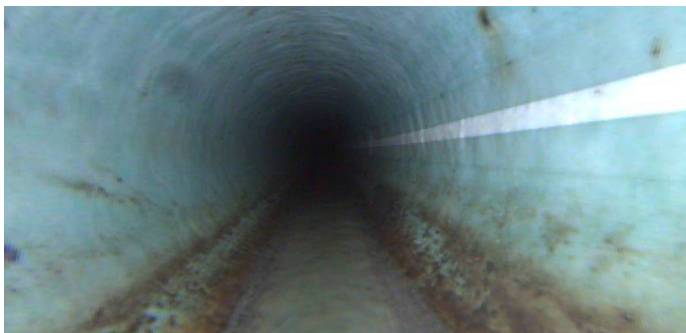
Code: **AMH**
Description: **Manhole**

Distance (ft): **.0**
Structural Grade: **0**
O&M Grade: **0**
Clock Start/From:
Clock To:
1st Value:
2nd Value:
Value Percent:
Continuous Index:
Within 8" of Joint: **NO**
Remarks: **M-305-018**

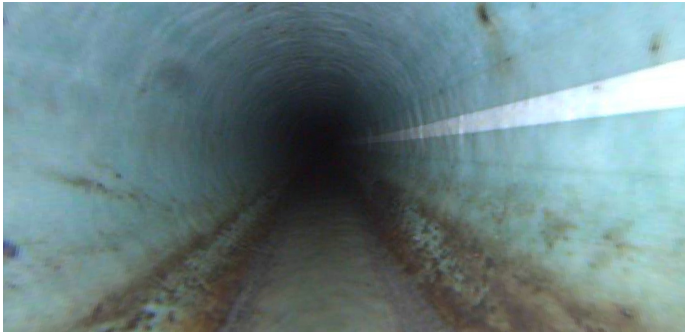
Code:	MWL
Description:	Water Level

Distance (ft):	.0
Structural Grade:	0
O&M Grade:	0
Clock Start/From:	
Clock To:	
1st Value:	
2nd Value:	
Value Percent:	5.000
Continuous Index:	
Within 8" of Joint:	NO
Remarks:

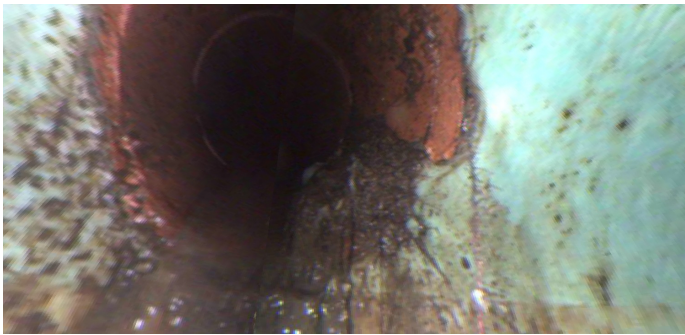
Code:	TBD
Description:	Tap Break-in Defective

Distance (ft):	10.8
Structural Grade:	0
O&M Grade:	3
Clock Start/From:	2
Clock To:	
1st Value:	4.000
2nd Value:	
Value Percent:	
Continuous Index:	
Within 8" of Joint:	
Remarks:	rfl

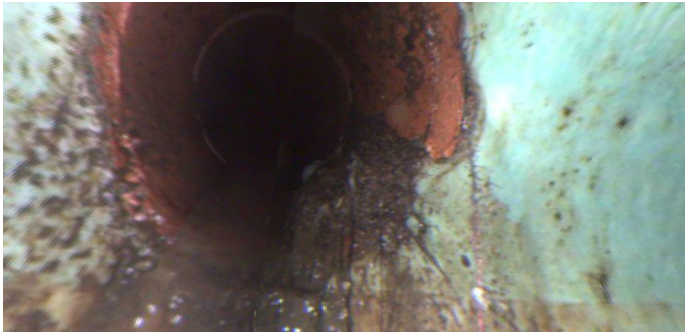
Code: **RFL**
Description: **Roots Fine Lateral**

Distance (ft): **10.8**
Structural Grade: **0**
O&M Grade: **1**
Clock Start/From: **5**
Clock To:
1st Value:
2nd Value:
Value Percent:
Continuous Index:
Within 8" of Joint: **NO**
Remarks:

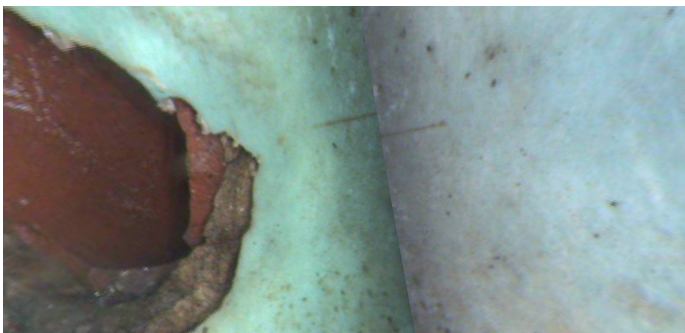
Code: **TB**
Description: **Tap Break-in**

Distance (ft): **14.1**
Structural Grade: **0**
O&M Grade: **0**
Clock Start/From: **10**
Clock To:
1st Value: **4.000**
2nd Value:
Value Percent:
Continuous Index:
Within 8" of Joint:
Remarks:

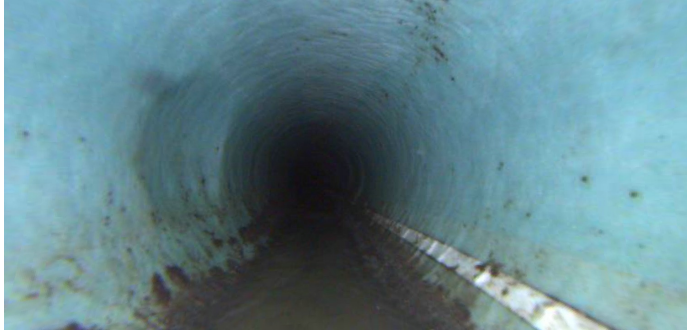
Code: **LFAC**
Description: **Lining Failure Abandoned Connection**

Distance (ft): **68.5**
Structural Grade: **0**
O&M Grade: **0**
Clock Start/From: **9**
Clock To:
1st Value:
2nd Value:
Value Percent:
Continuous Index:
Within 8" of Joint: **NO**
Remarks:

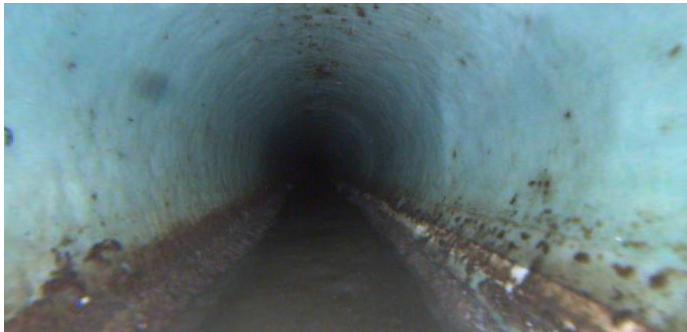
Code: **LFAC**
Description: **Lining Failure Abandoned Connection**

Distance (ft): **70.8**
Structural Grade: **0**
O&M Grade: **0**
Clock Start/From: **3**
Clock To:
1st Value:
2nd Value:
Value Percent:
Continuous Index:
Within 8" of Joint: **NO**
Remarks:

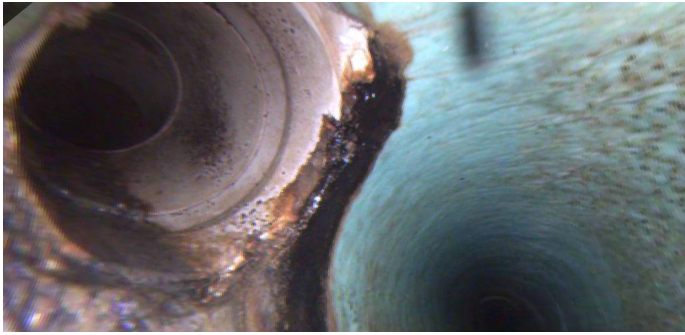
Code: **TB**
Description: **Tap Break-in**

Distance (ft): **80.2**
Structural Grade: **0**
O&M Grade: **0**
Clock Start/From: **10**
Clock To:
1st Value: **4.000**
2nd Value:
Value Percent:
Continuous Index:
Within 8" of Joint:
Remarks:

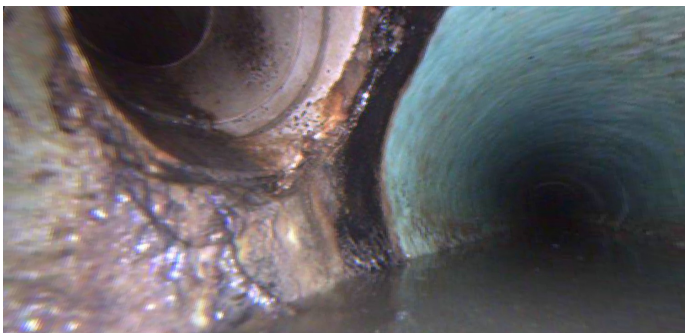
Code: **DAGS**
Description: **Deposits Attached Grease**

Distance (ft): **80.2**
Structural Grade: **0**
O&M Grade: **2**
Clock Start/From: **8**
Clock To: **9**
1st Value:
2nd Value:
Value Percent: **5.000**
Continuous Index:
Within 8" of Joint: **NO**
Remarks:

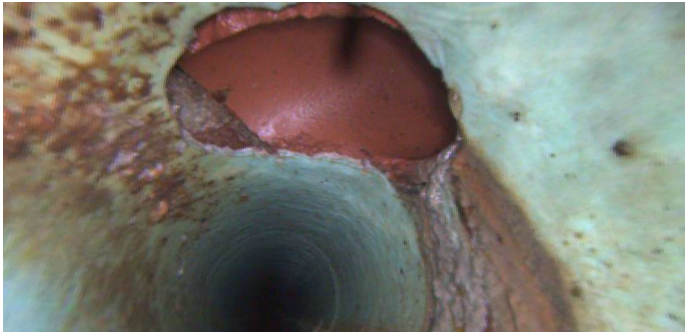
Code: **TB**
Description: **Tap Break-in**

Distance (ft): **85.9**
Structural Grade: **0**
O&M Grade: **0**
Clock Start/From: **12**
Clock To:
1st Value: **4.000**
2nd Value:
Value Percent:
Continuous Index:
Within 8" of Joint:
Remarks:

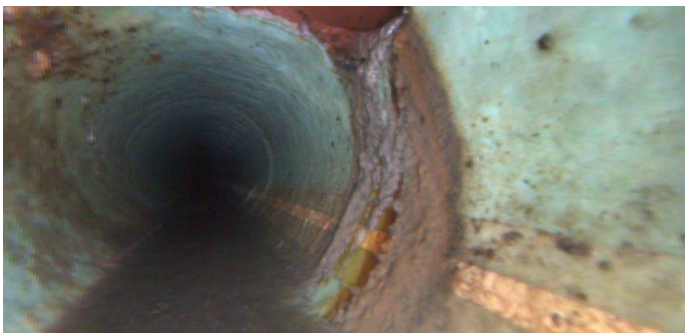
Code: **DAGS**
Description: **Deposits Attached Grease**

Distance (ft): **85.9**
Structural Grade: **0**
O&M Grade: **2**
Clock Start/From: **2**
Clock To: **5**
1st Value:
2nd Value:
Value Percent: **5.000**
Continuous Index:
Within 8" of Joint: **NO**
Remarks:

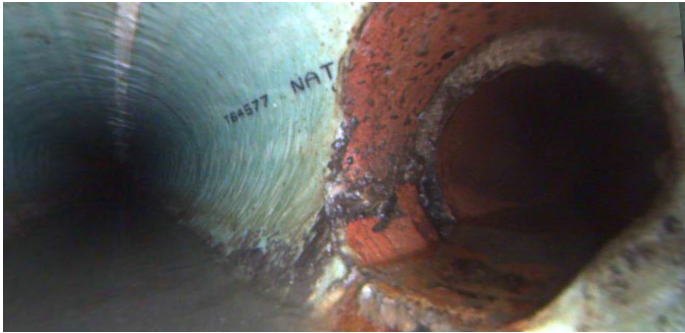
Code: **TBA**
Description: **Tap Break-in Active**

Distance (ft): **149.4**
Structural Grade: **0**
O&M Grade: **0**
Clock Start/From: **3**
Clock To:
1st Value: **4.000**
2nd Value:
Value Percent:
Continuous Index:
Within 8" of Joint:
Remarks:

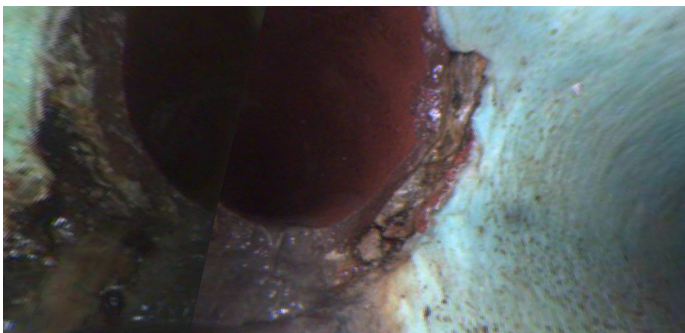
Code: **TB**
Description: **Tap Break-in**

Distance (ft): **163.7**
Structural Grade: **0**
O&M Grade: **0**
Clock Start/From: **10**
Clock To:
1st Value: **4.000**
2nd Value:
Value Percent:
Continuous Index:
Within 8" of Joint:
Remarks:

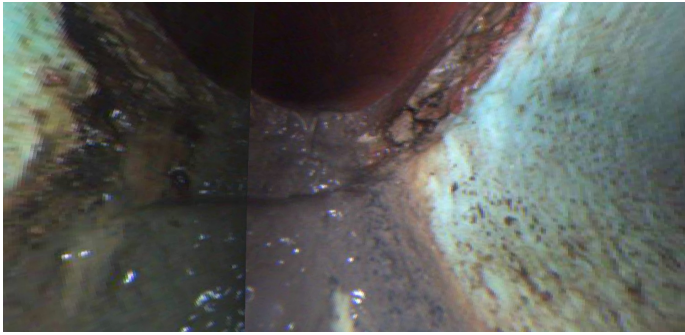
Code: **DAGS**
Description: **Deposits Attached Grease**

Distance (ft): **163.7**
Structural Grade: **0**
O&M Grade: **2**
Clock Start/From: **7**
Clock To: **9**
1st Value:
2nd Value:
Value Percent: **5.000**
Continuous Index:
Within 8" of Joint: **NO**
Remarks:

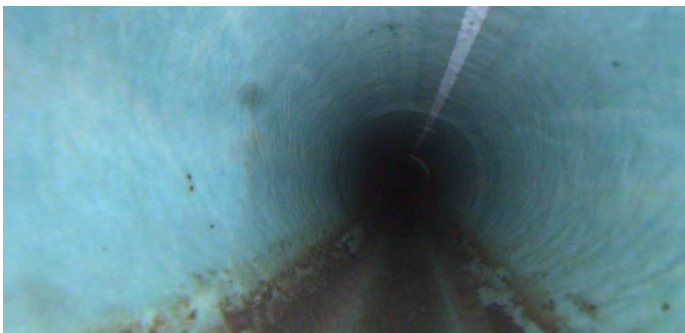
Code: **LFAC**
Description: **Lining Failure Abandoned Connection**

Distance (ft): **220.4**
Structural Grade: **0**
O&M Grade: **0**
Clock Start/From: **9**
Clock To:
1st Value:
2nd Value:
Value Percent:
Continuous Index:
Within 8" of Joint: **NO**
Remarks:

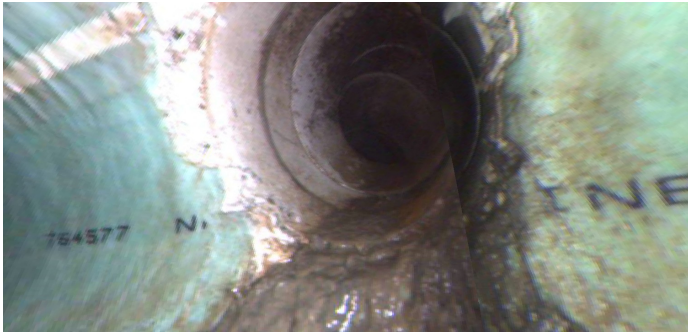
Code: **TB**
Description: **Tap Break-in**

Distance (ft): **224.7**
Structural Grade: **0**
O&M Grade: **0**
Clock Start/From: **2**
Clock To:
1st Value: **4.000**
2nd Value:
Value Percent:
Continuous Index:
Within 8" of Joint:
Remarks:

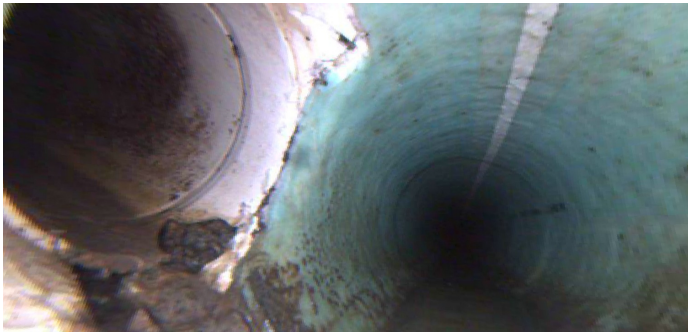
Code: **TB**
Description: **Tap Break-in**

Distance (ft): **228.1**
Structural Grade: **0**
O&M Grade: **0**
Clock Start/From: **10**
Clock To:
1st Value: **4.000**
2nd Value:
Value Percent:
Continuous Index:
Within 8" of Joint:
Remarks:

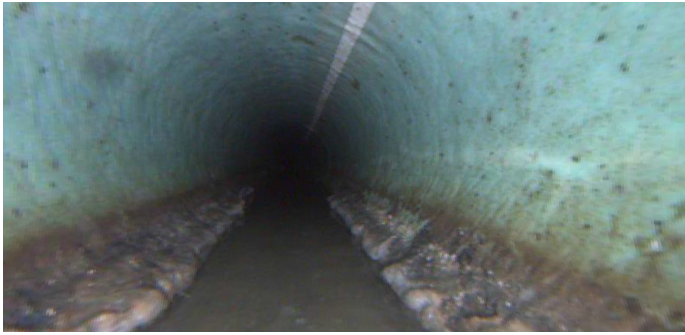
Code: **DAGS**
Description: **Deposits Attached Grease**

Distance (ft): **251.0**
Structural Grade: **0**
O&M Grade: **2**
Clock Start/From: **7**
Clock To: **5**
1st Value:
2nd Value:
Value Percent: **5.000**
Continuous Index:
Within 8" of Joint: **NO**
Remarks: **7 and 5 oclock**

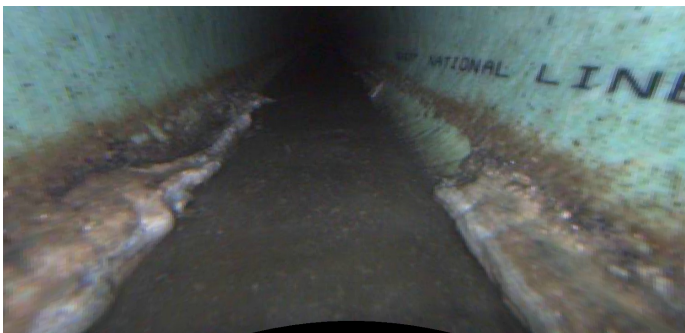
Code: **DAGS**
Description: **Deposits Attached Grease**

Distance (ft): **259.7**
Structural Grade: **0**
O&M Grade: **2**
Clock Start/From: **7**
Clock To: **5**
1st Value:
2nd Value:
Value Percent: **5.000**
Continuous Index:
Within 8" of Joint: **NO**
Remarks: **7 and 5 oclock**

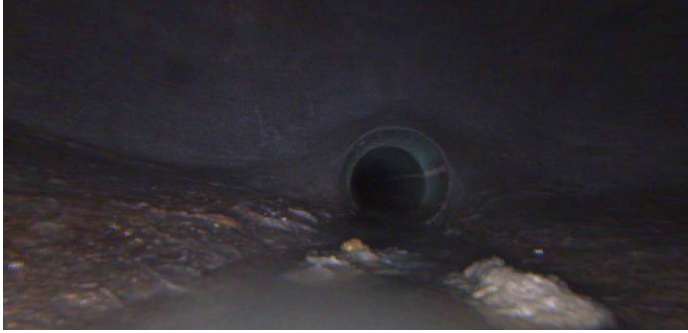
Code:	AMH
Description:	Manhole
Distance (ft):	283.5
Structural Grade:	0
O&M Grade:	0
Clock Start/From:	
Clock To:	
1st Value:	
2nd Value:	
Value Percent:	
Continuous Index:	
Within 8" of Joint:	NO
Remarks:	M-305-017
