Profile/Photo Observation Report

Street:	FOXCROFT STREET	Flow Control:	Not Controlled
City:	Hobart, IN	Year Renewed:	
Location:	Yard	Tape/Media #:	
Purpose:	Routine Assessment	Dia/Height:	10"
Use:	Sanitary	Material:	XXX
Drain Area:	NA	Lining:	Cured in Place
Category:	NA		
Comment:

Location Details:		Direction of Survey:	Downstream
US MH:	M-305-018	DS MH:	M-305-017
		Total Length Surveyed (ft):	283.5

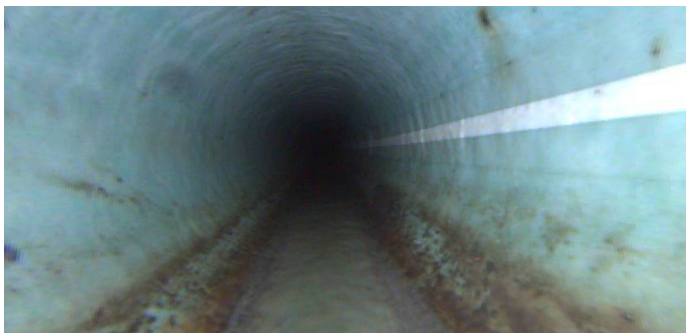
Code: **AMH**
Description: **Manhole**

Distance (ft): **.0**
Structural Grade: **0**
O&M Grade: **0**
Clock Start/From:
Clock To:
1st Value:
2nd Value:
Value Percent:
Continuous Index:
Within 8" of Joint: **NO**
Remarks: **M-305-018**

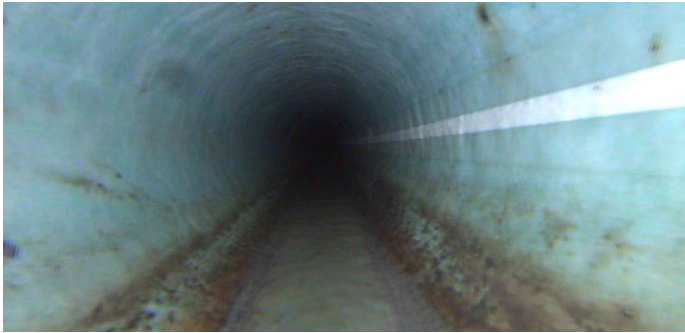
Code:	MWL
Description:	Water Level

Distance (ft):	.0
Structural Grade:	0
O&M Grade:	0
Clock Start/From:	
Clock To:	
1st Value:	
2nd Value:	
Value Percent:	5.000
Continuous Index:	
Within 8" of Joint:	NO
Remarks:

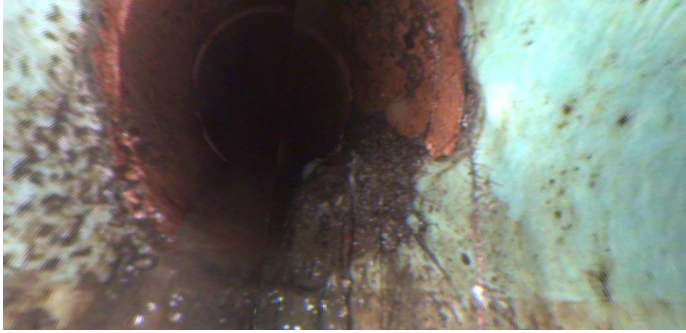
Code: **RFL**
Description: **Roots Fine Lateral**

Distance (ft): **10.8**
Structural Grade: **0**
O&M Grade: **1**
Clock Start/From: **5**
Clock To:
1st Value:
2nd Value:
Value Percent:
Continuous Index:
Within 8" of Joint: **NO**
Remarks:

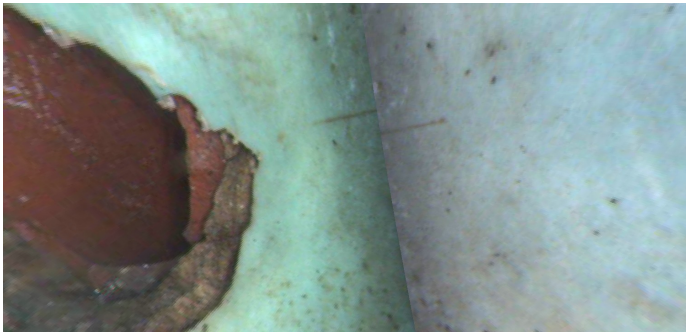
Code: **TB**
Description: **Tap Break-in**

Distance (ft): **14.1**
Structural Grade: **0**
O&M Grade: **0**
Clock Start/From: **10**
Clock To:
1st Value: **4.000**
2nd Value:
Value Percent:
Continuous Index:
Within 8" of Joint:
Remarks:

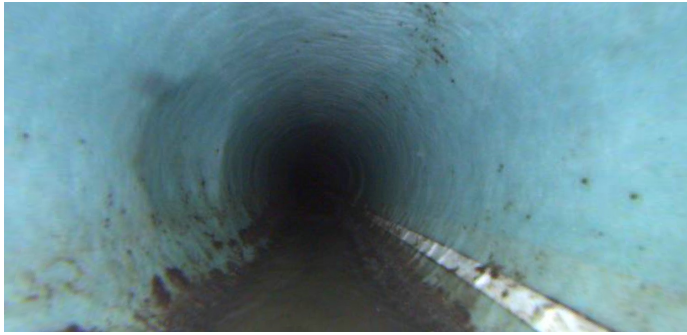
Code: **LFAC**
Description: **Lining Failure Abandoned Connection**

Distance (ft): **68.5**
Structural Grade: **0**
O&M Grade: **0**
Clock Start/From: **9**
Clock To:
1st Value:
2nd Value:
Value Percent:
Continuous Index:
Within 8" of Joint: **NO**
Remarks:

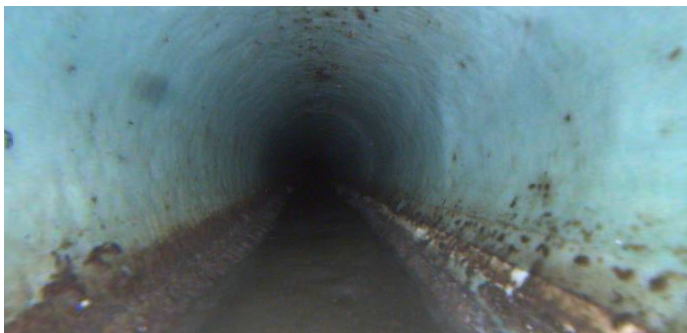
Code: **LFAC**
Description: **Lining Failure Abandoned Connection**

Distance (ft): **70.8**
Structural Grade: **0**
O&M Grade: **0**
Clock Start/From: **3**
Clock To:
1st Value:
2nd Value:
Value Percent:
Continuous Index:
Within 8" of Joint: **NO**
Remarks:

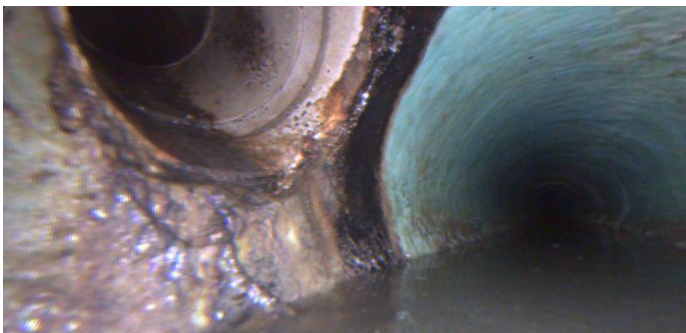
Code: **DAGS**
Description: **Deposits Attached Grease**

Distance (ft): **80.2**
Structural Grade: **0**
O&M Grade: **2**
Clock Start/From: **8**
Clock To: **9**
1st Value:
2nd Value:
Value Percent: **5.000**
Continuous Index:
Within 8" of Joint: **NO**
Remarks:

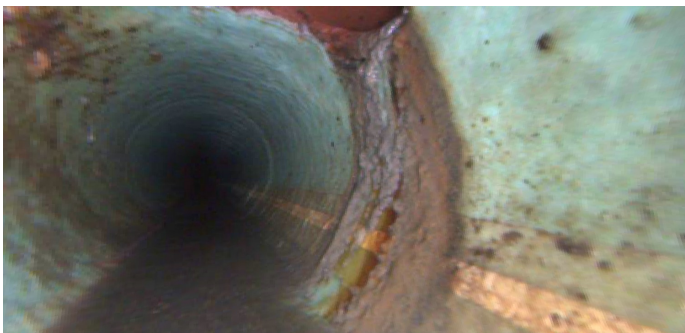
Code: **DAGS**
Description: **Deposits Attached Grease**

Distance (ft): **85.9**
Structural Grade: **0**
O&M Grade: **2**
Clock Start/From: **2**
Clock To: **5**
1st Value:
2nd Value:
Value Percent: **5.000**
Continuous Index:
Within 8" of Joint: **NO**
Remarks:

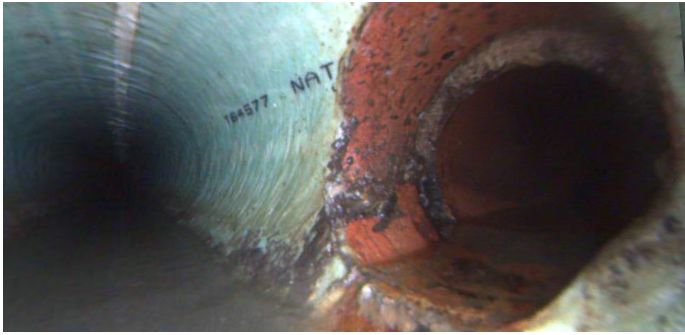
Code: **TBA**
Description: **Tap Break-in Active**

Distance (ft): **149.4**
Structural Grade: **0**
O&M Grade: **0**
Clock Start/From: **3**
Clock To:
1st Value: **4.000**
2nd Value:
Value Percent:
Continuous Index:
Within 8" of Joint:
Remarks:

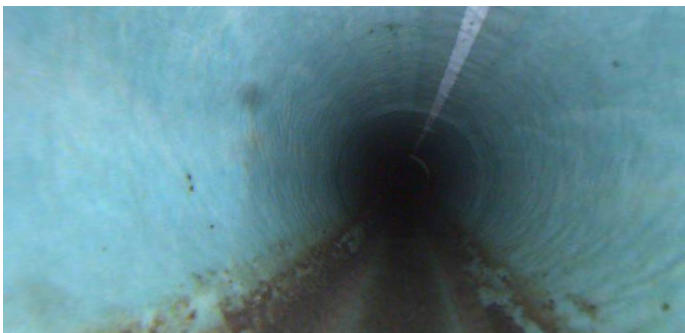
Code: **LFAC**
Description: **Lining Failure Abandoned Connection**

Distance (ft): **220.4**
Structural Grade: **0**
O&M Grade: **0**
Clock Start/From: **9**
Clock To:
1st Value:
2nd Value:
Value Percent:
Continuous Index:
Within 8" of Joint: **NO**
Remarks:

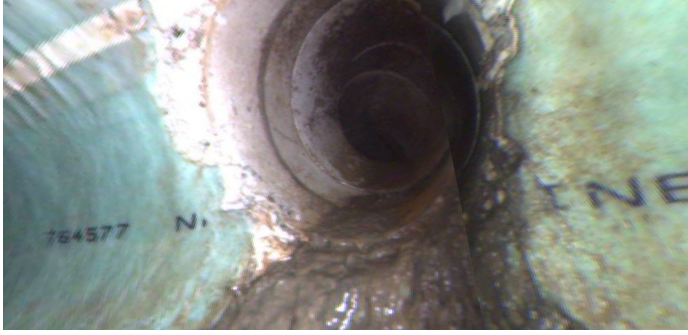
Code: **TB**
Description: **Tap Break-in**

Distance (ft): **224.7**
Structural Grade: **0**
O&M Grade: **0**
Clock Start/From: **2**
Clock To:
1st Value: **4.000**
2nd Value:
Value Percent:
Continuous Index:
Within 8" of Joint:
Remarks:

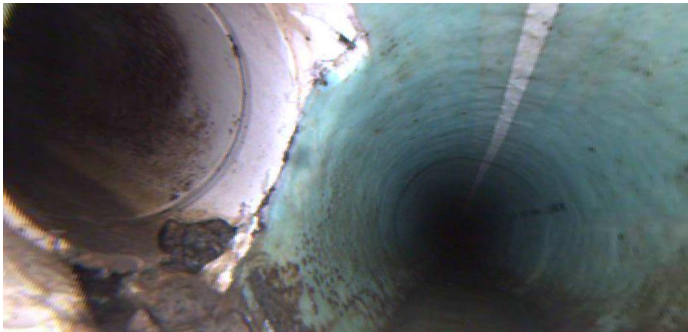
Code: **TB**
Description: **Tap Break-in**

Distance (ft): **228.1**
Structural Grade: **0**
O&M Grade: **0**
Clock Start/From: **10**
Clock To:
1st Value: **4.000**
2nd Value:
Value Percent:
Continuous Index:
Within 8" of Joint:
Remarks:

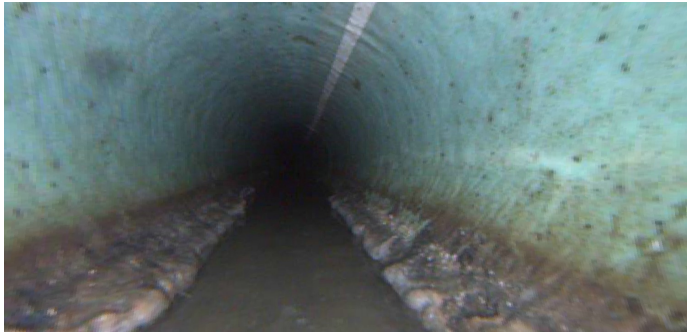
Code:	DAGS
Description:	Deposits Attached Grease
Distance (ft):	251.0
Structural Grade:	0
O&M Grade:	2
Clock Start/From:	7
Clock To:	5
1st Value:	
2nd Value:	
Value Percent:	5.000
Continuous Index:	
Within 8" of Joint:	NO
Remarks:	7 and 5 oclock

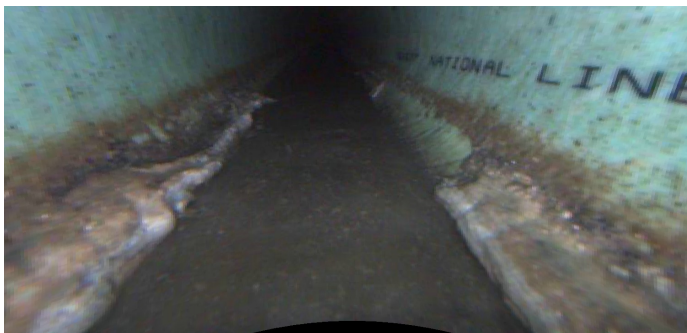
Code:	DAGS
Description:	Deposits Attached Grease
Distance (ft):	259.7
Structural Grade:	0
O&M Grade:	2
Clock Start/From:	7
Clock To:	5
1st Value:	
2nd Value:	
Value Percent:	5.000
Continuous Index:	
Within 8" of Joint:	NO
Remarks:	7 and 5 oclock

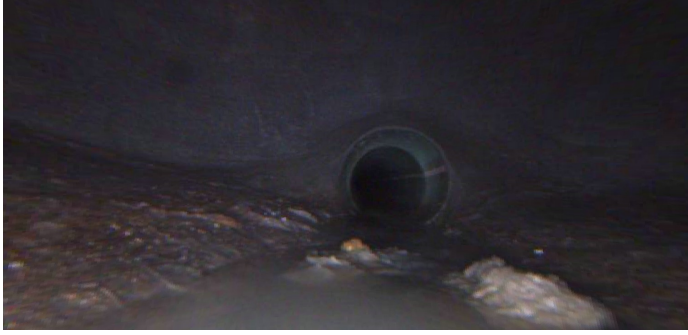
Code:	AMH
Description:	Manhole
Distance (ft):	283.5
Structural Grade:	0
O&M Grade:	0
Clock Start/From:	
Clock To:	
1st Value:	
2nd Value:	
Value Percent:	
Continuous Index:	
Within 8" of Joint:	NO
Remarks:	M-305-017
