Profile/Photo Observation Report

Date:	04/18/2018	Weather:		Coding:	PACP 6.0
Pipe Length (ft):	297.2	Owner:	NA	Pre Clean:	No Pre-Cleaning
P.O.#:		Surveyor:	Byrd Fitzgerald	PSR:	P-305-021-020
Customer:		Clean Date:	01/01/1900	Shape:	C

Street:	FOXCROFT STREET	Flow Control:	Not Controlled
City:	Hobart, IN	Year Renewed:	
Location:	Yard	Tape/Media #:	
Purpose:	Routine Assessment	Dia/Height:	10"
Use:	Sanitary	Material:	XXX
Drain Area:	NA	Lining:	Cured in Place
Category:	NA		
Comment:

Location Details:		Direction of Survey:	Downstream
US MH:	M-305-020	DS MH:	M-305-021
		Total Length Surveyed (ft):	293.3

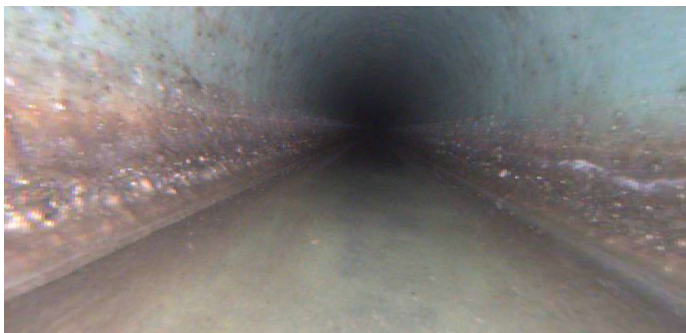
Code: **AMH**
Description: **Manhole**

Distance (ft): **.0**
Structural Grade: **0**
O&M Grade: **0**
Clock Start/From:
Clock To:
1st Value:
2nd Value:
Value Percent:
Continuous Index:
Within 8" of Joint: **NO**
Remarks: **M-305-020**

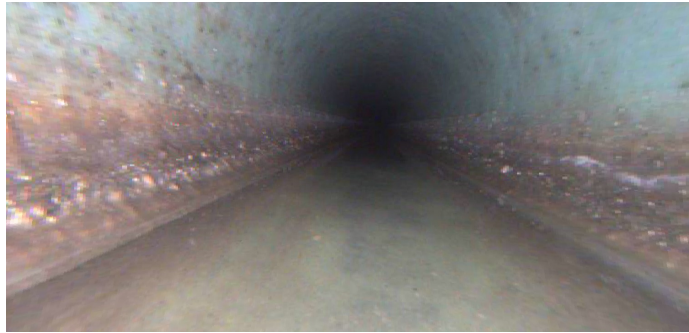
Code: **MWL**
Description: **Water Level**

Distance (ft): **.0**
Structural Grade: **0**
O&M Grade: **0**
Clock Start/From:
Clock To:
1st Value:
2nd Value:
Value Percent: **5.000**
Continuous Index:
Within 8" of Joint: **NO**
Remarks:

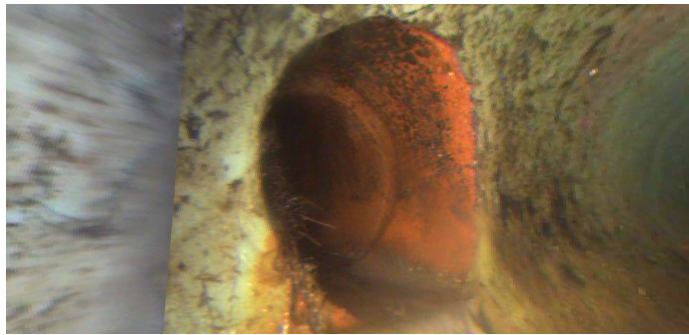
Code: **TB**
Description: **Tap Break-in**

Distance (ft): **38.5**
Structural Grade: **0**
O&M Grade: **0**
Clock Start/From: **3**
Clock To:
1st Value: **4.000**
2nd Value:
Value Percent:
Continuous Index:
Within 8" of Joint:
Remarks:

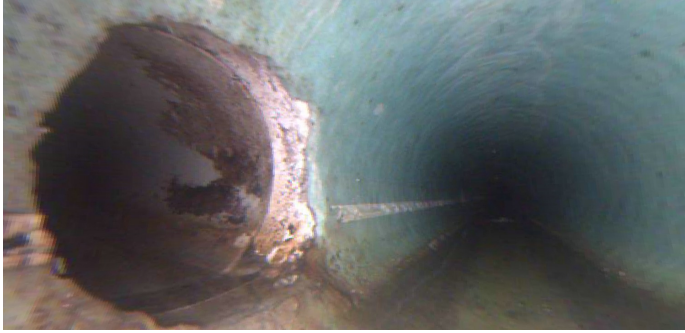
Code: **TB**
Description: **Tap Break-in**

Distance (ft): **44.9**
Structural Grade: **0**
O&M Grade: **0**
Clock Start/From: **9**
Clock To:
1st Value: **4.000**
2nd Value:
Value Percent:
Continuous Index:
Within 8" of Joint:
Remarks:

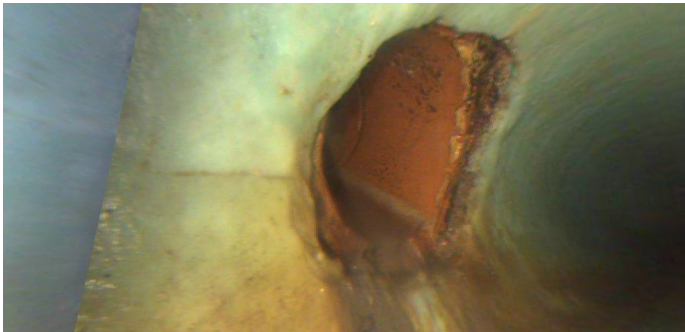
Code: **TB**
Description: **Tap Break-in**

Distance (ft): **126.3**
Structural Grade: **0**
O&M Grade: **0**
Clock Start/From: **2**
Clock To:
1st Value: **4.000**
2nd Value:
Value Percent:
Continuous Index:
Within 8" of Joint:
Remarks:

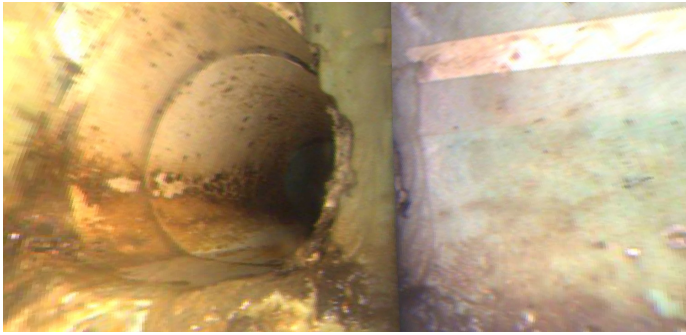
Code: **TB**
Description: **Tap Break-in**

Distance (ft): **130.8**
Structural Grade: **0**
O&M Grade: **0**
Clock Start/From: **9**
Clock To:
1st Value: **4.000**
2nd Value:
Value Percent:
Continuous Index:
Within 8" of Joint:
Remarks:

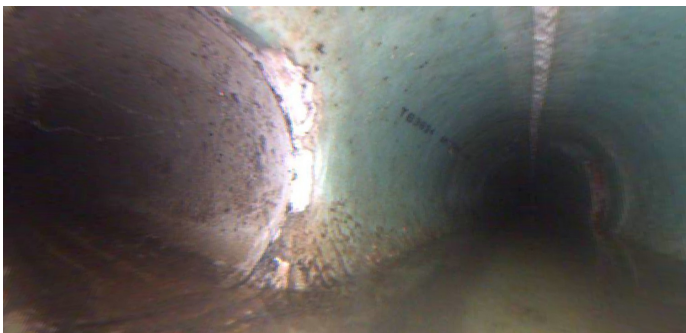
Code: **TB**
Description: **Tap Break-in**

Distance (ft): **194.7**
Structural Grade: **0**
O&M Grade: **0**
Clock Start/From: **9**
Clock To:
1st Value: **6.000**
2nd Value:
Value Percent:
Continuous Index:
Within 8" of Joint:
Remarks:

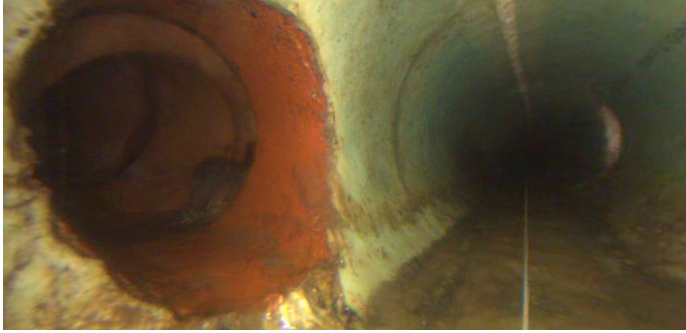
Code: **TF**
Description: **Tap Factory**

Distance (ft): **197.5**
Structural Grade: **0**
O&M Grade: **0**
Clock Start/From: **3**
Clock To:
1st Value: **4.000**
2nd Value:
Value Percent:
Continuous Index:
Within 8" of Joint:
Remarks:

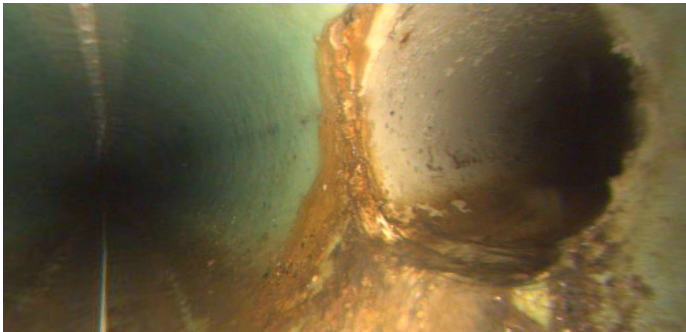
Code: **TBA**
Description: **Tap Break-in Active**

Distance (ft): **266.3**
Structural Grade: **0**
O&M Grade: **0**
Clock Start/From: **9**
Clock To:
1st Value: **4.000**
2nd Value:
Value Percent:
Continuous Index:
Within 8" of Joint:
Remarks:

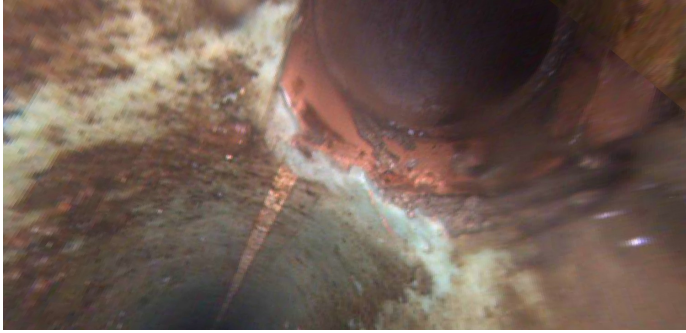
Code: **TB**
Description: **Tap Break-in**

Distance (ft): **278.1**
Structural Grade: **0**
O&M Grade: **0**
Clock Start/From: **1**
Clock To:
1st Value: **4.000**
2nd Value:
Value Percent:
Continuous Index:
Within 8" of Joint:
Remarks:

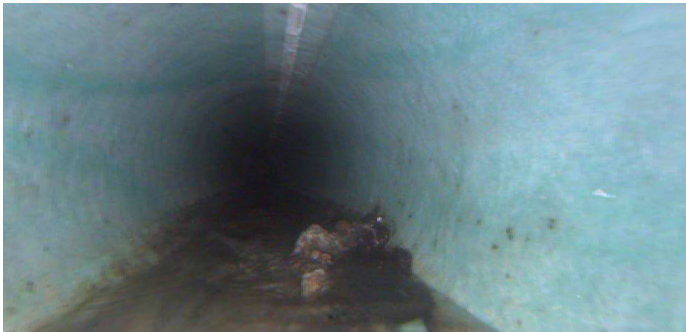
Code: **DSZ**
Description: **Deposits Settled Other**

Distance (ft): **285.7**
Structural Grade: **0**
O&M Grade: **2**
Clock Start/From: **6**
Clock To:
1st Value:
2nd Value:
Value Percent: **5.000**
Continuous Index:
Within 8" of Joint: **NO**
Remarks: **debris**

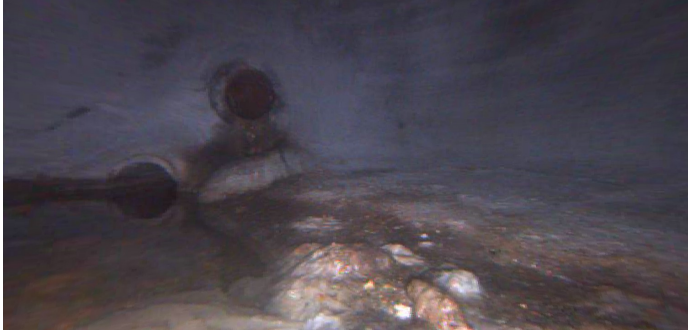
Code:	AMH
Description:	Manhole
Distance (ft):	293.3
Structural Grade:	0
O&M Grade:	0
Clock Start/From:	
Clock To:	
1st Value:	
2nd Value:	
Value Percent:	
Continuous Index:	
Within 8" of Joint:	NO
Remarks:	M-305-021
