Profile/Photo Observation Report

Street:	FOXCROFT STREET	Flow Control:	Not Controlled
City:	Hobart, IN	Year Renewed:	
Location:	Yard	Tape/Media #:	
Purpose:	Routine Assessment	Dia/Height:	10"
Use:	Sanitary	Material:	XXX
Drain Area:	NA	Lining:	Cured in Place
Category:	NA		
Comment:

Location Details:		Direction of Survey:	Downstream
US MH:	M-305-020	DS MH:	M-305-021
		Total Length Surveyed (ft):	293.3

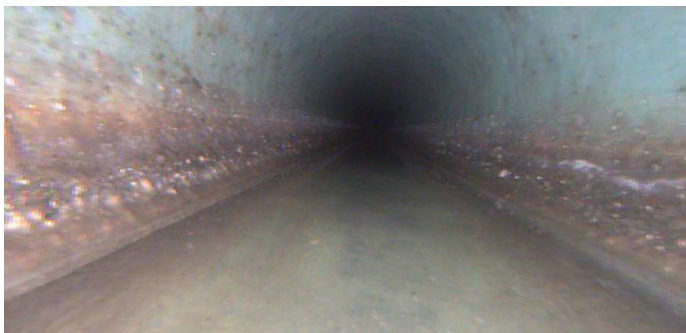
Code: **AMH**
Description: **Manhole**

Distance (ft): **.0**
Structural Grade: **0**
O&M Grade: **0**
Clock Start/From:
Clock To:
1st Value:
2nd Value:
Value Percent:
Continuous Index:
Within 8" of Joint: **NO**
Remarks: **M-305-020**

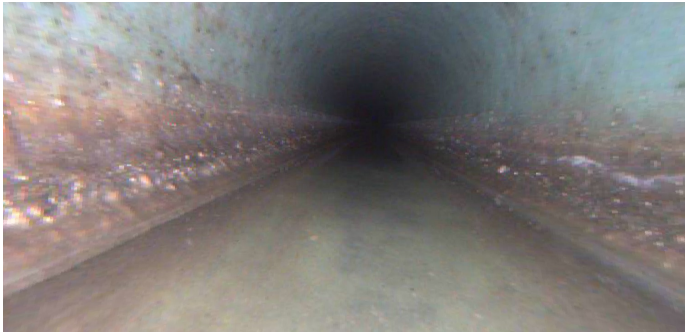
Code:	MWL
Description:	Water Level

Distance (ft):	.0
Structural Grade:	0
O&M Grade:	0
Clock Start/From:	
Clock To:	
1st Value:	
2nd Value:	
Value Percent:	5.000
Continuous Index:	
Within 8" of Joint:	NO
Remarks:

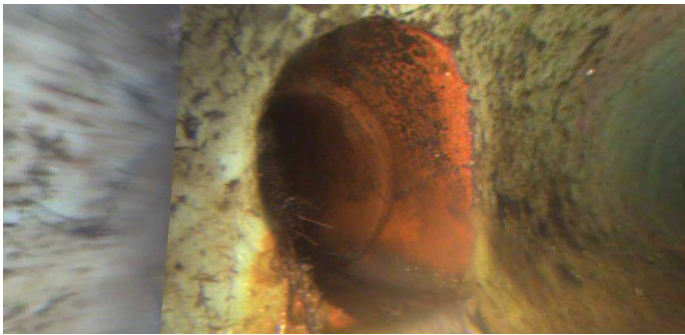
Code:	TB
Description:	Tap Break-in

Distance (ft):	38.5
Structural Grade:	0
O&M Grade:	0
Clock Start/From:	3
Clock To:	
1st Value:	4.000
2nd Value:	
Value Percent:	
Continuous Index:	
Within 8" of Joint:	
Remarks:

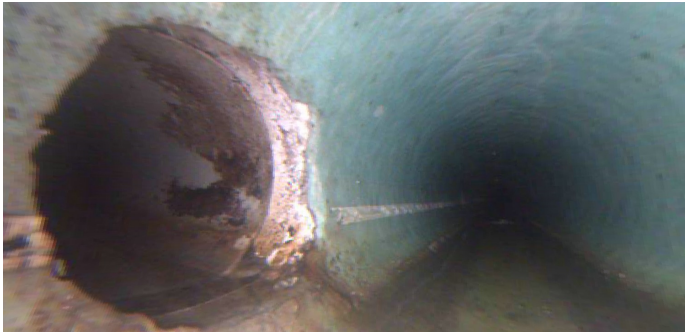
Code: **TB**
Description: **Tap Break-in**

Distance (ft): **44.9**
Structural Grade: **0**
O&M Grade: **0**
Clock Start/From: **9**
Clock To:
1st Value: **4.000**
2nd Value:
Value Percent:
Continuous Index:
Within 8" of Joint:
Remarks:

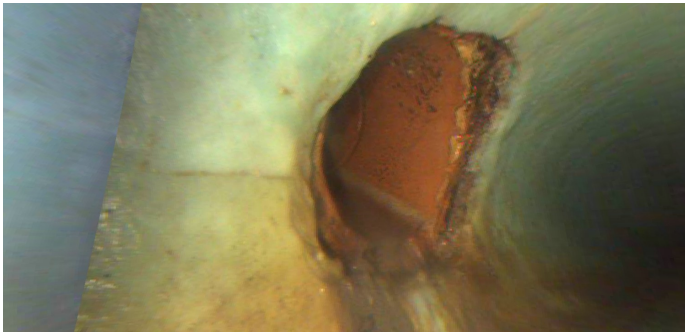
Code: **TB**
Description: **Tap Break-in**

Distance (ft): **126.3**
Structural Grade: **0**
O&M Grade: **0**
Clock Start/From: **2**
Clock To:
1st Value: **4.000**
2nd Value:
Value Percent:
Continuous Index:
Within 8" of Joint:
Remarks:

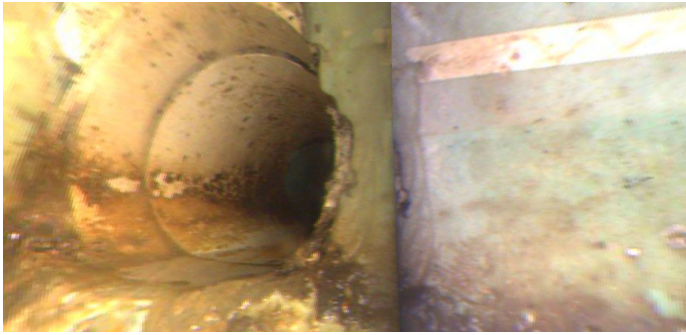
Code: **TB**
Description: **Tap Break-in**

Distance (ft): **130.8**
Structural Grade: **0**
O&M Grade: **0**
Clock Start/From: **9**
Clock To:
1st Value: **4.000**
2nd Value:
Value Percent:
Continuous Index:
Within 8" of Joint:
Remarks:

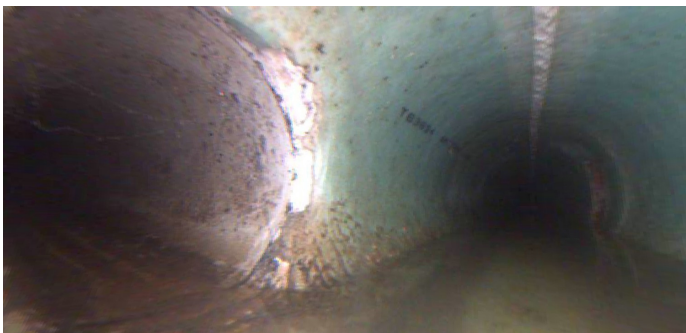
Code: **TB**
Description: **Tap Break-in**

Distance (ft): **194.7**
Structural Grade: **0**
O&M Grade: **0**
Clock Start/From: **9**
Clock To:
1st Value: **6.000**
2nd Value:
Value Percent:
Continuous Index:
Within 8" of Joint:
Remarks:

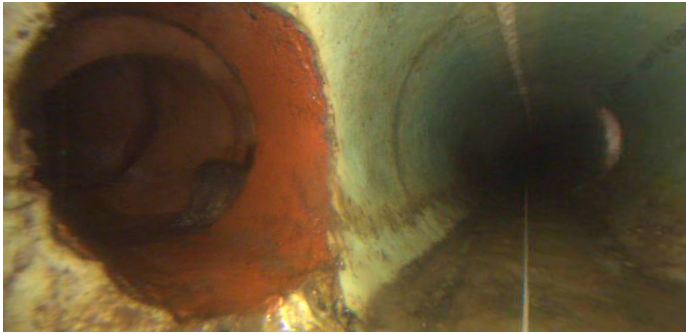
Code: **TF**
Description: **Tap Factory**

Distance (ft): **197.5**
Structural Grade: **0**
O&M Grade: **0**
Clock Start/From: **3**
Clock To:
1st Value: **4.000**
2nd Value:
Value Percent:
Continuous Index:
Within 8" of Joint:
Remarks:

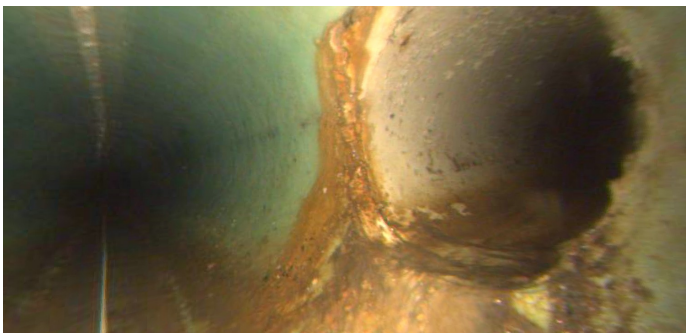
Code: **TBA**
Description: **Tap Break-in Active**

Distance (ft): **266.3**
Structural Grade: **0**
O&M Grade: **0**
Clock Start/From: **9**
Clock To:
1st Value: **4.000**
2nd Value:
Value Percent:
Continuous Index:
Within 8" of Joint:
Remarks:

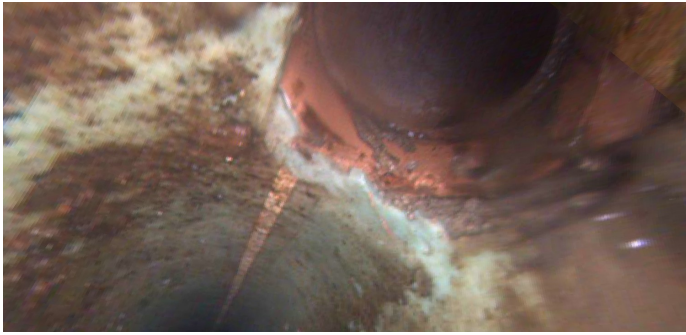
Code: **TB**
Description: **Tap Break-in**

Distance (ft): **278.1**
Structural Grade: **0**
O&M Grade: **0**
Clock Start/From: **1**
Clock To:
1st Value: **4.000**
2nd Value:
Value Percent:
Continuous Index:
Within 8" of Joint:
Remarks:

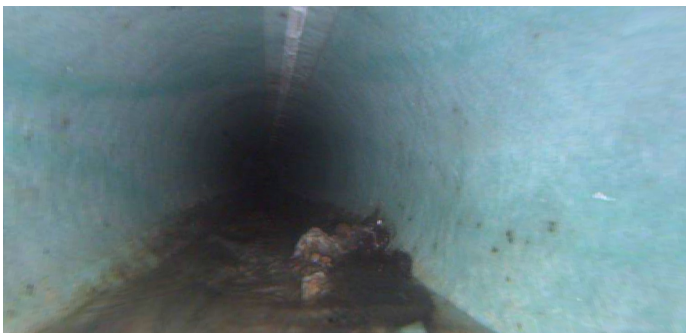
Code: **DSZ**
Description: **Deposits Settled Other**

Distance (ft): **285.7**
Structural Grade: **0**
O&M Grade: **2**
Clock Start/From: **6**
Clock To:
1st Value:
2nd Value:
Value Percent: **5.000**
Continuous Index:
Within 8" of Joint: **NO**
Remarks: **debris**

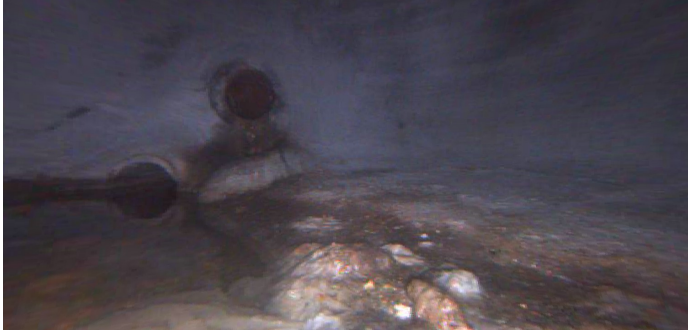
Code:	AMH
Description:	Manhole
Distance (ft):	293.3
Structural Grade:	0
O&M Grade:	0
Clock Start/From:	
Clock To:	
1st Value:	
2nd Value:	
Value Percent:	
Continuous Index:	
Within 8" of Joint:	NO
Remarks:	M-305-021
