Profile/Photo Observation Report

Date:	04/19/2018	Weather:		Coding:	PACP 6.0
Pipe Length (ft):	235.5	Owner:	NA	Pre Clean:	No Pre-Cleaning
P.O.#:		Surveyor:	Byrd Fitzgerald	PSR:	P-305-023-022
Customer:		Clean Date:	01/01/1900	Shape:	Z

Street:	ALLEY BETWEEN CRESTWOOD DR &	Flow Control:	Not Controlled
City:	Hobart, IN	Year Renewed:	
Location:	Yard	Tape/Media #:	
Purpose:	Routine Assessment	Dia/Height:	10"
Use:	Sanitary	Material:	XXX
Drain Area:	NA	Lining:	Cured in Place
Category:	NA		
Comment:

Location Details:		Direction of Survey:	Downstream
US MH:	M-305-023	DS MH:	M-305-022
		Total Length Surveyed (ft):	259.6

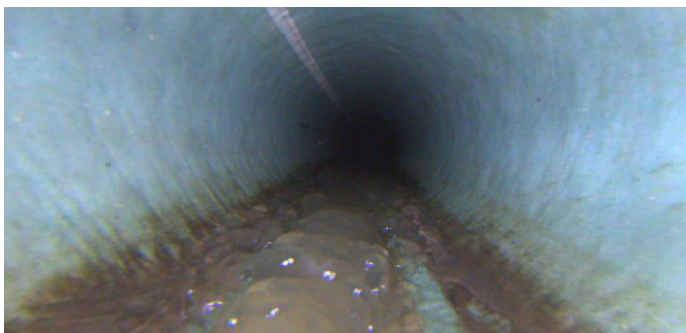
Code: **AMH**
Description: **Manhole**

Distance (ft): **.0**
Structural Grade: **0**
O&M Grade: **0**
Clock Start/From:
Clock To:
1st Value:
2nd Value:
Value Percent:
Continuous Index:
Within 8" of Joint: **NO**
Remarks: **M-305-023**

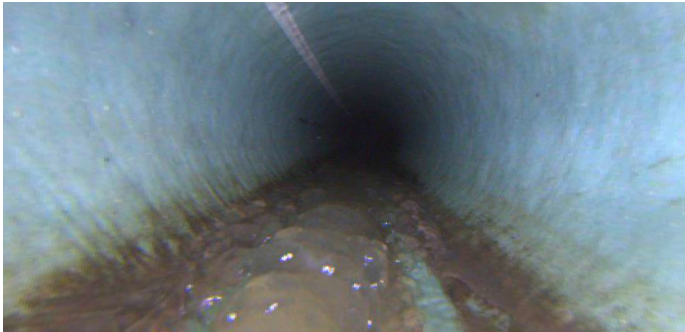
Code:	MWL
Description:	Water Level

Distance (ft):	.0
Structural Grade:	0
O&M Grade:	0
Clock Start/From:	
Clock To:	
1st Value:	
2nd Value:	
Value Percent:	5.000
Continuous Index:	
Within 8" of Joint:	NO
Remarks:

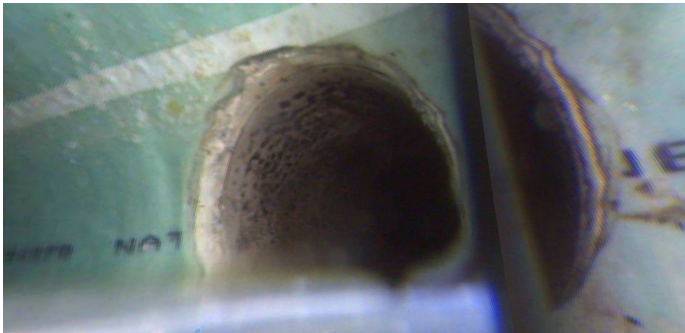
Code:	TB
Description:	Tap Break-in

Distance (ft):	9.0
Structural Grade:	0
O&M Grade:	0
Clock Start/From:	10
Clock To:	
1st Value:	6.000
2nd Value:	
Value Percent:	
Continuous Index:	
Within 8" of Joint:	
Remarks:

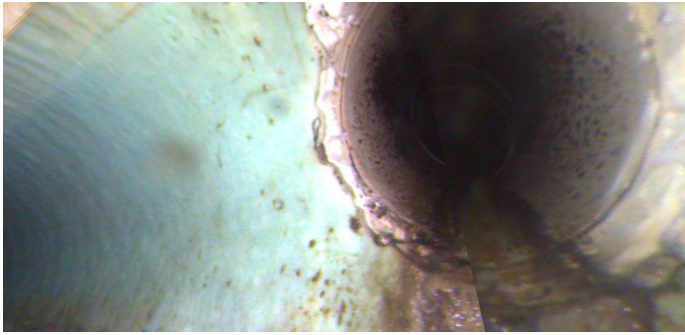
Code: **TB**
Description: **Tap Break-in**

Distance (ft): **55.5**
Structural Grade: **0**
O&M Grade: **0**
Clock Start/From: **2**
Clock To:
1st Value: **6.000**
2nd Value:
Value Percent:
Continuous Index:
Within 8" of Joint:
Remarks:

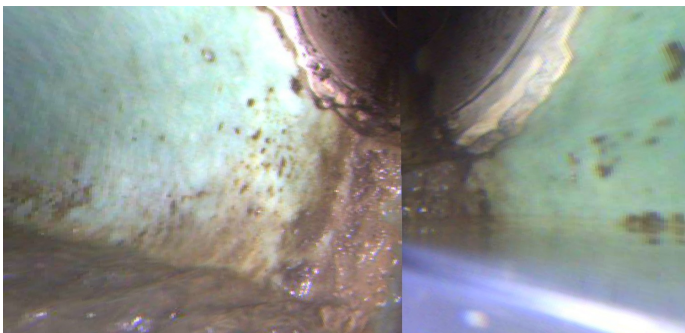
Code: **DAGS**
Description: **Deposits Attached Grease**

Distance (ft): **55.5**
Structural Grade: **0**
O&M Grade: **2**
Clock Start/From: **3**
Clock To: **5**
1st Value:
2nd Value:
Value Percent: **5.000**
Continuous Index:
Within 8" of Joint: **NO**
Remarks:

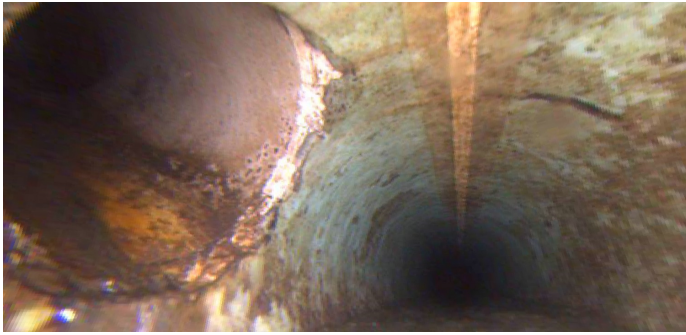
Code: **TB**
Description: **Tap Break-in**

Distance (ft): **81.8**
Structural Grade: **0**
O&M Grade: **0**
Clock Start/From: **10**
Clock To:
1st Value: **4.000**
2nd Value:
Value Percent:
Continuous Index:
Within 8" of Joint:
Remarks:

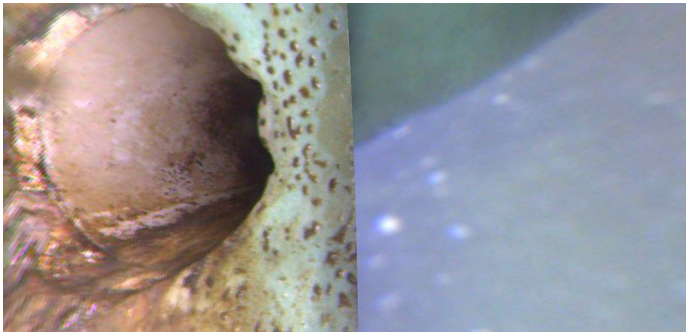
Code: **TB**
Description: **Tap Break-in**

Distance (ft): **128.5**
Structural Grade: **0**
O&M Grade: **0**
Clock Start/From: **2**
Clock To:
1st Value: **4.000**
2nd Value:
Value Percent:
Continuous Index:
Within 8" of Joint:
Remarks:

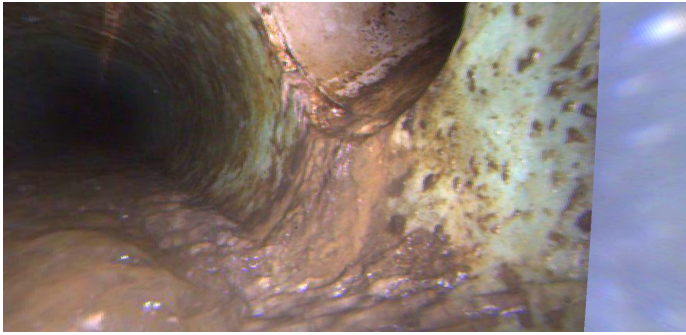
Code: **DAGS**
Description: **Deposits Attached Grease**

Distance (ft): **128.5**
Structural Grade: **0**
O&M Grade: **2**
Clock Start/From: **3**
Clock To: **5**
1st Value:
2nd Value:
Value Percent: **5.000**
Continuous Index:
Within 8" of Joint: **NO**
Remarks:

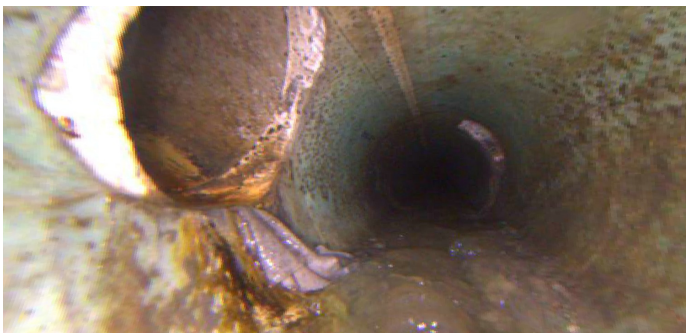
Code: **TB**
Description: **Tap Break-in**

Distance (ft): **203.9**
Structural Grade: **0**
O&M Grade: **0**
Clock Start/From: **10**
Clock To:
1st Value: **4.000**
2nd Value:
Value Percent:
Continuous Index:
Within 8" of Joint:
Remarks:

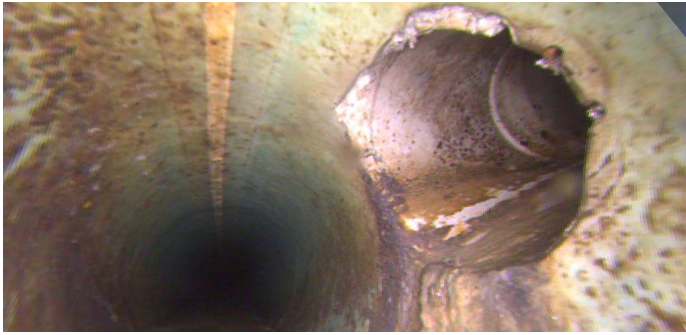
Code: **TB**
Description: **Tap Break-in**

Distance (ft): **205.6**
Structural Grade: **0**
O&M Grade: **0**
Clock Start/From: **2**
Clock To:
1st Value: **4.000**
2nd Value:
Value Percent:
Continuous Index:
Within 8" of Joint:
Remarks:

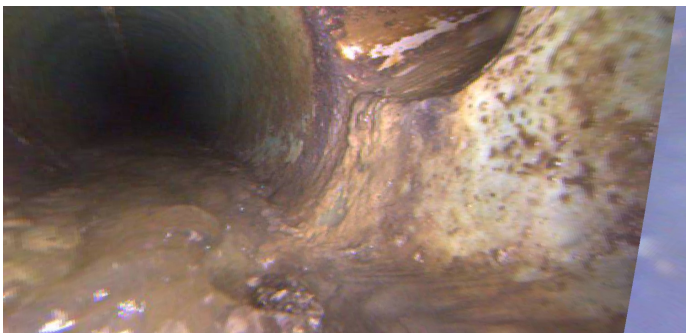
Code: **DAGS**
Description: **Deposits Attached Grease**

Distance (ft): **205.6**
Structural Grade: **0**
O&M Grade: **2**
Clock Start/From: **3**
Clock To: **5**
1st Value:
2nd Value:
Value Percent: **5.000**
Continuous Index:
Within 8" of Joint: **NO**
Remarks:

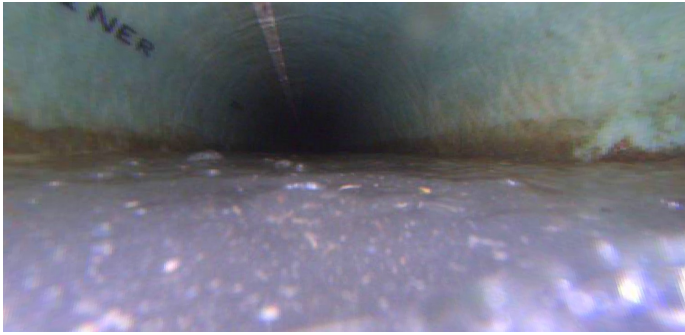
Code: **MWL**
Description: **Water Level**

Distance (ft): **219.6**
Structural Grade: **0**
O&M Grade: **0**
Clock Start/From:
Clock To:
1st Value:
2nd Value:
Value Percent: **25.000**
Continuous Index:
Within 8" of Joint: **NO**
Remarks:

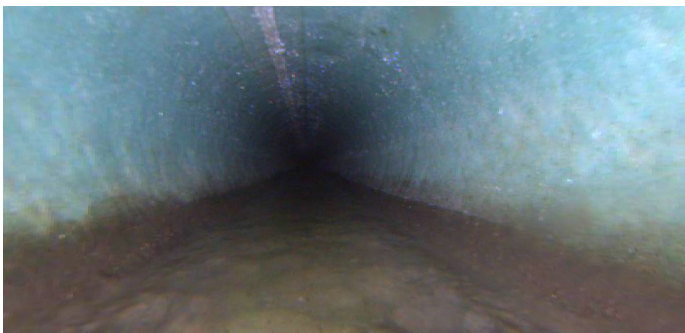
Code: **MWL**
Description: **Water Level**

Distance (ft): **231.8**
Structural Grade: **0**
O&M Grade: **0**
Clock Start/From:
Clock To:
1st Value:
2nd Value:
Value Percent: **5.000**
Continuous Index:
Within 8" of Joint: **NO**
Remarks:

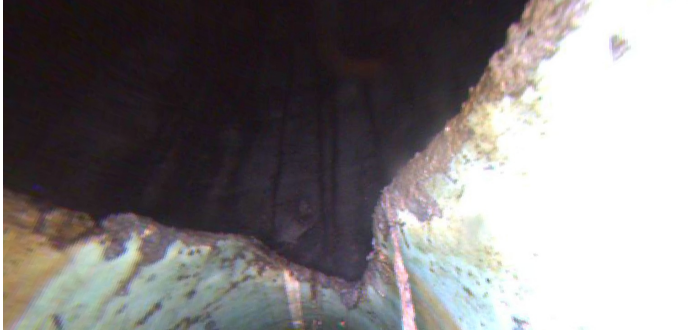
Code:	AMH
Description:	Manhole
Distance (ft):	259.6
Structural Grade:	0
O&M Grade:	0
Clock Start/From:	
Clock To:	
1st Value:	
2nd Value:	
Value Percent:	
Continuous Index:	
Within 8" of Joint:	NO
Remarks:	M-305-022
