Profile/Photo Observation Report

Street:	FOXCROFT STREET	Flow Control:	Not Controlled
City:	Hobart, IN	Year Renewed:	
Location:	Yard	Tape/Media #:	
Purpose:	Routine Assessment	Dia/Height:	10"
Use:	Sanitary	Material:	XXX
Drain Area:	NA	Lining:	Cured in Place
Category:	NA		
Comment:

Location Details:		Direction of Survey:	Downstream
US MH:	M-305-023	DS MH:	M-305-022
		Total Length Surveyed (ft):	259.6

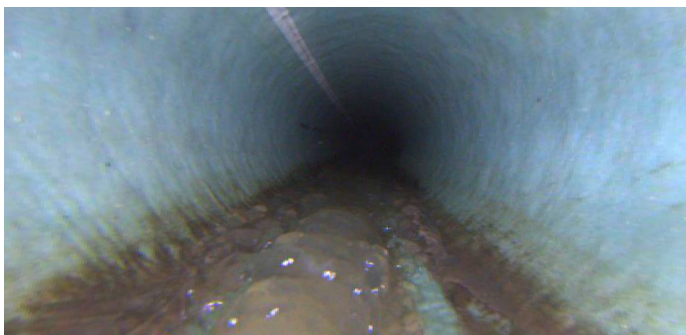
Code: **AMH**
Description: **Manhole**

Distance (ft): **.0**
Structural Grade: **0**
O&M Grade: **0**
Clock Start/From:
Clock To:
1st Value:
2nd Value:
Value Percent:
Continuous Index:
Within 8" of Joint: **NO**
Remarks: **M-305-023**

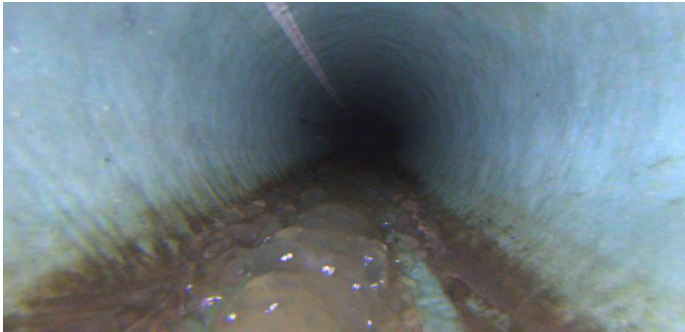
Code:	MWL
Description:	Water Level

Distance (ft):	.0
Structural Grade:	0
O&M Grade:	0
Clock Start/From:	
Clock To:	
1st Value:	
2nd Value:	
Value Percent:	5.000
Continuous Index:	
Within 8" of Joint:	NO
Remarks:

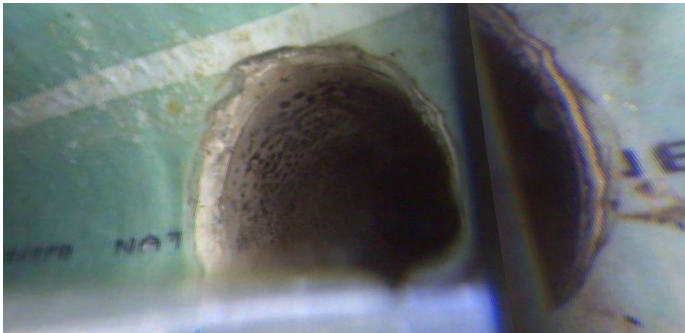
Code:	TB
Description:	Tap Break-in

Distance (ft):	9.0
Structural Grade:	0
O&M Grade:	0
Clock Start/From:	10
Clock To:	
1st Value:	6.000
2nd Value:	
Value Percent:	
Continuous Index:	
Within 8" of Joint:	
Remarks:

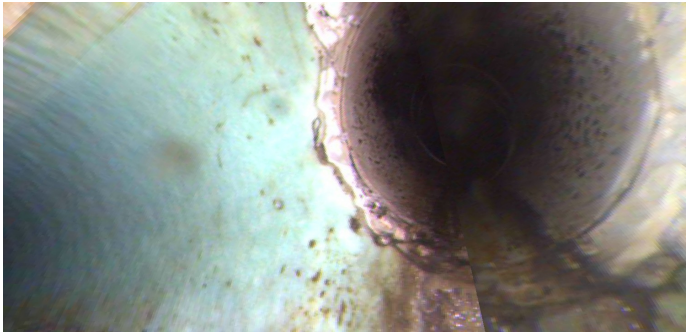
Code: **TB**
Description: **Tap Break-in**

Distance (ft): **55.5**
Structural Grade: **0**
O&M Grade: **0**
Clock Start/From: **2**
Clock To:
1st Value: **6.000**
2nd Value:
Value Percent:
Continuous Index:
Within 8" of Joint:
Remarks:

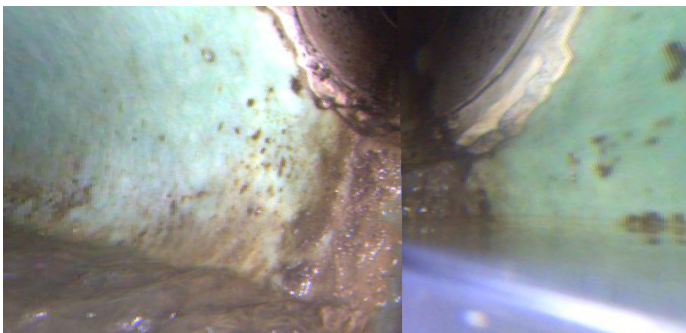
Code: **DAGS**
Description: **Deposits Attached Grease**

Distance (ft): **55.5**
Structural Grade: **0**
O&M Grade: **2**
Clock Start/From: **3**
Clock To: **5**
1st Value:
2nd Value:
Value Percent: **5.000**
Continuous Index:
Within 8" of Joint: **NO**
Remarks:

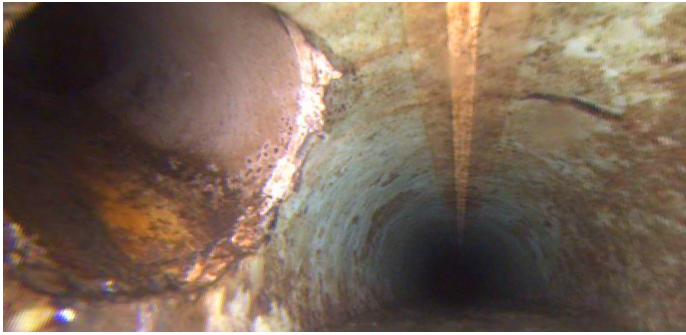
Code: **TB**
Description: **Tap Break-in**

Distance (ft): **81.8**
Structural Grade: **0**
O&M Grade: **0**
Clock Start/From: **10**
Clock To:
1st Value: **4.000**
2nd Value:
Value Percent:
Continuous Index:
Within 8" of Joint:
Remarks:

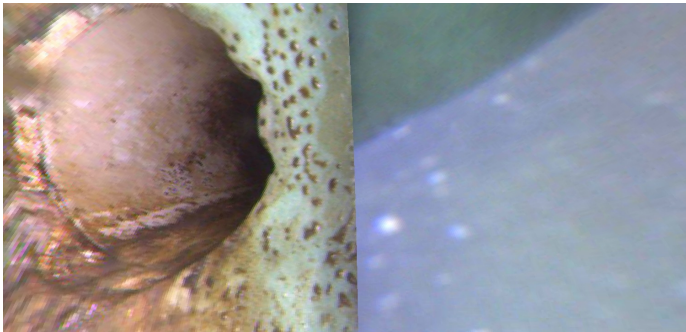
Code: **TB**
Description: **Tap Break-in**

Distance (ft): **128.5**
Structural Grade: **0**
O&M Grade: **0**
Clock Start/From: **2**
Clock To:
1st Value: **4.000**
2nd Value:
Value Percent:
Continuous Index:
Within 8" of Joint:
Remarks:

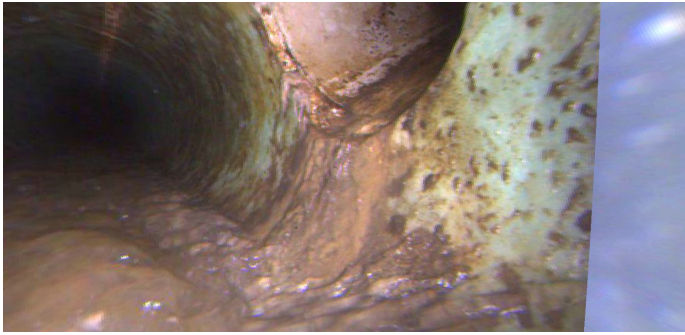
Code: **DAGS**
Description: **Deposits Attached Grease**

Distance (ft): **128.5**
Structural Grade: **0**
O&M Grade: **2**
Clock Start/From: **3**
Clock To: **5**
1st Value:
2nd Value:
Value Percent: **5.000**
Continuous Index:
Within 8" of Joint: **NO**
Remarks:

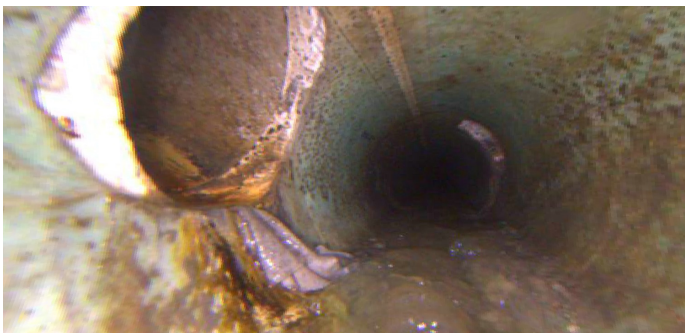
Code: **TB**
Description: **Tap Break-in**

Distance (ft): **203.9**
Structural Grade: **0**
O&M Grade: **0**
Clock Start/From: **10**
Clock To:
1st Value: **4.000**
2nd Value:
Value Percent:
Continuous Index:
Within 8" of Joint:
Remarks:

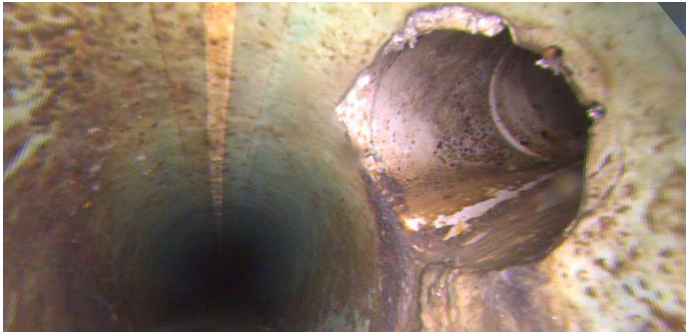
Code: **TB**
Description: **Tap Break-in**

Distance (ft): **205.6**
Structural Grade: **0**
O&M Grade: **0**
Clock Start/From: **2**
Clock To:
1st Value: **4.000**
2nd Value:
Value Percent:
Continuous Index:
Within 8" of Joint:
Remarks:

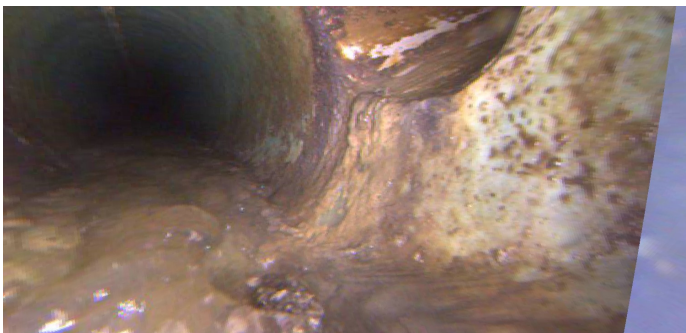
Code: **DAGS**
Description: **Deposits Attached Grease**

Distance (ft): **205.6**
Structural Grade: **0**
O&M Grade: **2**
Clock Start/From: **3**
Clock To: **5**
1st Value:
2nd Value:
Value Percent: **5.000**
Continuous Index:
Within 8" of Joint: **NO**
Remarks:

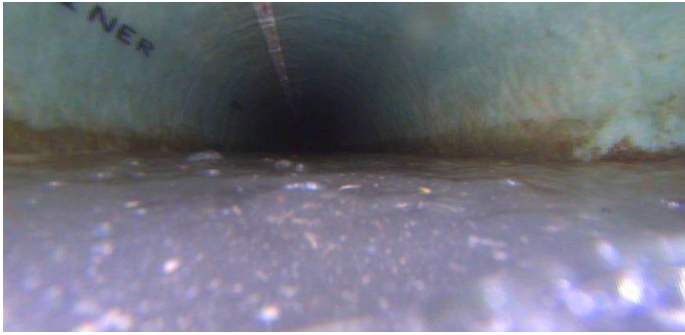
Code: **MWL**
Description: **Water Level**

Distance (ft): **219.6**
Structural Grade: **0**
O&M Grade: **0**
Clock Start/From:
Clock To:
1st Value:
2nd Value:
Value Percent: **25.000**
Continuous Index:
Within 8" of Joint: **NO**
Remarks:

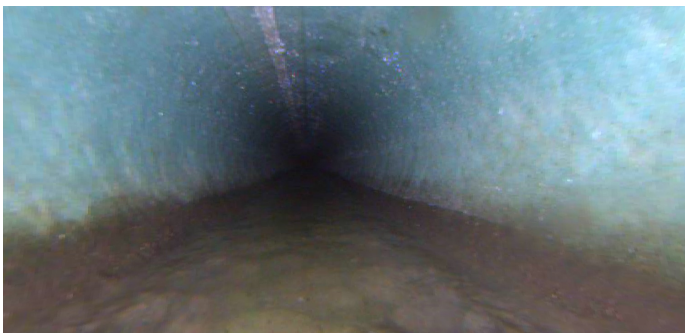
Code: **MWL**
Description: **Water Level**

Distance (ft): **231.8**
Structural Grade: **0**
O&M Grade: **0**
Clock Start/From:
Clock To:
1st Value:
2nd Value:
Value Percent: **5.000**
Continuous Index:
Within 8" of Joint: **NO**
Remarks:

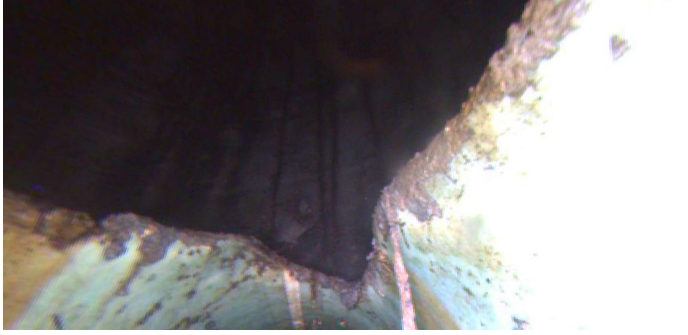
Code:	AMH
Description:	Manhole
Distance (ft):	259.6
Structural Grade:	0
O&M Grade:	0
Clock Start/From:	
Clock To:	
1st Value:	
2nd Value:	
Value Percent:	
Continuous Index:	
Within 8" of Joint:	NO
Remarks:	M-305-022
