# Profile/Photo Observation Report

Street:	<b>FOXCROFT STREET</b>	Flow Control:	<b>Not Controlled</b>
City:	<b>Hobart, IN</b>	Year Renewed:	
Location:	<b>Yard</b>	Tape/Media #:	
Purpose:	<b>Routine Assessment</b>	Dia/Height:	<b>10"</b>
Use:	<b>Sanitary</b>	Material:	<b>XXX</b>
Drain Area:	<b>NA</b>	Lining:	<b>Cured in Place</b>
Category:	<b>NA</b>		
Comment:			
Location Details:		Direction of Survey:	<b>Upstream</b>
US MH:	<b>M-305-028</b>	DS MH:	<b>M-305-027</b>
		Total Length Surveyed (ft):	<b>270.0</b>

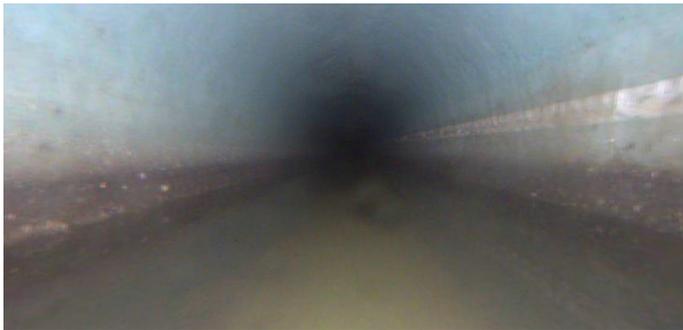
Code: **AMH**  
Description: **Manhole**

Distance (ft): **.0**  
Structural Grade: **0**  
O&M Grade: **0**  
Clock Start/From:  
Clock To:  
1st Value:  
2nd Value:  
Value Percent:  
Continuous Index:  
Within 8" of Joint: **NO**  
Remarks: **M-305-027**

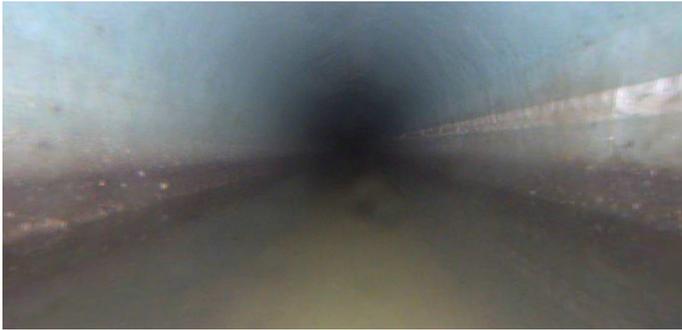
Code: **MWL**  
Description: **Water Level**

Distance (ft): **.0**  
Structural Grade: **0**  
O&M Grade: **0**  
Clock Start/From:  
Clock To:  
1st Value:  
2nd Value:  
Value Percent: **10.000**  
Continuous Index:  
Within 8" of Joint: **NO**  
Remarks:

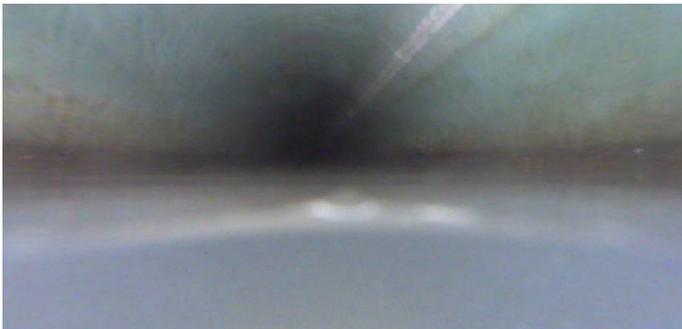
Code: **MWL**  
Description: **Water Level**

Distance (ft): **18.0**  
Structural Grade: **0**  
O&M Grade: **0**  
Clock Start/From:  
Clock To:  
1st Value:  
2nd Value:  
Value Percent: **25.000**  
Continuous Index:  
Within 8" of Joint: **NO**  
Remarks:

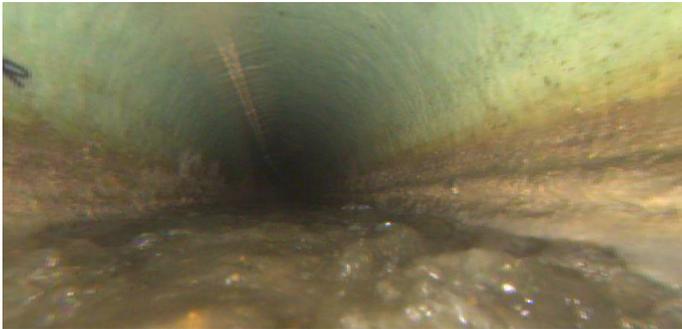
Code: **MGO**  
Description: **General Observation**

Distance (ft): **35.5**  
Structural Grade: **0**  
O&M Grade: **0**  
Clock Start/From:  
Clock To:  
1st Value:  
2nd Value:  
Value Percent:  
Continuous Index:  
Within 8" of Joint: **NO**  
Remarks: **rear camera/mcu**

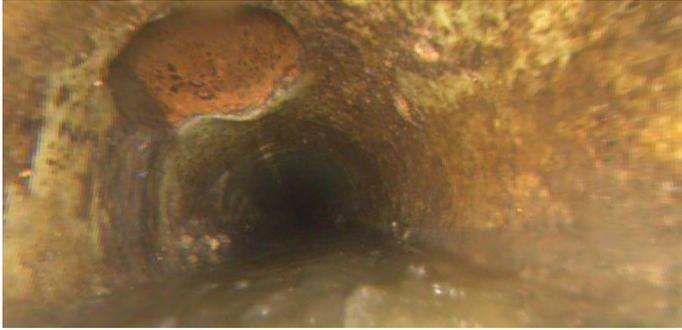
Code: **TB**  
Description: **Tap Break-in**

Distance (ft): **41.3**  
Structural Grade: **0**  
O&M Grade: **0**  
Clock Start/From: **1**  
Clock To:  
1st Value: **4.000**  
2nd Value:  
Value Percent:  
Continuous Index:  
Within 8" of Joint:  
Remarks:

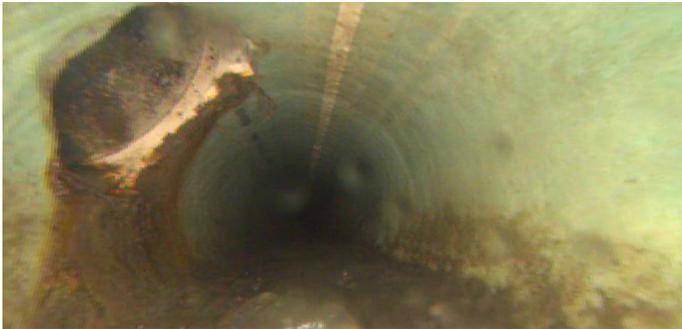
Code: **TB**  
Description: **Tap Break-in**

Distance (ft): **123.6**  
Structural Grade: **0**  
O&M Grade: **0**  
Clock Start/From: **2**  
Clock To:  
1st Value: **4.000**  
2nd Value:  
Value Percent:  
Continuous Index:  
Within 8" of Joint:  
Remarks:

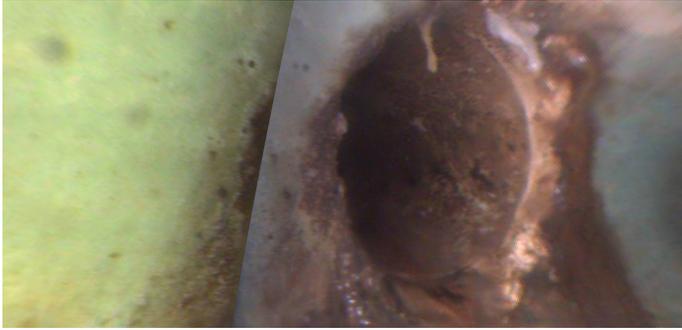
Code: **TB**  
Description: **Tap Break-in**

Distance (ft): **131.8**  
Structural Grade: **0**  
O&M Grade: **0**  
Clock Start/From: **10**  
Clock To:  
1st Value: **4.000**  
2nd Value:  
Value Percent:  
Continuous Index:  
Within 8" of Joint:  
Remarks:

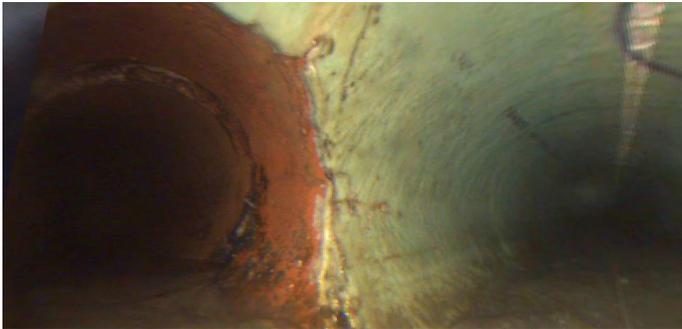
Code: **TB**  
Description: **Tap Break-in**

Distance (ft): **190.2**  
Structural Grade: **0**  
O&M Grade: **0**  
Clock Start/From: **3**  
Clock To:  
1st Value: **4.000**  
2nd Value:  
Value Percent:  
Continuous Index:  
Within 8" of Joint:  
Remarks:

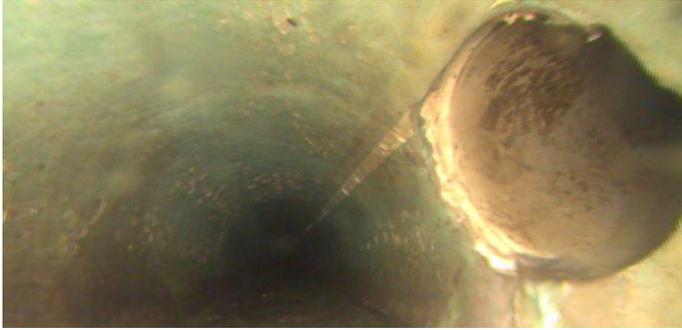
Code: **TB**  
Description: **Tap Break-in**

Distance (ft): **216.9**  
Structural Grade: **0**  
O&M Grade: **0**  
Clock Start/From: **10**  
Clock To:  
1st Value: **4.000**  
2nd Value:  
Value Percent:  
Continuous Index:  
Within 8" of Joint:  
Remarks:

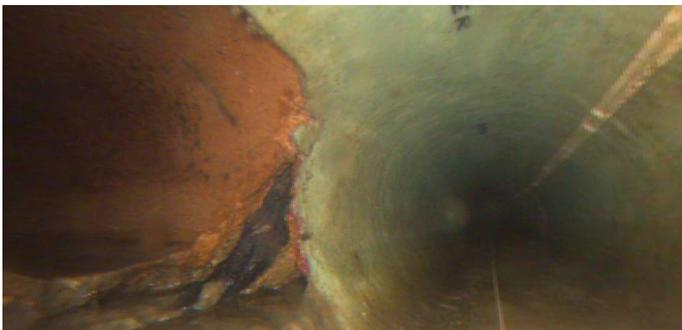
Code: **TB**  
Description: **Tap Break-in**

Distance (ft): **259.5**  
Structural Grade: **0**  
O&M Grade: **0**  
Clock Start/From: **9**  
Clock To:  
1st Value: **4.000**  
2nd Value:  
Value Percent:  
Continuous Index:  
Within 8" of Joint:  
Remarks:

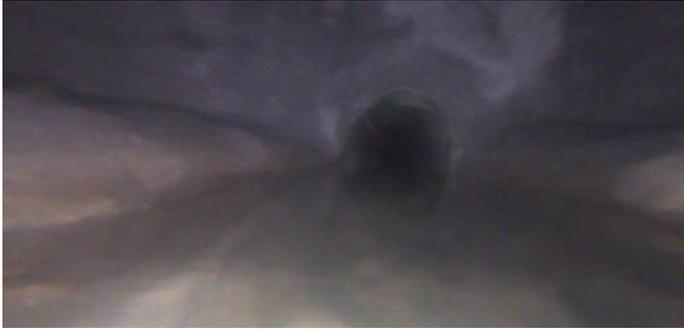
Code: **AMH**  
Description: **Manhole**

Distance (ft): **270.0**  
Structural Grade: **0**  
O&M Grade: **0**  
Clock Start/From:  
Clock To:  
1st Value:  
2nd Value:  
Value Percent:  
Continuous Index:  
Within 8" of Joint: **NO**  
Remarks: **M-305-028**
