## Profile/Photo Observation Report

Street:	<b>FOXCROFT STREET</b>	Flow Control:	<b>Not Controlled</b>
City:	<b>Hobart, IN</b>	Year Renewed:	
Location:	<b>Sidewalk</b>	Tape/Media #:	
Purpose:	<b>Routine Assessment</b>	Dia/Height:	<b>10"</b>
Use:	<b>Sanitary</b>	Material:	<b>PVC</b>
Drain Area:	<b>NA</b>	Lining:	<b>Cured in Place</b>
Category:	<b>NA</b>		
Comment:

Location Details:		Direction of Survey:	<b>Upstream</b>
US MH:	<b>M-305-029</b>	DS MH:	<b>M-305-037</b>
		Total Length Surveyed (ft):	<b>300.3</b>

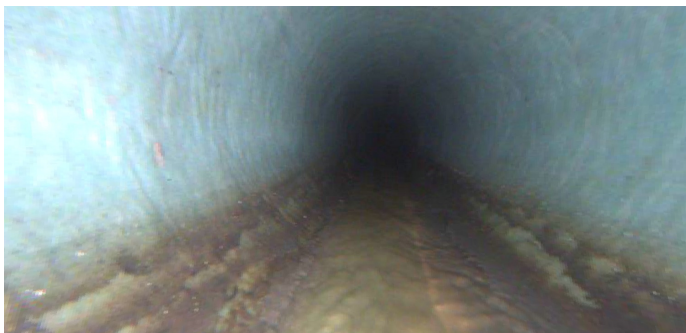
Code: **AMH**  
Description: **Manhole**

Distance (ft): **.0**  
Structural Grade: **0**  
O&M Grade: **0**  
Clock Start/From:  
Clock To:  
1st Value:  
2nd Value:  
Value Percent:  
Continuous Index:  
Within 8" of Joint: **NO**  
Remarks: **M-305-037**

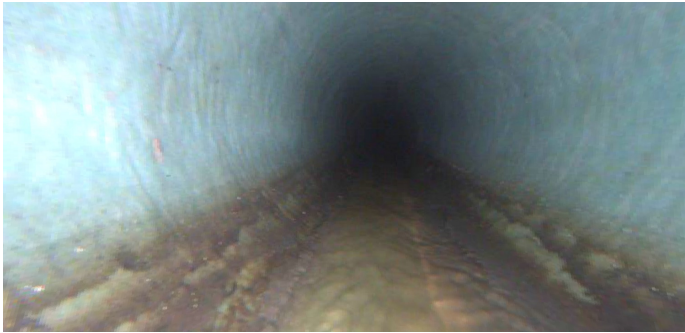
Code:	<b>MWL</b>
Description:	<b>Water Level</b>

Distance (ft):	<b>.0</b>
Structural Grade:	<b>0</b>
O&M Grade:	<b>0</b>
Clock Start/From:	
Clock To:	
1st Value:	
2nd Value:	
Value Percent:	<b>10.000</b>
Continuous Index:	
Within 8" of Joint:	<b>NO</b>
Remarks:

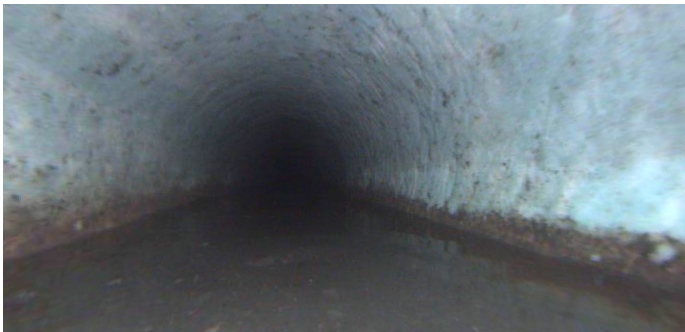
Code:	<b>MWL</b>
Description:	<b>Water Level</b>

Distance (ft):	<b>117.6</b>
Structural Grade:	<b>0</b>
O&M Grade:	<b>0</b>
Clock Start/From:	
Clock To:	
1st Value:	
2nd Value:	
Value Percent:	<b>30.000</b>
Continuous Index:	
Within 8" of Joint:	<b>NO</b>
Remarks:

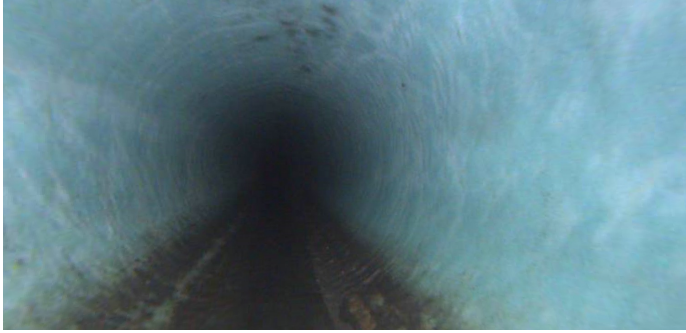
Code: **MWL**  
Description: **Water Level**

Distance (ft): **135.2**  
Structural Grade: **0**  
O&M Grade: **0**  
Clock Start/From:  
Clock To:  
1st Value:  
2nd Value:  
Value Percent: **5.000**  
Continuous Index:  
Within 8" of Joint: **NO**  
Remarks:

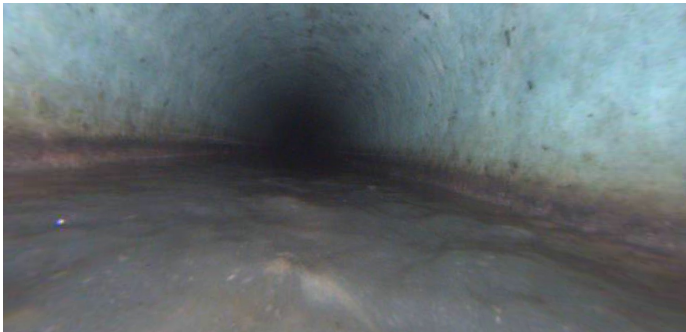
Code: **MWL**  
Description: **Water Level**

Distance (ft): **146.4**  
Structural Grade: **0**  
O&M Grade: **0**  
Clock Start/From:  
Clock To:  
1st Value:  
2nd Value:  
Value Percent: **40.000**  
Continuous Index:  
Within 8" of Joint: **NO**  
Remarks:

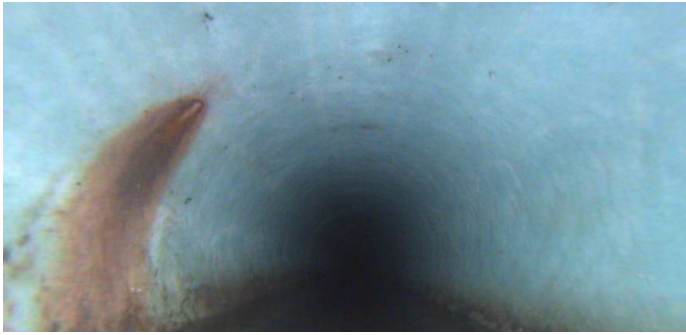
Code: **IS**  
Description: **Infil Stain**

Distance (ft): **157.2**  
Structural Grade: **0**  
O&M Grade: **0**  
Clock Start/From: **10**  
Clock To:  
1st Value:  
2nd Value:  
Value Percent:  
Continuous Index:  
Within 8" of Joint:  
Remarks:

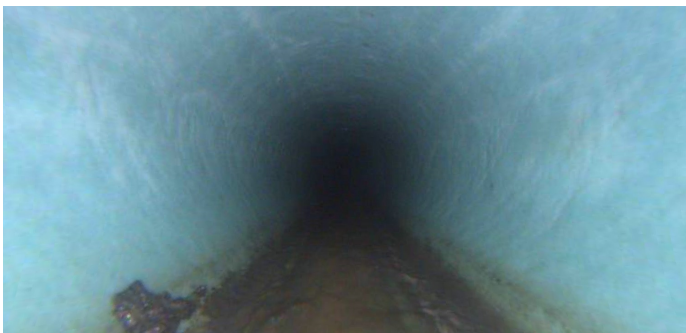
Code: **MWL**  
Description: **Water Level**

Distance (ft): **171.9**  
Structural Grade: **0**  
O&M Grade: **0**  
Clock Start/From:  
Clock To:  
1st Value:  
2nd Value:  
Value Percent: **5.000**  
Continuous Index:  
Within 8" of Joint: **NO**  
Remarks:

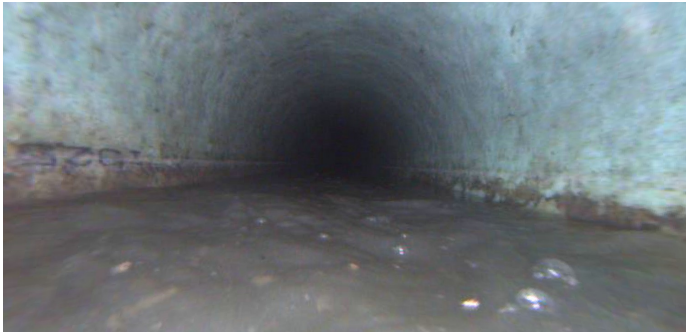
Code: **MWL**  
Description: **Water Level**

Distance (ft): **189.4**  
Structural Grade: **0**  
O&M Grade: **0**  
Clock Start/From:  
Clock To:  
1st Value:  
2nd Value:  
Value Percent: **40.000**  
Continuous Index:  
Within 8" of Joint: **NO**  
Remarks:

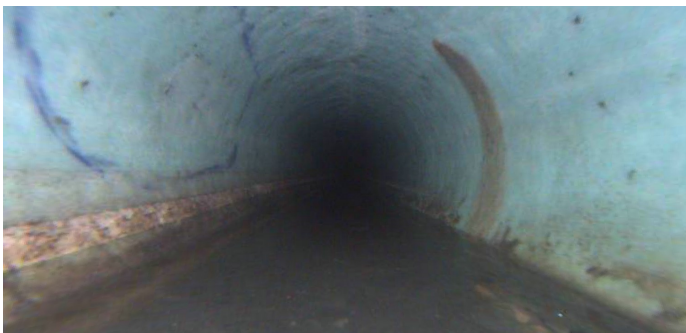
Code: **IS**  
Description: **Infil Stain**

Distance (ft): **218.5**  
Structural Grade: **0**  
O&M Grade: **0**  
Clock Start/From: **1**  
Clock To: **4**  
1st Value:  
2nd Value:  
Value Percent:  
Continuous Index:  
Within 8" of Joint:  
Remarks:

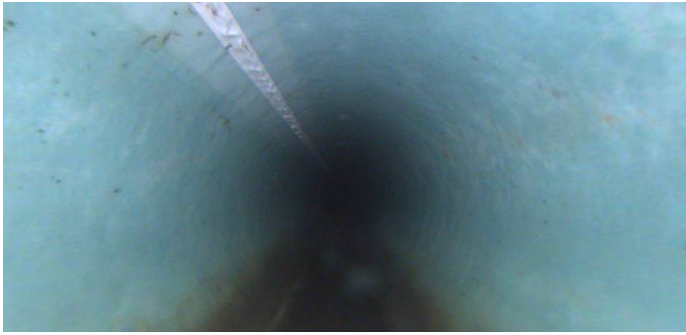
Code: **MWL**  
Description: **Water Level**

Distance (ft): **265.0**  
Structural Grade: **0**  
O&M Grade: **0**  
Clock Start/From:  
Clock To:  
1st Value:  
2nd Value:  
Value Percent: **5.000**  
Continuous Index:  
Within 8" of Joint: **NO**  
Remarks:

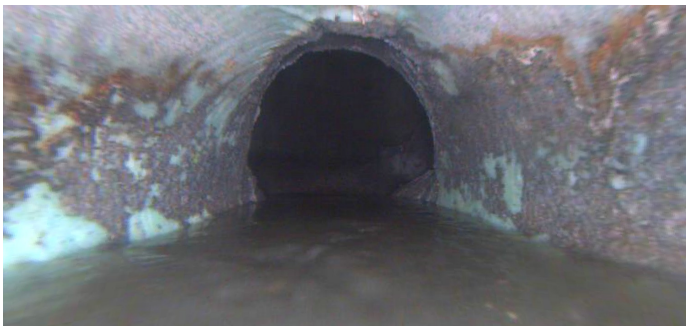
Code: **MWL**  
Description: **Water Level**

Distance (ft): **297.9**  
Structural Grade: **0**  
O&M Grade: **0**  
Clock Start/From:  
Clock To:  
1st Value:  
2nd Value:  
Value Percent: **30.000**  
Continuous Index:  
Within 8" of Joint: **NO**  
Remarks:

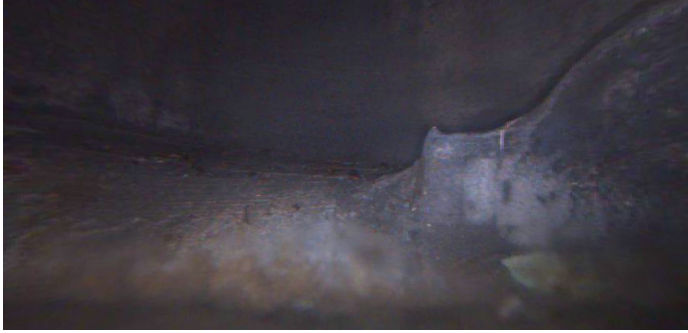
Code:	AMH
Description:	Manhole
Distance (ft):	300.3
Structural Grade:	0
O&M Grade:	0
Clock Start/From:	
Clock To:	
1st Value:	
2nd Value:	
Value Percent:	
Continuous Index:	
Within 8" of Joint:	NO
Remarks:	M-305-029
