Profile/Photo Observation Report

Date:	04/18/2018	Weather:		Coding:	PACP 6.0
Pipe Length (ft):	293.6	Owner:	NA	Pre Clean:	No Pre-Cleaning
P.O.#:		Surveyor:	Byrd Fitzgerald	PSR:	P-305-035-036
Customer:		Clean Date:	01/01/1900	Shape:	C

Street:	OFF CRABAPPLE LN	Flow Control:	Not Controlled
City:	Hobart, IN	Year Renewed:	
Location:	Yard	Tape/Media #:	
Purpose:	Routine Assessment	Dia/Height:	10"
Use:	Sanitary	Material:	XXX
Drain Area:	NA	Lining:	Cured in Place
Category:	NA		
Comment:	Flow direction wrong

Location Details:		Direction of Survey:	Downstream
US MH:	M-305-036	DS MH:	M-305-035
		Total Length Surveyed (ft):	288.3

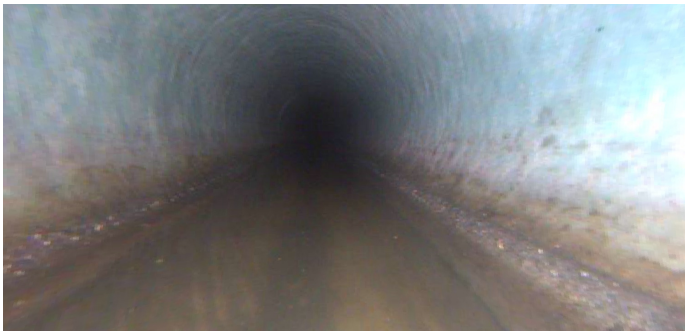
Code: **AMH**
Description: **Manhole**

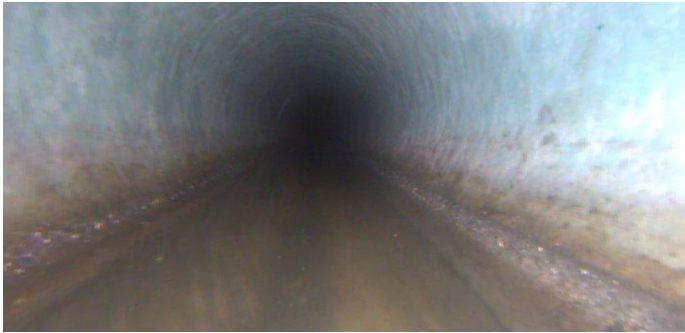
Code:	MWL
Description:	Water Level

Distance (ft):	.0
Structural Grade:	0
O&M Grade:	0
Clock Start/From:	
Clock To:	
1st Value:	
2nd Value:	
Value Percent:	5.000
Continuous Index:	
Within 8" of Joint:	NO
Remarks:

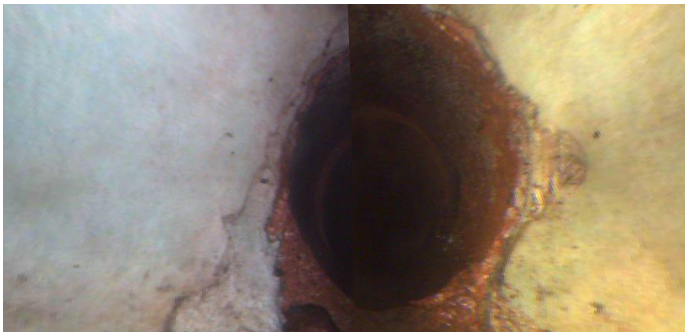
Code:	TB
Description:	Tap Break-in

Distance (ft):	12.1
Structural Grade:	0
O&M Grade:	0
Clock Start/From:	2
Clock To:	
1st Value:	4.000
2nd Value:	
Value Percent:	
Continuous Index:	
Within 8" of Joint:	
Remarks:

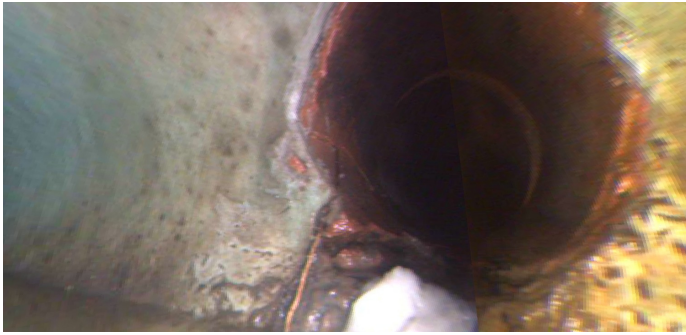
Code: **TB**
Description: **Tap Break-in**

Distance (ft): **102.6**
Structural Grade: **0**
O&M Grade: **0**
Clock Start/From: **2**
Clock To:
1st Value: **4.000**
2nd Value:
Value Percent:
Continuous Index:
Within 8" of Joint:
Remarks:

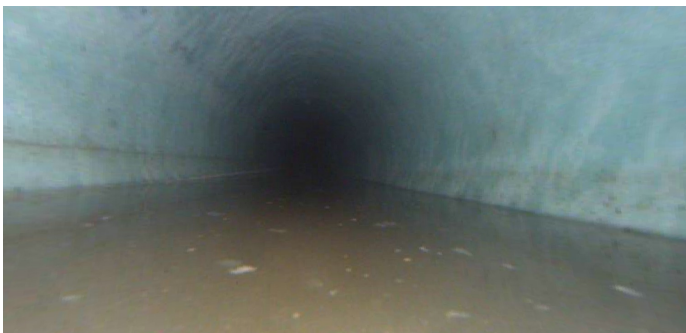
Code: **MWL**
Description: **Water Level**

Distance (ft): **158.8**
Structural Grade: **0**
O&M Grade: **0**
Clock Start/From:
Clock To:
1st Value:
2nd Value:
Value Percent: **25.000**
Continuous Index:
Within 8" of Joint: **NO**
Remarks:

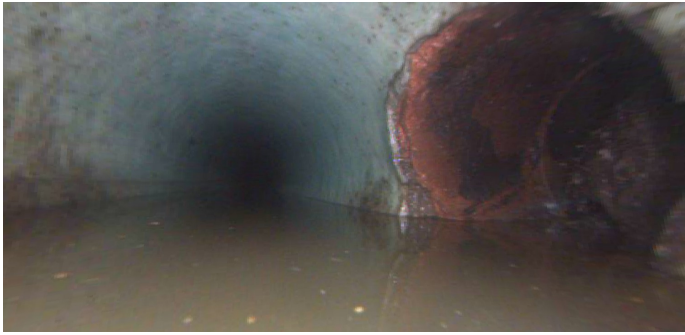
Code: **TB**
Description: **Tap Break-in**

Distance (ft): **175.0**
Structural Grade: **0**
O&M Grade: **0**
Clock Start/From: **3**
Clock To:
1st Value: **6.000**
2nd Value:
Value Percent:
Continuous Index:
Within 8" of Joint:
Remarks:

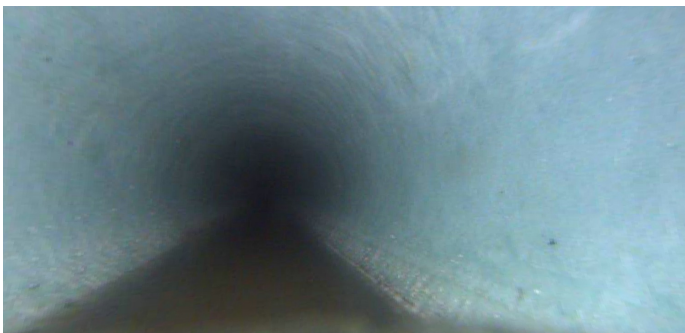
Code: **MWL**
Description: **Water Level**

Distance (ft): **268.8**
Structural Grade: **0**
O&M Grade: **0**
Clock Start/From:
Clock To:
1st Value:
2nd Value:
Value Percent: **5.000**
Continuous Index:
Within 8" of Joint: **NO**
Remarks:

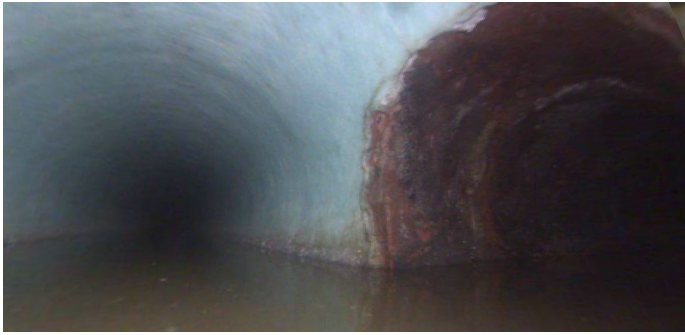
Code: **TB**
Description: **Tap Break-in**

Distance (ft): **276.4**
Structural Grade: **0**
O&M Grade: **0**
Clock Start/From: **3**
Clock To:
1st Value: **6.000**
2nd Value:
Value Percent:
Continuous Index:
Within 8" of Joint:
Remarks:

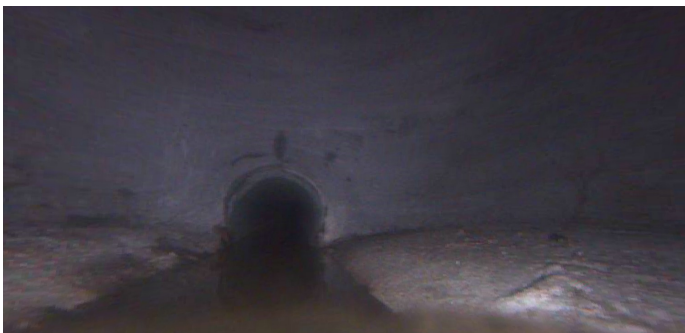
Code: **AMH**
Description: **Manhole**

Distance (ft): **288.3**
Structural Grade: **0**
O&M Grade: **0**
Clock Start/From:
Clock To:
1st Value:
2nd Value:
Value Percent:
Continuous Index:
Within 8" of Joint: **NO**
Remarks: **M-305-035**
