Profile/Photo Observation Report

Street:	FOXCROFT STREET	Flow Control:	Not Controlled
City:	Hobart, IN	Year Renewed:	
Location:	Yard	Tape/Media #:	
Purpose:	Routine Assessment	Dia/Height:	10"
Use:	Sanitary	Material:	XXX
Drain Area:	NA	Lining:	Cured in Place
Category:	NA		
Comment:	Flow direction wrong

Location Details:		Direction of Survey:	Downstream
US MH:	M-305-036	DS MH:	M-305-035
		Total Length Surveyed (ft):	288.3

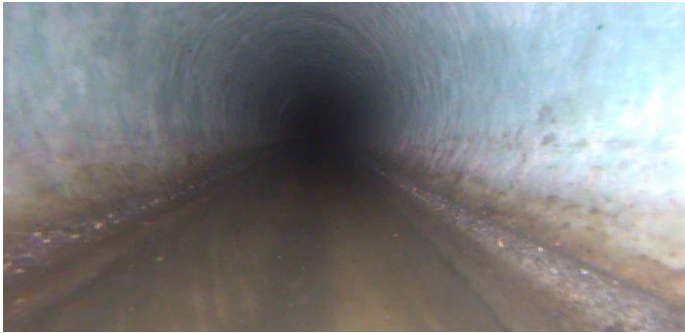
Code:	MWL
Description:	Water Level

Distance (ft):	.0
Structural Grade:	0
O&M Grade:	0
Clock Start/From:	
Clock To:	
1st Value:	
2nd Value:	
Value Percent:	5.000
Continuous Index:	
Within 8" of Joint:	NO
Remarks:

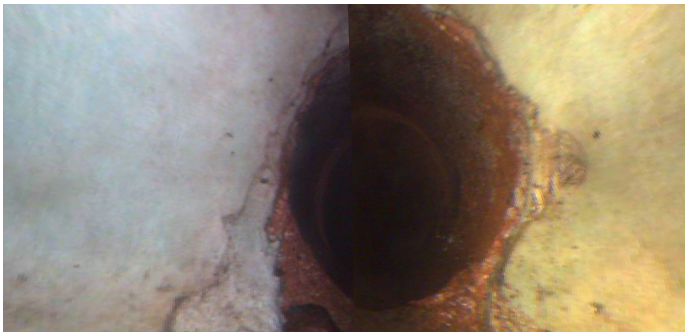
Code:	TB
Description:	Tap Break-in

Distance (ft):	12.1
Structural Grade:	0
O&M Grade:	0
Clock Start/From:	2
Clock To:	
1st Value:	4.000
2nd Value:	
Value Percent:	
Continuous Index:	
Within 8" of Joint:	
Remarks:

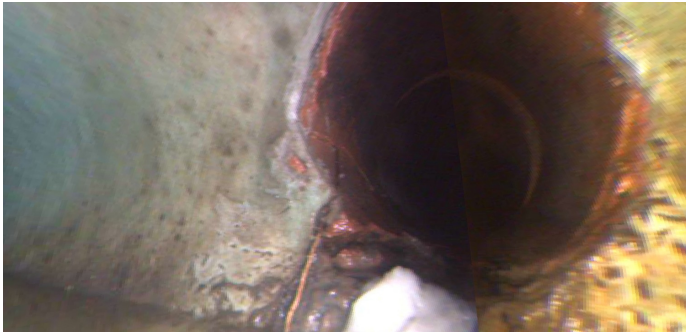
Code: **TB**
Description: **Tap Break-in**

Distance (ft): **102.6**
Structural Grade: **0**
O&M Grade: **0**
Clock Start/From: **2**
Clock To:
1st Value: **4.000**
2nd Value:
Value Percent:
Continuous Index:
Within 8" of Joint:
Remarks:

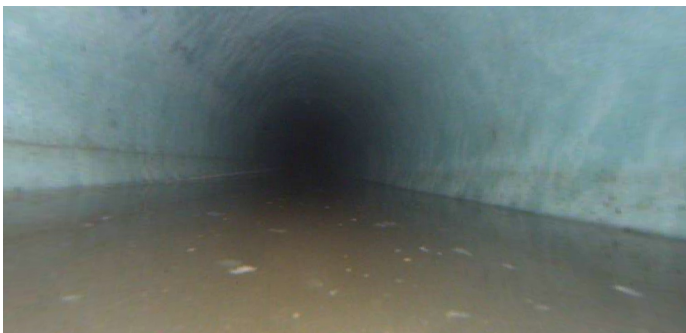
Code: **MWL**
Description: **Water Level**

Distance (ft): **158.8**
Structural Grade: **0**
O&M Grade: **0**
Clock Start/From:
Clock To:
1st Value:
2nd Value:
Value Percent: **25.000**
Continuous Index:
Within 8" of Joint: **NO**
Remarks:

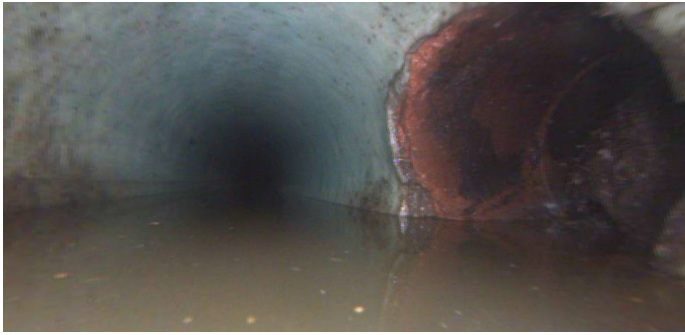
Code: **TB**
Description: **Tap Break-in**

Distance (ft): **175.0**
Structural Grade: **0**
O&M Grade: **0**
Clock Start/From: **3**
Clock To:
1st Value: **6.000**
2nd Value:
Value Percent:
Continuous Index:
Within 8" of Joint:
Remarks:

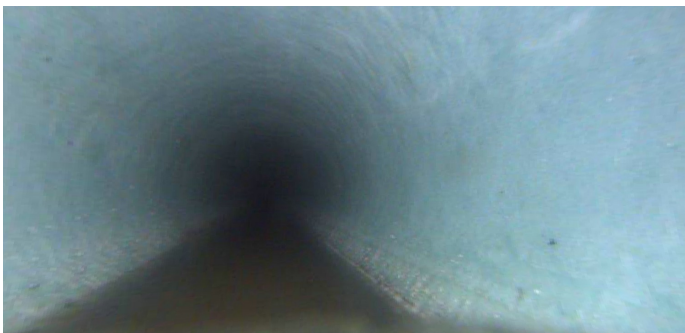
Code: **MWL**
Description: **Water Level**

Distance (ft): **268.8**
Structural Grade: **0**
O&M Grade: **0**
Clock Start/From:
Clock To:
1st Value:
2nd Value:
Value Percent: **5.000**
Continuous Index:
Within 8" of Joint: **NO**
Remarks:

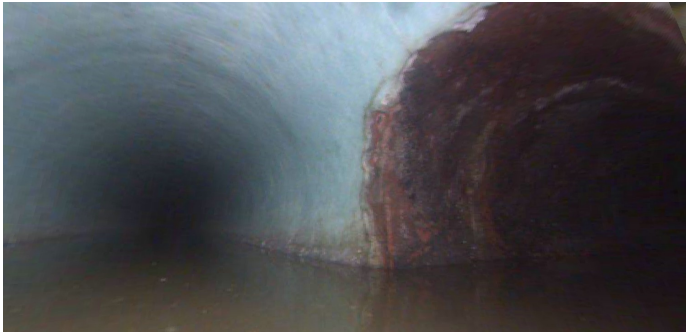
Code: **TB**
Description: **Tap Break-in**

Distance (ft): **276.4**
Structural Grade: **0**
O&M Grade: **0**
Clock Start/From: **3**
Clock To:
1st Value: **6.000**
2nd Value:
Value Percent:
Continuous Index:
Within 8" of Joint:
Remarks:

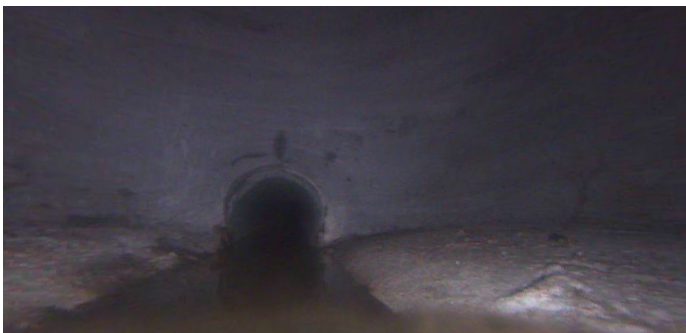
Code: **AMH**
Description: **Manhole**

Distance (ft): **288.3**
Structural Grade: **0**
O&M Grade: **0**
Clock Start/From:
Clock To:
1st Value:
2nd Value:
Value Percent:
Continuous Index:
Within 8" of Joint: **NO**
Remarks: **M-305-035**
