Profile/Photo Observation Report

Date:	04/24/2018	Weather:		Coding:	PACP 6.0
Pipe Length (ft):		Owner:	City of Hobart	Pre Clean:	No Pre-Cleaning
P.O.#:	74	Surveyor:	M. Pielacha	PSR:	P-305-044-045
Customer:	City of Hobart	Clean Date:		Shape:	C

Street:	3rd Street	Flow Control:	Not Controlled
City:	Hobart, IN	Year Renewed:	
Location:	Light Highway	Tape/Media #:	DEP 74
Purpose:	Routine Assessment	Dia/Height:	15"
Use:	Sanitary	Material:	CP
Drain Area:		Lining:	
Category:	NA		
Comment:	YES501824 Submittal 2		
Location Details:		Direction of Survey:	Upstream
US MH:	M-305-044	DS MH:	M-405-045
		Total Length Surveyed (ft):	25.9

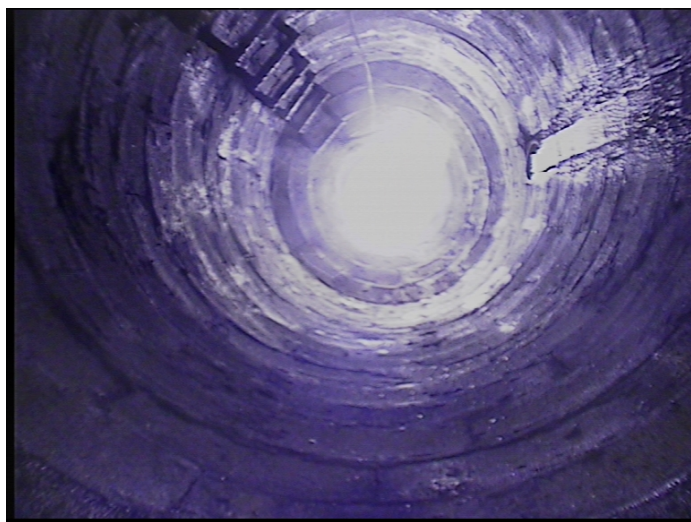
Code: **AMH**
Description: **Manhole**

Distance (ft): **.0**
Structural Grade: **0**
O&M Grade: **0**
Clock Start/From:
Clock To:
1st Value:
2nd Value:
Value Percent:
Continuous Index:
Within 8" of Joint: **NO**
Remarks: **M-405-045**

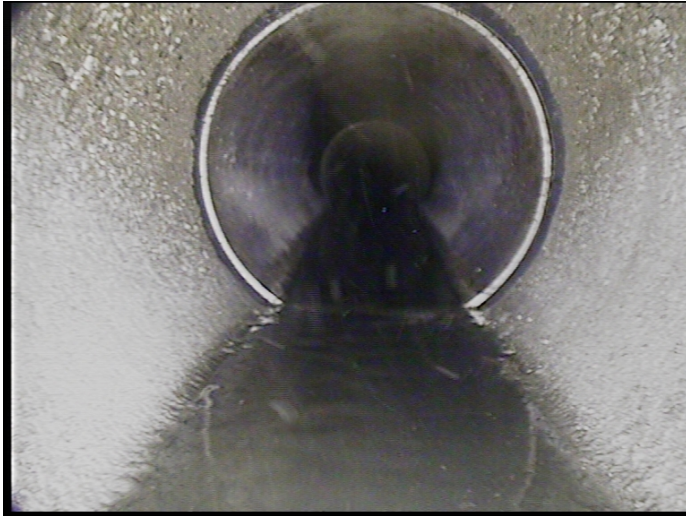
Code: **MWL**
Description: **Water Level**

Distance (ft): **.0**
Structural Grade: **0**
O&M Grade: **0**
Clock Start/From:
Clock To:
1st Value:
2nd Value:
Value Percent: **5.000**
Continuous Index:
Within 8" of Joint: **NO**
Remarks:

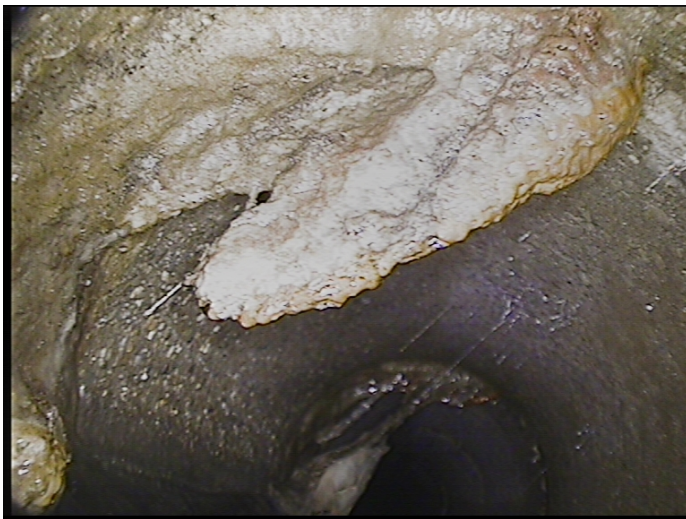
Code: **DAE**
Description: **Deposits Attached Encrustation**

Distance (ft): **21.2**
Structural Grade: **0**
O&M Grade: **2**
Clock Start/From: **9**
Clock To: **12**
1st Value:
2nd Value:
Value Percent: **10.000**
Continuous Index:
Within 8" of Joint: **NO**
Remarks:

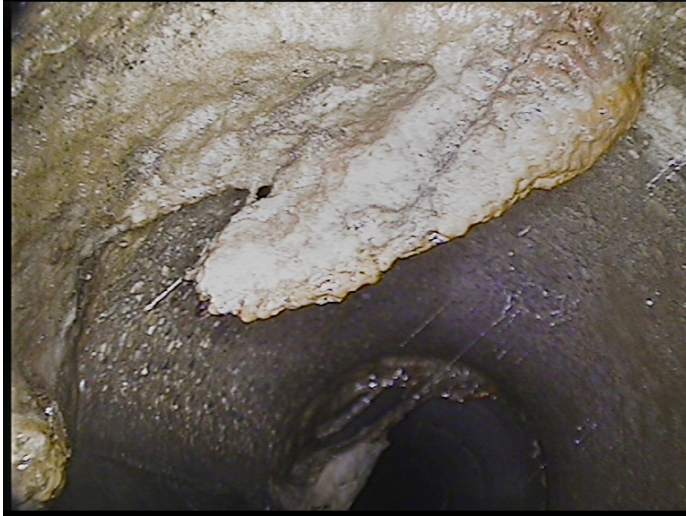
Code: **ID**
Description: **Infil Dripper**

Distance (ft): **21.2**
Structural Grade: **0**
O&M Grade: **3**
Clock Start/From: **10**
Clock To:
1st Value:
2nd Value:
Value Percent:
Continuous Index:
Within 8" of Joint: **YES**
Remarks:

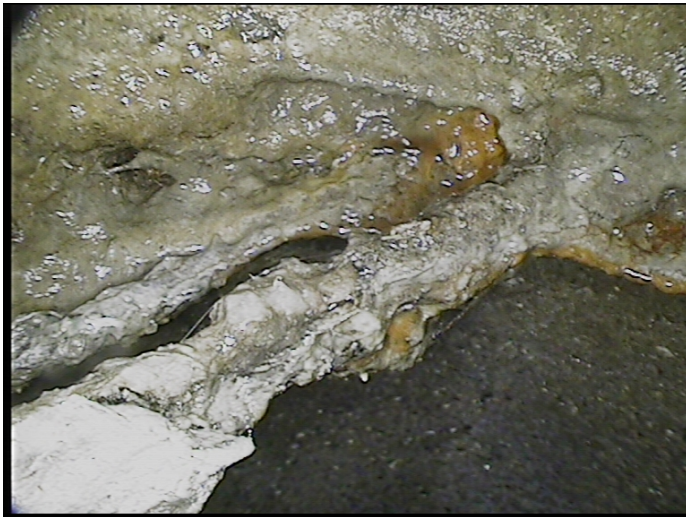
Code: **RTJ**
Description: **Roots Tap Joint**

Distance (ft): **25.9**
Structural Grade: **0**
O&M Grade: **2**
Clock Start/From: **10**
Clock To:
1st Value:
2nd Value:
Value Percent: **15.000**
Continuous Index:
Within 8" of Joint: **YES**
Remarks:

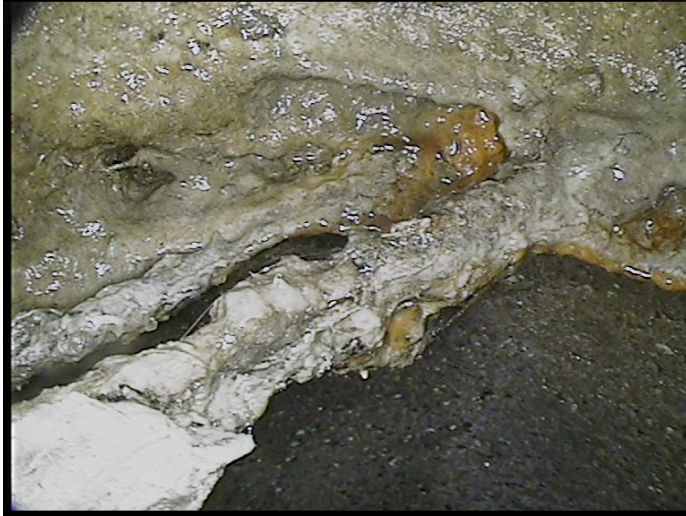
Code:	MSA
Description:	Abandoned Survey
Distance (ft):	25.9
Structural Grade:	0
O&M Grade:	0
Clock Start/From:	
Clock To:	
1st Value:	
2nd Value:	
Value Percent:	
Continuous Index:	
Within 8" of Joint:	NO
Remarks:	Tap root
