Profile/Photo Observation Report

Street:	FOXCROFT STREET	Flow Control:	Not Controlled
City:	Hobart, IN	Year Renewed:	
Location:	Yard	Tape/Media #:	
Purpose:	Routine Assessment	Dia/Height:	12"
Use:	Sanitary	Material:	VCP
Drain Area:	NA	Lining:	
Category:	NA		
Comment:	F_S_P_C at 3 ft debris		
Location Details:		Direction of Survey:	Upstream
US MH:	M-305-046	DS MH:	M-305-044
		Total Length Surveyed (ft):	4.9

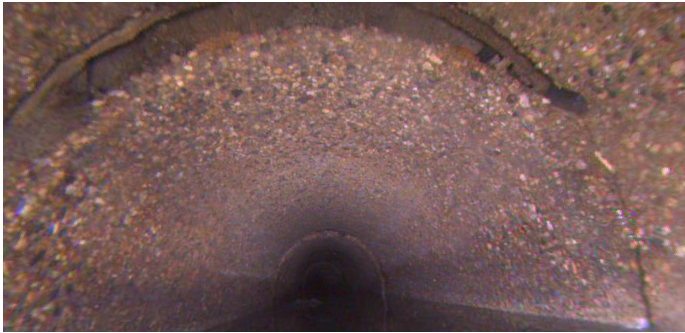
Code:	MWL
Description:	Water Level

Distance (ft):	.0
Structural Grade:	0
O&M Grade:	0
Clock Start/From:	
Clock To:	
1st Value:	
2nd Value:	
Value Percent:	40.000
Continuous Index:	
Within 8" of Joint:	NO
Remarks:

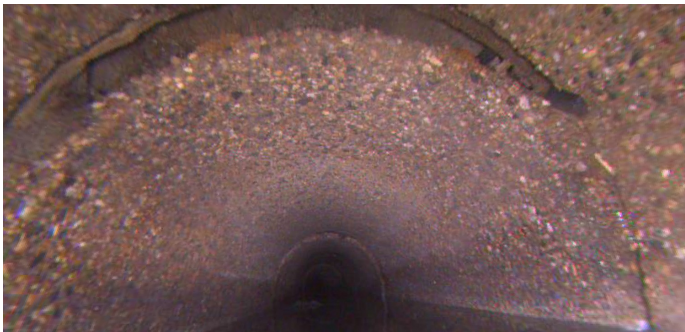
Code:	SAP
Description:	Surface Aggregate Projecting

Distance (ft):	.0
Structural Grade:	3
O&M Grade:	0
Clock Start/From:	8
Clock To:	4
1st Value:	
2nd Value:	
Value Percent:	
Continuous Index:	
Within 8" of Joint:	
Remarks:

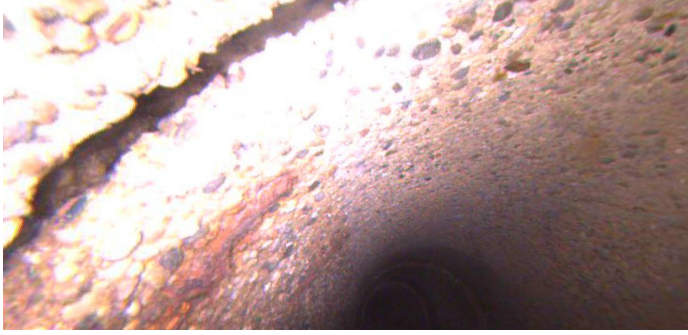
Code:	MSA
Description:	Abandoned Survey
Distance (ft):	4.9
Structural Grade:	0
O&M Grade:	0
Clock Start/From:	
Clock To:	
1st Value:	
2nd Value:	
Value Percent:	
Continuous Index:	
Within 8" of Joint:	NO
Remarks:	debris under water
