Profile/Photo Observation Report

Street:	W 3RD ST & WOODLAND LN	Flow Control:	Not Controlled
City:	Hobart, IN	Year Renewed:	
Location:	Yard	Tape/Media #:	
Purpose:	Routine Assessment	Dia/Height:	10"
Use:	Sanitary	Material:	VCP
Drain Area:	NA	Lining:	
Category:	NA		
Comment:	P_C at 37 ft build up At the lateral		
Location Details:		Direction of Survey:	Downstream
US MH:	M-305-046	DS MH:	M-305-044
		Total Length Surveyed (ft):	38.9

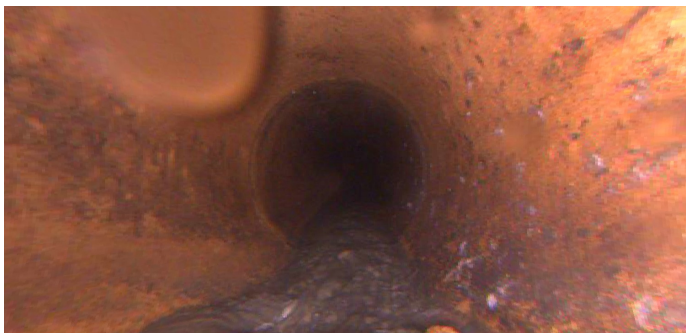
Code: **AMH**
Description: **Manhole**

Distance (ft): **.0**
Structural Grade: **0**
O&M Grade: **0**
Clock Start/From:
Clock To:
1st Value:
2nd Value:
Value Percent:
Continuous Index:
Within 8" of Joint: **NO**
Remarks: **M-305-046**

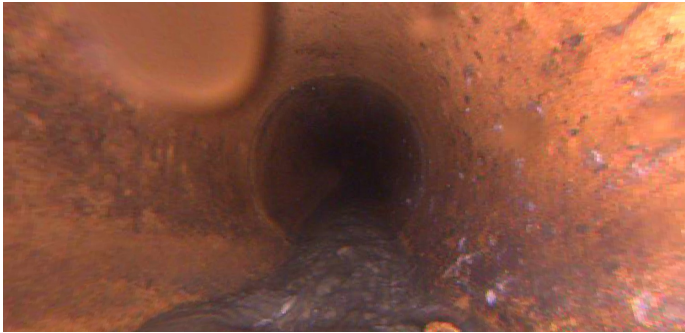
Code:	MWL
Description:	Water Level

Distance (ft):	.0
Structural Grade:	0
O&M Grade:	0
Clock Start/From:	
Clock To:	
1st Value:	
2nd Value:	
Value Percent:	5.000
Continuous Index:	
Within 8" of Joint:	NO
Remarks:

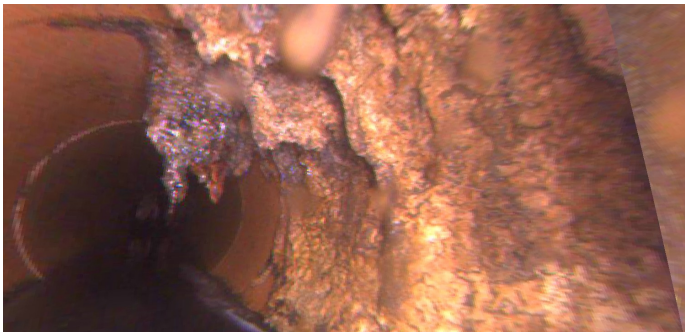
Code:	DAE
Description:	Deposits Attached Encrustation

Distance (ft):	30.6
Structural Grade:	0
O&M Grade:	2
Clock Start/From:	12
Clock To:	5
1st Value:	
2nd Value:	
Value Percent:	10.000
Continuous Index:	
Within 8" of Joint:	NO
Remarks:

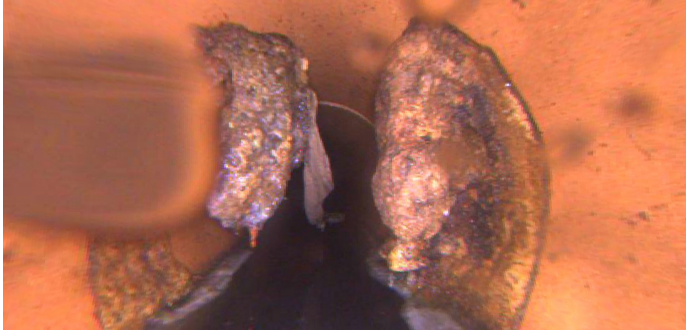
Code: **DAE**
Description: **Deposits Attached Encrustation**

Distance (ft): **36.9**
Structural Grade: **0**
O&M Grade: **4**
Clock Start/From: **7**
Clock To: **5**
1st Value:
2nd Value:
Value Percent: **25.000**
Continuous Index:
Within 8" of Joint: **NO**
Remarks:

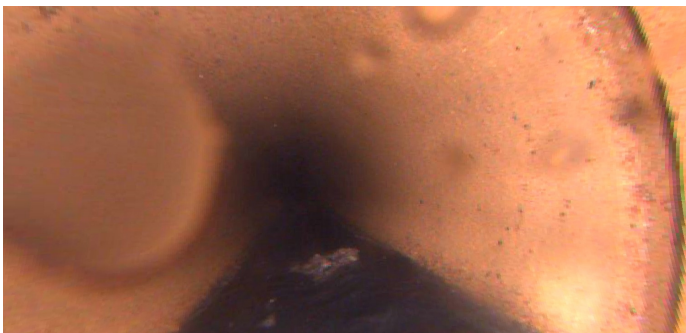
Code: **MSA**
Description: **Abandoned Survey**

Distance (ft): **38.9**
Structural Grade: **0**
O&M Grade: **0**
Clock Start/From:
Clock To:
1st Value:
2nd Value:
Value Percent:
Continuous Index:
Within 8" of Joint: **NO**
Remarks: **dae**
