Profile/Photo Observation Report

Date:	04/20/2018	Weather:		Coding:	PACP 6.0
Pipe Length (ft):	111.1	Owner:	NA	Pre Clean:	No Pre-Cleaning
P.O.#:		Surveyor:	Byrd Fitzgerald	PSR:	P-305-047-046
Customer:		Clean Date:	01/01/1900	Shape:	C

Street:	W 3RD ST & WOODLAND LN	Flow Control:	Not Controlled
City:	Hobart, IN	Year Renewed:	
Location:	Sidewalk	Tape/Media #:	
Purpose:	Routine Assessment	Dia/Height:	12"
Use:	Sanitary	Material:	VCP
Drain Area:	NA	Lining:	
Category:	NA		
Comment:	P_C at 25 ft build up at the joint		
Location Details:		Direction of Survey:	Upstream
US MH:	M-305-046	DS MH:	M-305-047
		Total Length Surveyed (ft):	27.0

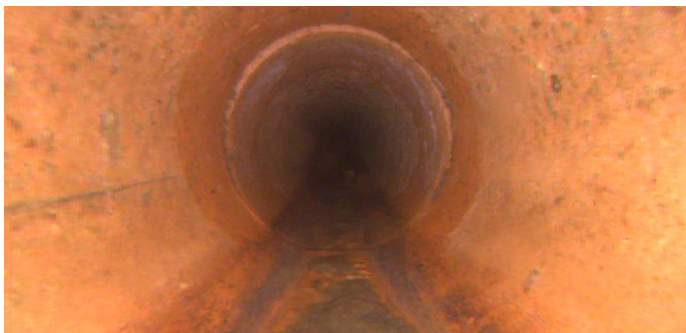
Code: **AMH**
Description: **Manhole**

Distance (ft): **.0**
Structural Grade: **0**
O&M Grade: **0**
Clock Start/From:
Clock To:
1st Value:
2nd Value:
Value Percent:
Continuous Index:
Within 8" of Joint: **NO**
Remarks: **M-305-047**

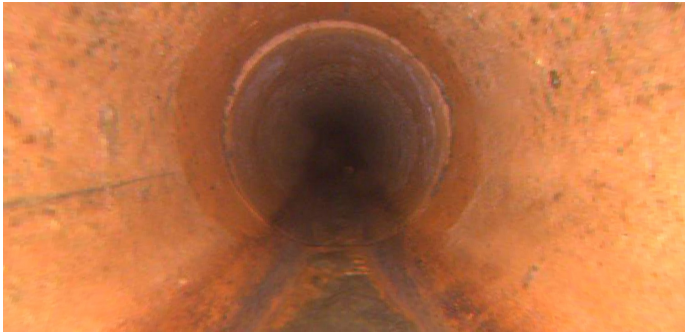
Code:	MWL
Description:	Water Level

Distance (ft):	.0
Structural Grade:	0
O&M Grade:	0
Clock Start/From:	
Clock To:	
1st Value:	
2nd Value:	
Value Percent:	5.000
Continuous Index:	
Within 8" of Joint:	NO
Remarks:

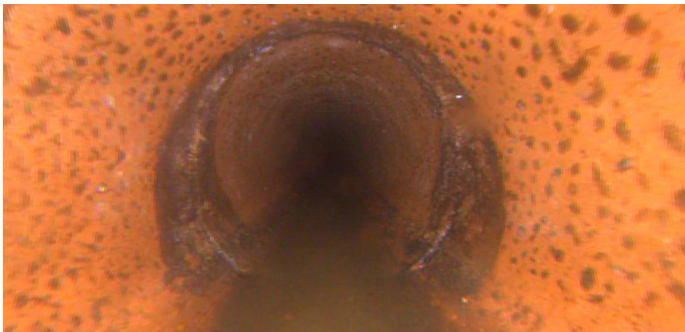
Code:	DAE
Description:	Deposits Attached Encrustation

Distance (ft):	11.1
Structural Grade:	0
O&M Grade:	2
Clock Start/From:	7
Clock To:	5
1st Value:	
2nd Value:	
Value Percent:	5.000
Continuous Index:	S01
Within 8" of Joint:	YES
Remarks:	wandering

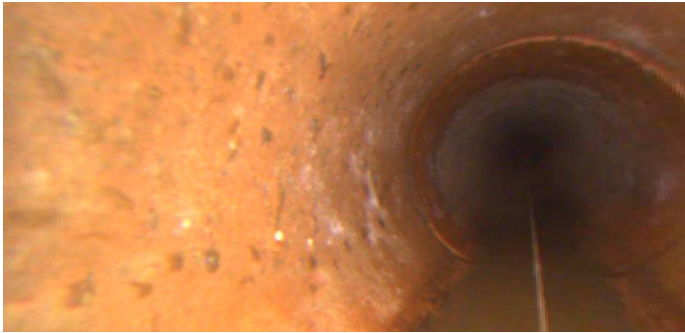
Code: **DAE**
Description: **Deposits Attached Encrustation**

Distance (ft): **22.5**
Structural Grade: **0**
O&M Grade: **2**
Clock Start/From: **7**
Clock To: **5**
1st Value:
2nd Value:
Value Percent: **5.000**
Continuous Index: **F01**
Within 8" of Joint: **YES**
Remarks: **wandering**

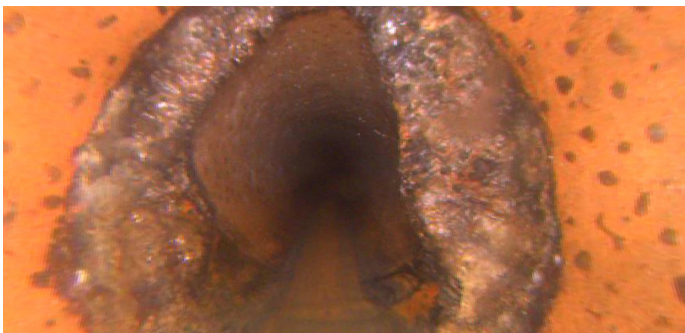
Code: **DAE**
Description: **Deposits Attached Encrustation**

Distance (ft): **26.0**
Structural Grade: **0**
O&M Grade: **4**
Clock Start/From: **7**
Clock To: **5**
1st Value:
2nd Value:
Value Percent: **25.000**
Continuous Index:
Within 8" of Joint: **YES**
Remarks:

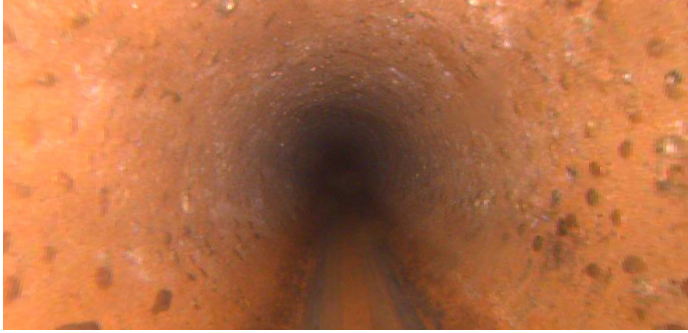
Code:	MSA
Description:	Abandoned Survey
Distance (ft):	27.0
Structural Grade:	0
O&M Grade:	0
Clock Start/From:	
Clock To:	
1st Value:	
2nd Value:	
Value Percent:	
Continuous Index:	
Within 8" of Joint:	NO
Remarks:	dae
