Profile/Photo Observation Report

Street:	Woodland Lane	Flow Control:	Not Controlled
City:	Hobart, IN	Year Renewed:	
Location:	Other	Tape/Media #:	
Purpose:	Routine Assessment	Dia/Height:	8"
Use:	Sanitary Sewage Pipe	Material:	VCP
Drain Area:		Lining:	None
Category:	NA		
Comment:			
Location Details:	320 WOODLAND LN DRIVEWAY	Direction of Survey:	Downstream
US MH:	M-305-046	DS MH:	M-305-047
		Total Length Surveyed (ft):	110.2

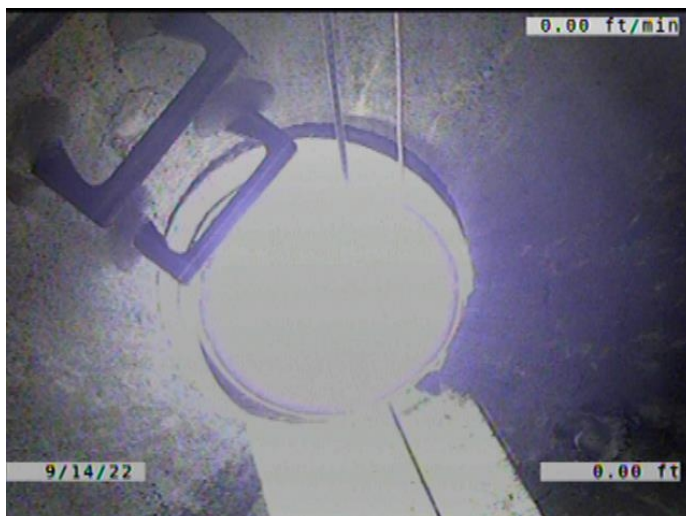
Code: **AMH**
Description: **Manhole**

Distance (ft): **.0**
Structural Grade: **0**
O&M Grade: **0**
Clock Start/From:
Clock To:
1st Value:
2nd Value:
Value Percent:
Continuous Index:
Within 8" of Joint: **NO**
Remarks: **M-305-046**

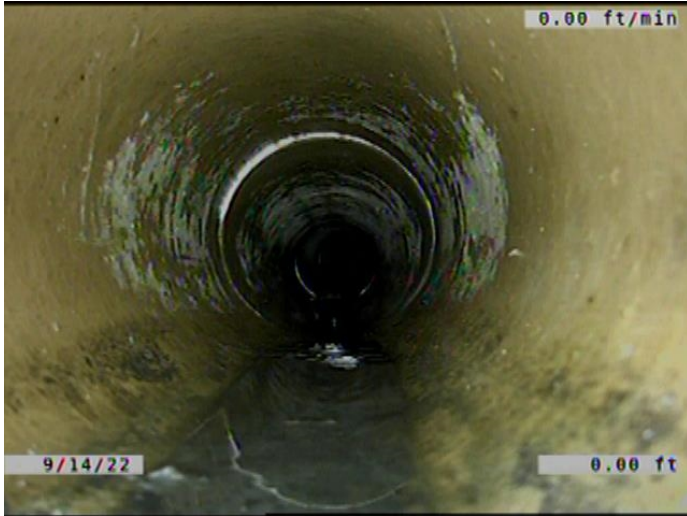
Code:	MWL
Description:	Miscellaneous Water Level
Distance (ft):	.0
Structural Grade:	0
O&M Grade:	0
Clock Start/From:	
Clock To:	
1st Value:	
2nd Value:	
Value Percent:	5.000
Continuous Index:	
Within 8" of Joint:	NO
Remarks:

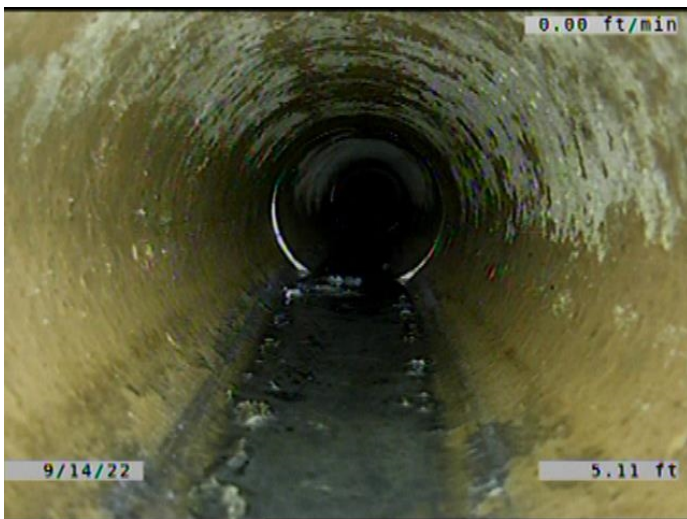
Code:	DSF
Description:	Deposits Settled Fine
Distance (ft):	5.1
Structural Grade:	0
O&M Grade:	2
Clock Start/From:	5
Clock To:	7
1st Value:	
2nd Value:	
Value Percent:	5.000
Continuous Index:	S01
Within 8" of Joint:	YES
Remarks:

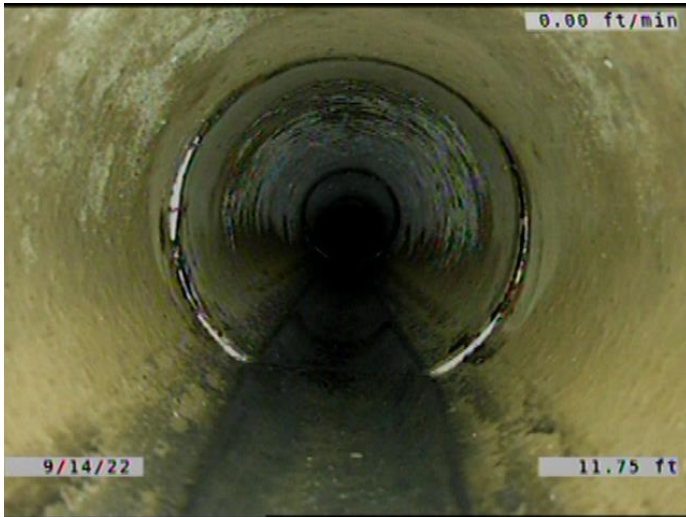
Code: **MWLS**
Description: **Miscellaneous Water Level Sag**

Distance (ft): **11.8**
Structural Grade: **2**
O&M Grade: **0**
Clock Start/From:
Clock To:
1st Value:
2nd Value:
Value Percent: **5.000**
Continuous Index: **S02**
Within 8" of Joint: **NO**
Remarks:

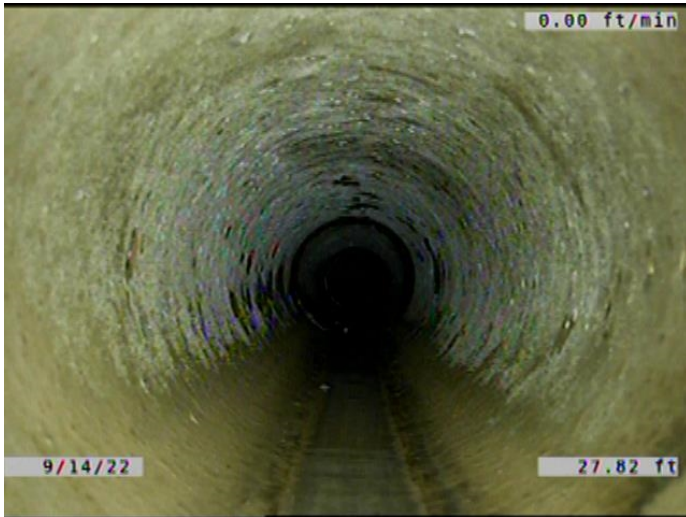
Code: **MWLS**
Description: **Miscellaneous Water Level Sag**

Distance (ft): **27.8**
Structural Grade: **2**
O&M Grade: **0**
Clock Start/From:
Clock To:
1st Value:
2nd Value:
Value Percent: **5.000**
Continuous Index: **F02**
Within 8" of Joint: **NO**
Remarks:

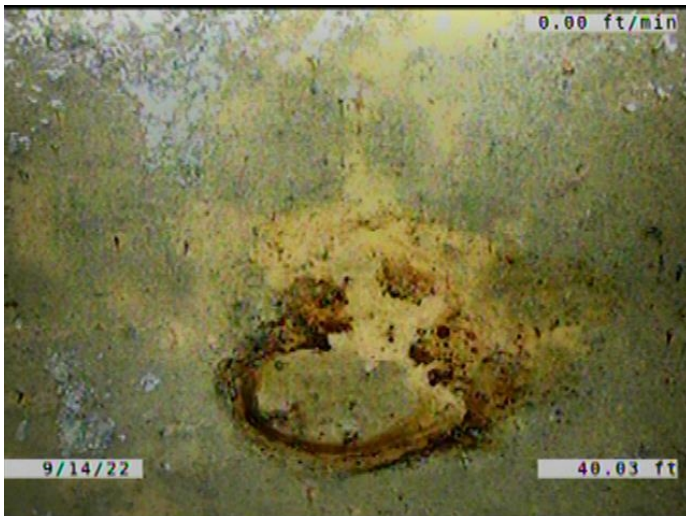
Code: **ISB**
Description: **Infiltration Stain Barrel**

Distance (ft): **40.0**
Structural Grade: **0**
O&M Grade: **1**
Clock Start/From: **12**
Clock To: **2**
1st Value:
2nd Value:
Value Percent:
Continuous Index:
Within 8" of Joint: **NO**
Remarks:

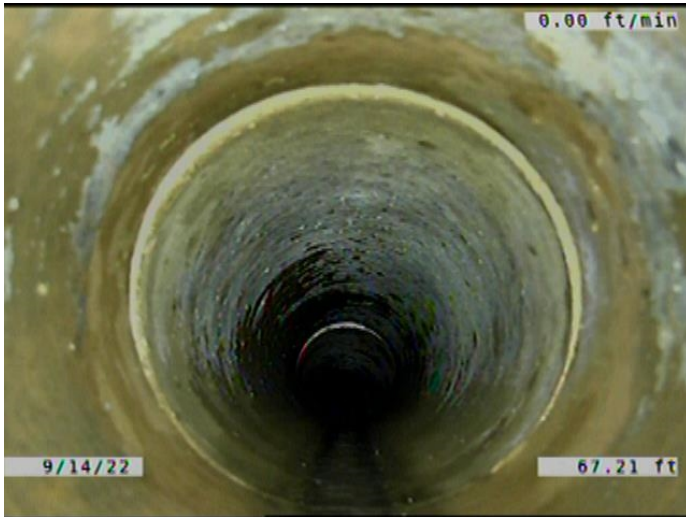
Code: **LD**
Description: **Line Down**

Distance (ft): **67.2**
Structural Grade: **0**
O&M Grade: **2**
Clock Start/From:
Clock To:
1st Value:
2nd Value:
Value Percent: **15.000**
Continuous Index:
Within 8" of Joint: **NO**
Remarks:

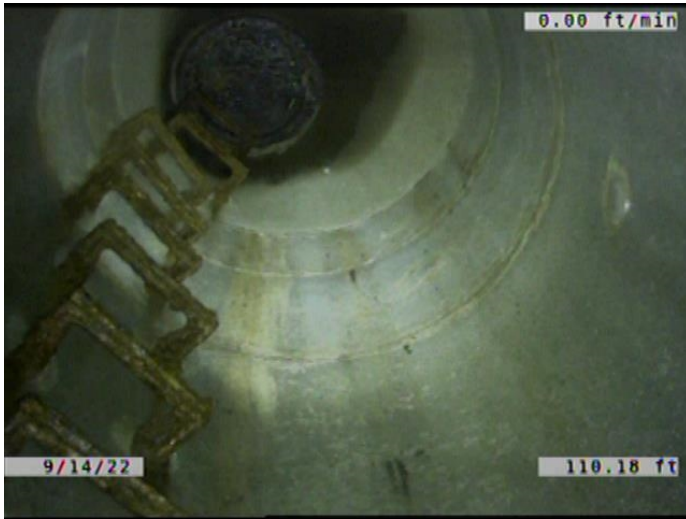
Code:	AMH
Description:	Manhole
Distance (ft):	110.2
Structural Grade:	0
O&M Grade:	0
Clock Start/From:	
Clock To:	
1st Value:	
2nd Value:	
Value Percent:	
Continuous Index:	
Within 8" of Joint:	NO
Remarks:	M-305-047
