Profile/Photo Observation Report

Street:	FOXCROFT STREET	Flow Control:	Not Controlled
City:	Hobart, IN	Year Renewed:	
Location:	Yard	Tape/Media #:	
Purpose:	Routine Assessment	Dia/Height:	12"
Use:	Sanitary	Material:	VCP
Drain Area:	NA	Lining:	
Category:	NA		
Comment:

Location Details:		Direction of Survey:	Upstream
US MH:	M-305-048	DS MH:	M-305-046
		Total Length Surveyed (ft):	13.1

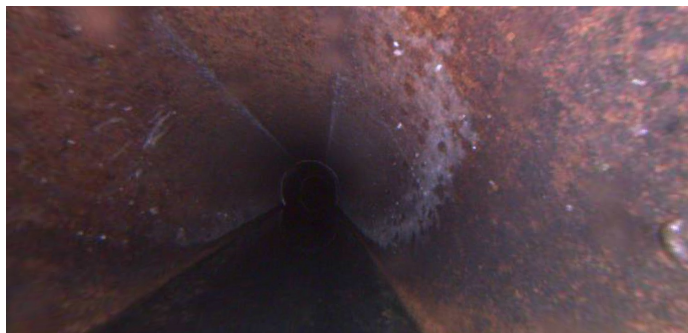
Code: **AMH**
Description: **Manhole**

Distance (ft): **.0**
Structural Grade: **0**
O&M Grade: **0**
Clock Start/From:
Clock To:
1st Value:
2nd Value:
Value Percent:
Continuous Index:
Within 8" of Joint: **NO**
Remarks: **M-305-046**

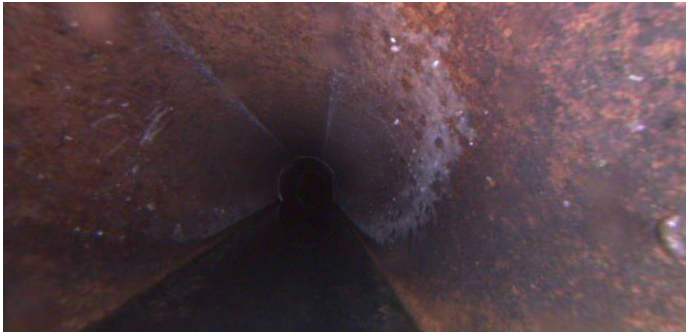
Code:	MWL
Description:	Water Level

Distance (ft):	.0
Structural Grade:	0
O&M Grade:	0
Clock Start/From:	
Clock To:	
1st Value:	
2nd Value:	
Value Percent:	10.000
Continuous Index:	
Within 8" of Joint:	NO
Remarks:

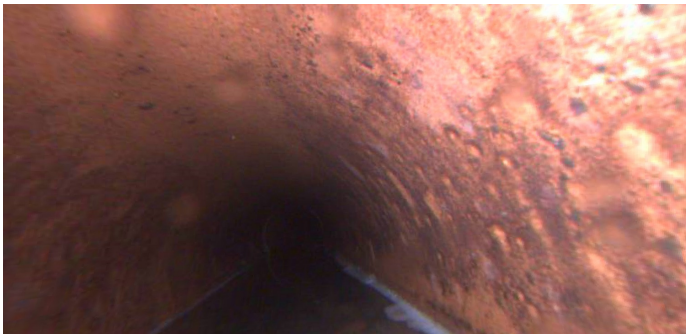
Code:	MSA
Description:	Abandoned Survey

Distance (ft):	13.1
Structural Grade:	0
O&M Grade:	0
Clock Start/From:	
Clock To:	
1st Value:	
2nd Value:	
Value Percent:	
Continuous Index:	
Within 8" of Joint:	NO
Remarks:	unknown
