Profile/Photo Observation Report

Date:	04/20/2018	Weather:		Coding:	PACP 6.0
Pipe Length (ft):	100.5	Owner:	NA	Pre Clean:	No Pre-Cleaning
P.O.#:		Surveyor:	Byrd Fitzgerald	PSR:	P-305-048-046
Customer:		Clean Date:	01/01/1900	Shape:	C

Street:	W 3RD ST	Flow Control:	Not Controlled
City:	Hobart, IN	Year Renewed:	
Location:	Yard	Tape/Media #:	
Purpose:	Routine Assessment	Dia/Height:	12"
Use:	Sanitary	Material:	VCP
Drain Area:	NA	Lining:	
Category:	NA		
Comment:	O_C False at 76 ft last image is of the top of pipe		
Location Details:		Direction of Survey:	Downstream
US MH:	M-305-048	DS MH:	M-305-046
		Total Length Surveyed (ft):	77.5

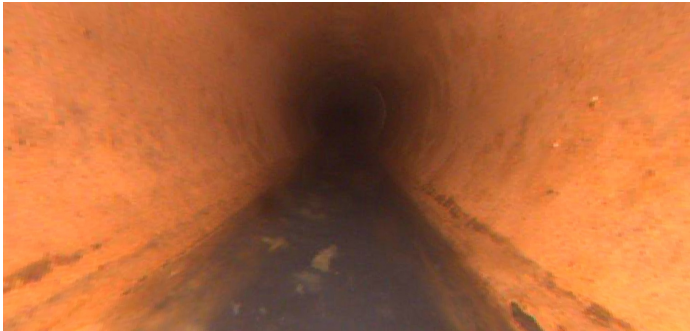
AMH

Manhole

.0

M-305-048

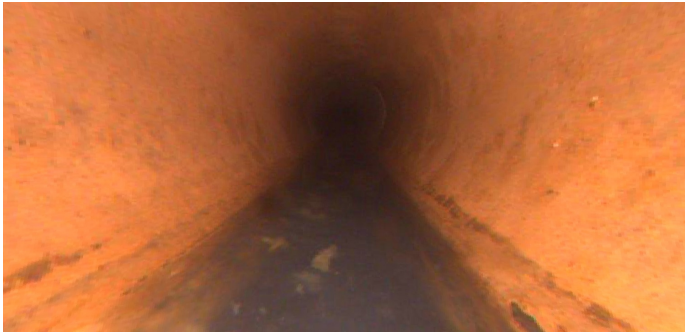
Code:	MWL
Description:	Water Level

Distance (ft):	.0
Structural Grade:	0
O&M Grade:	0
Clock Start/From:	
Clock To:	
1st Value:	
2nd Value:	
Value Percent:	5.000
Continuous Index:	
Within 8" of Joint:	NO
Remarks:

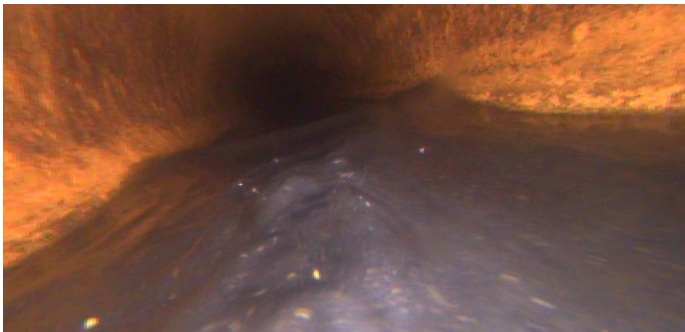
Code:	MSA
Description:	Abandoned Survey

Distance (ft):	77.5
Structural Grade:	0
O&M Grade:	0
Clock Start/From:	
Clock To:	
1st Value:	
2nd Value:	
Value Percent:	
Continuous Index:	
Within 8" of Joint:	NO
Remarks:	no blockage/camera flipped?
