Profile/Photo Observation Report

Street:	FOXCROFT STREET	Flow Control:	Not Controlled
City:	Hobart, IN	Year Renewed:	
Location:	Yard	Tape/Media #:	
Purpose:	Routine Assessment	Dia/Height:	12"
Use:	Sanitary	Material:	VCP
Drain Area:	NA	Lining:	
Category:	NA		
Comment:	O_C False at 76 ft last image is of the top of pipe		
Location Details:		Direction of Survey:	Downstream
US MH:	M-305-048	DS MH:	M-305-046
		Total Length Surveyed (ft):	77.5

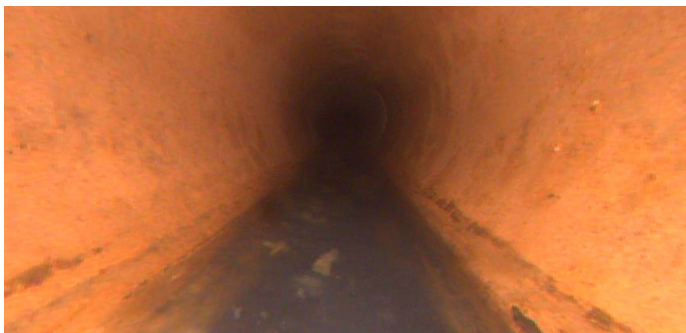
Code: **AMH**
Description: **Manhole**

Distance (ft): **.0**
Structural Grade: **0**
O&M Grade: **0**
Clock Start/From:
Clock To:
1st Value:
2nd Value:
Value Percent:
Continuous Index:
Within 8" of Joint: **NO**
Remarks: **M-305-048**

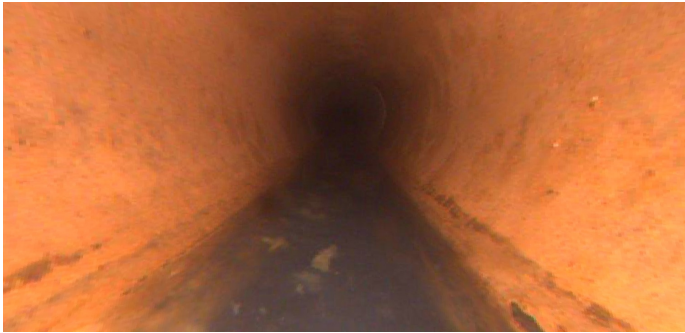
Code:	MWL
Description:	Water Level

Distance (ft):	.0
Structural Grade:	0
O&M Grade:	0
Clock Start/From:	
Clock To:	
1st Value:	
2nd Value:	
Value Percent:	5.000
Continuous Index:	
Within 8" of Joint:	NO
Remarks:

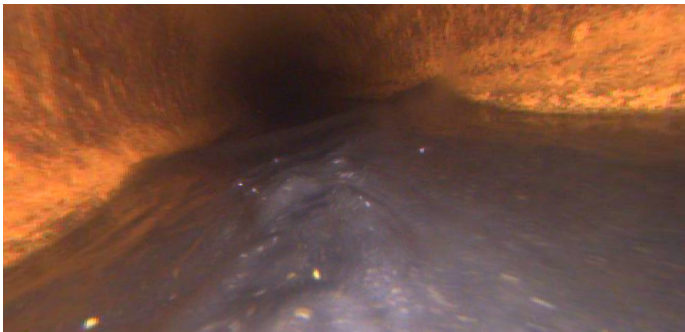
Code:	MSA
Description:	Abandoned Survey

Distance (ft):	77.5
Structural Grade:	0
O&M Grade:	0
Clock Start/From:	
Clock To:	
1st Value:	
2nd Value:	
Value Percent:	
Continuous Index:	
Within 8" of Joint:	NO
Remarks:	no blockage/camera flipped?
