Profile/Photo Observation Report

Date:	04/23/2018	Weather:		Coding:	PACP 6.0
Pipe Length (ft):	192.0	Owner:	NA	Pre Clean:	No Pre-Cleaning
P.O.#:		Surveyor:	Jen Costello	PSR:	P-305-049-048
Customer:		Clean Date:	01/01/1900	Shape:	C

Street:	W 3RD ST & WOODLAND LN	Flow Control:	Not Controlled
City:	Hobart, IN	Year Renewed:	
Location:	Yard	Tape/Media #:	
Purpose:	Routine Assessment	Dia/Height:	10"
Use:	Sanitary	Material:	VCP
Drain Area:	NA	Lining:	
Category:	NA		
Comment:	Flow direction wrong		
Location Details:		Direction of Survey:	Downstream
US MH:	M-305-048	DS MH:	M-305-049
		Total Length Surveyed (ft):	185.1

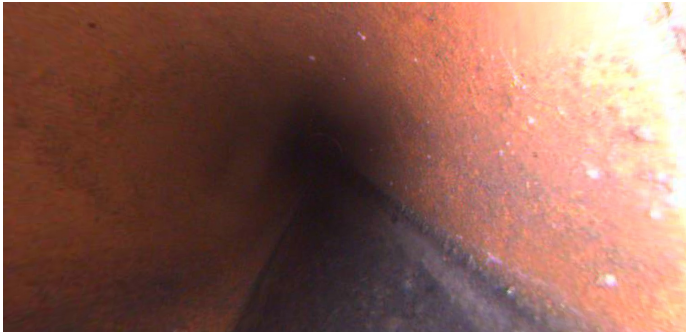
Code:	MWL
Description:	Water Level

Distance (ft):	.0
Structural Grade:	0
O&M Grade:	0
Clock Start/From:	
Clock To:	
1st Value:	
2nd Value:	
Value Percent:	5.000
Continuous Index:	
Within 8" of Joint:	NO
Remarks:

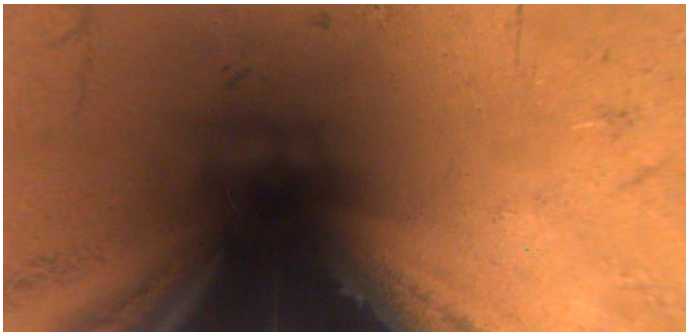
Code:	MGO
Description:	General Observation

Distance (ft):	28.7
Structural Grade:	0
O&M Grade:	0
Clock Start/From:	
Clock To:	
1st Value:	
2nd Value:	
Value Percent:	
Continuous Index:	
Within 8" of Joint:	NO
Remarks:	rear camera

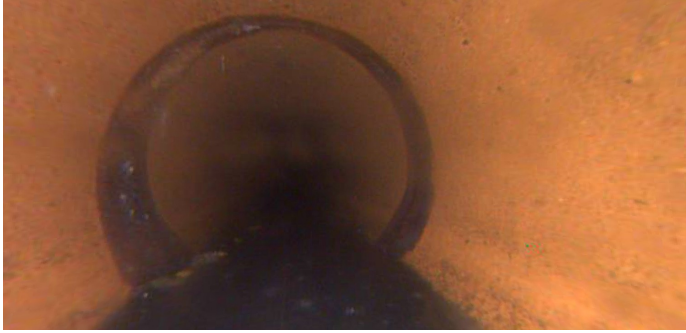
Code: **IW**
Description: **Infil Weeper**

Distance (ft): **55.9**
Structural Grade: **0**
O&M Grade: **2**
Clock Start/From: **8**
Clock To: **4**
1st Value:
2nd Value:
Value Percent:
Continuous Index:
Within 8" of Joint: **YES**
Remarks:

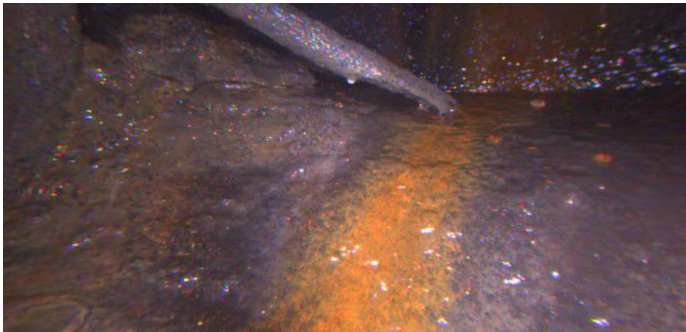
Code: **AMH**
Description: **Manhole**

Distance (ft): **185.1**
Structural Grade: **0**
O&M Grade: **0**
Clock Start/From:
Clock To:
1st Value:
2nd Value:
Value Percent:
Continuous Index:
Within 8" of Joint: **NO**
Remarks: **M-305-049**
