Profile/Photo Observation Report

Street:	FOXCROFT STREET	Flow Control:	Not Controlled
City:	Hobart, IN	Year Renewed:	
Location:	Yard	Tape/Media #:	
Purpose:	Routine Assessment	Dia/Height:	10"
Use:	Sanitary	Material:	VCP
Drain Area:	NA	Lining:	
Category:	NA		
Comment:	Flow direction wrong

Location Details:		Direction of Survey:	Downstream
US MH:	M-305-048	DS MH:	M-305-049
		Total Length Surveyed (ft):	185.1

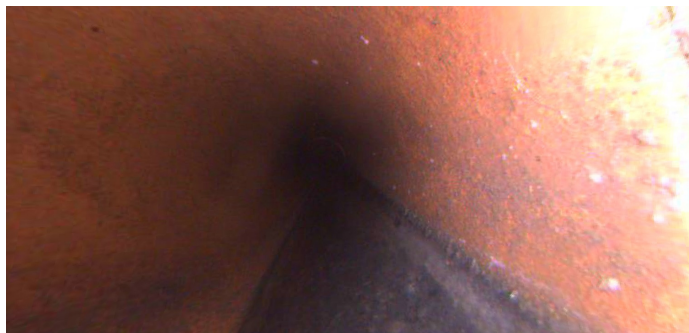
Code: **AMH**
Description: **Manhole**

Distance (ft): **.0**
Structural Grade: **0**
O&M Grade: **0**
Clock Start/From:
Clock To:
1st Value:
2nd Value:
Value Percent:
Continuous Index:
Within 8" of Joint: **NO**
Remarks: **M-305-048**

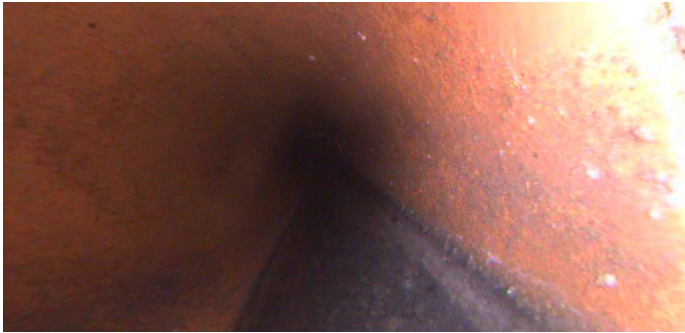
Code:	MWL
Description:	Water Level

Distance (ft):	.0
Structural Grade:	0
O&M Grade:	0
Clock Start/From:	
Clock To:	
1st Value:	
2nd Value:	
Value Percent:	5.000
Continuous Index:	
Within 8" of Joint:	NO
Remarks:

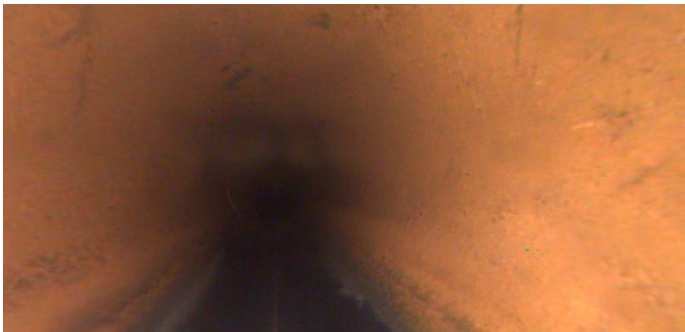
Code:	MGO
Description:	General Observation

Distance (ft):	28.7
Structural Grade:	0
O&M Grade:	0
Clock Start/From:	
Clock To:	
1st Value:	
2nd Value:	
Value Percent:	
Continuous Index:	
Within 8" of Joint:	NO
Remarks:	rear camera

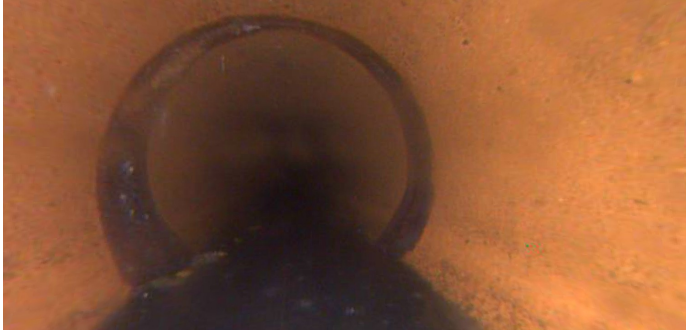
Code: **IW**
Description: **Infil Weeper**

Distance (ft): **55.9**
Structural Grade: **0**
O&M Grade: **2**
Clock Start/From: **8**
Clock To: **4**
1st Value:
2nd Value:
Value Percent:
Continuous Index:
Within 8" of Joint: **YES**
Remarks:

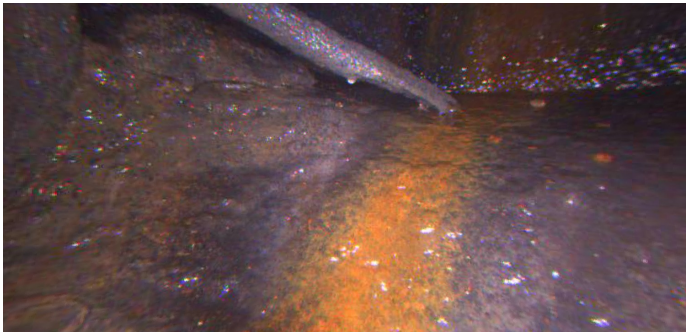
Code: **AMH**
Description: **Manhole**

Distance (ft): **185.1**
Structural Grade: **0**
O&M Grade: **0**
Clock Start/From:
Clock To:
1st Value:
2nd Value:
Value Percent:
Continuous Index:
Within 8" of Joint: **NO**
Remarks: **M-305-049**
