Profile/Photo Observation Report

Street:	FOXCROFT STREET	Flow Control:	Not Controlled
City:	Hobart, IN	Year Renewed:	
Location:	Yard	Tape/Media #:	
Purpose:	Routine Assessment	Dia/Height:	10"
Use:	Sanitary	Material:	PVC
Drain Area:	NA	Lining:	
Category:	NA		
Comment:	Flow direction wrong . MH at 185 ft incorrect mapping		
Location Details:		Direction of Survey:	Upstream
US MH:	M-305-053	DS MH:	M-305-054
		Total Length Surveyed (ft):	186.2

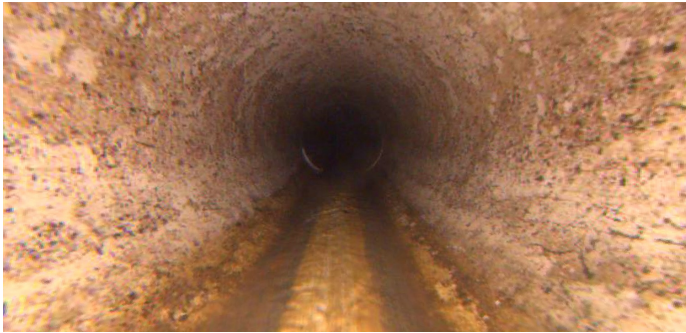
Code: **MWL**
Description: **Water Level**

Distance (ft): **.0**
Structural Grade: **0**
O&M Grade: **0**
Clock Start/From:
Clock To:
1st Value:
2nd Value:
Value Percent: **5.000**
Continuous Index:
Within 8" of Joint: **NO**
Remarks:

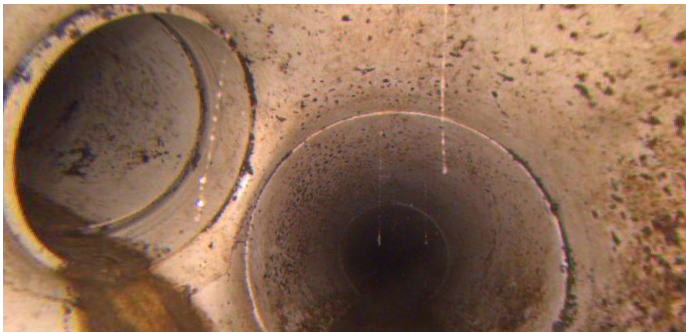
Code: **TFA**
Description: **Tap Factory Active**

Distance (ft): **10.6**
Structural Grade: **0**
O&M Grade: **0**
Clock Start/From: **9**
Clock To:
1st Value: **4.000**
2nd Value:
Value Percent:
Continuous Index:
Within 8" of Joint:
Remarks:

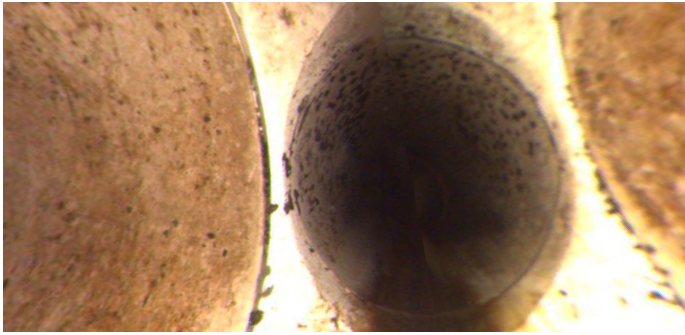
Code: **TF**
Description: **Tap Factory**

Distance (ft): **73.1**
Structural Grade: **0**
O&M Grade: **0**
Clock Start/From: **2**
Clock To:
1st Value: **4.000**
2nd Value:
Value Percent:
Continuous Index:
Within 8" of Joint:
Remarks:

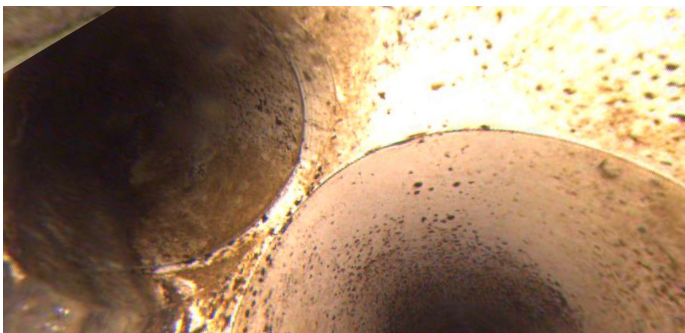
Code: **TF**
Description: **Tap Factory**

Distance (ft): **84.0**
Structural Grade: **0**
O&M Grade: **0**
Clock Start/From: **10**
Clock To:
1st Value: **4.000**
2nd Value:
Value Percent:
Continuous Index:
Within 8" of Joint:
Remarks:

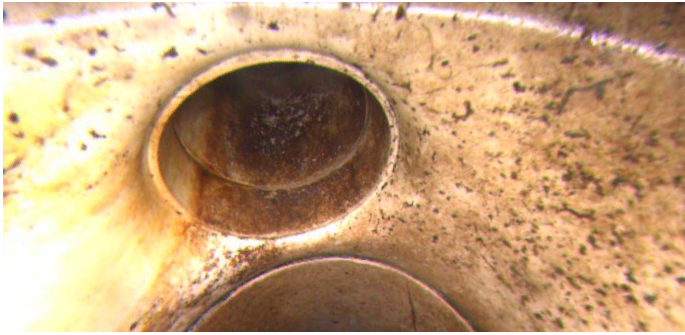
Code: **TF**
Description: **Tap Factory**

Distance (ft): **133.7**
Structural Grade: **0**
O&M Grade: **0**
Clock Start/From: **12**
Clock To:
1st Value: **4.000**
2nd Value:
Value Percent:
Continuous Index:
Within 8" of Joint:
Remarks:

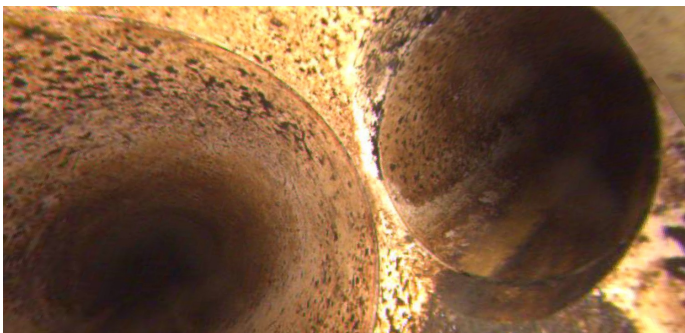
Code: **TF**
Description: **Tap Factory**

Distance (ft): **150.2**
Structural Grade: **0**
O&M Grade: **0**
Clock Start/From: **2**
Clock To:
1st Value: **4.000**
2nd Value:
Value Percent:
Continuous Index:
Within 8" of Joint:
Remarks:

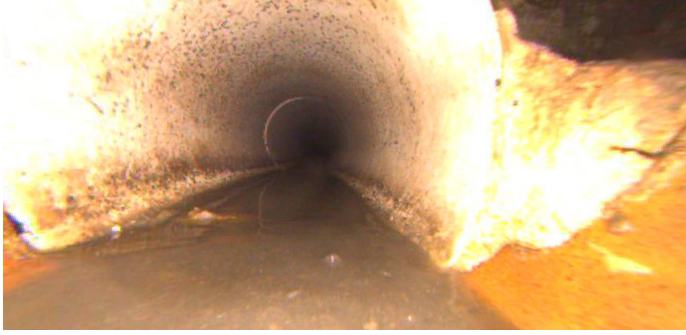
Code:	AMH
Description:	Manhole
Distance (ft):	186.2
Structural Grade:	0
O&M Grade:	0
Clock Start/From:	
Clock To:	
1st Value:	
2nd Value:	
Value Percent:	
Continuous Index:	
Within 8" of Joint:	NO
Remarks:	M-305-053
