Profile/Photo Observation Report

Date:	04/24/2018	Weather:		Coding:	PACP 6.0
Pipe Length (ft):	178.8	Owner:	NA	Pre Clean:	No Pre-Cleaning
P.O.#:		Surveyor:	Jen Costello	PSR:	P-305-055-054
Customer:		Clean Date:	01/01/1900	Shape:	C

Street:	ALLEY BETWEEN WOODLAND LN &	Flow Control:	Not Controlled
City:	Hobart, IN	Year Renewed:	
Location:	Yard	Tape/Media #:	
Purpose:	Routine Assessment	Dia/Height:	10"
Use:	Sanitary	Material:	PVC
Drain Area:	NA	Lining:	
Category:	NA		
Comment:	Flow direction wrong

Location Details:		Direction of Survey:	Upstream
US MH:	M-305-054	DS MH:	M-305-055
		Total Length Surveyed (ft):	193.0

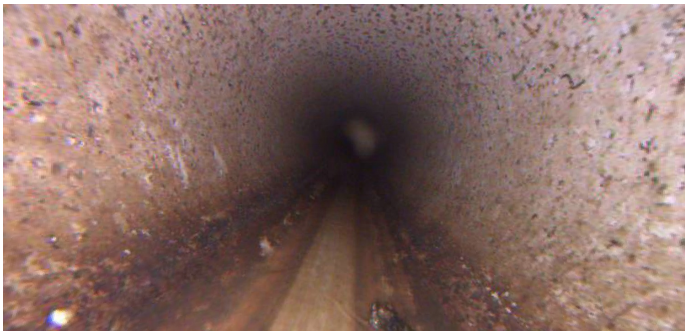
Code: **AMH**
Description: **Manhole**

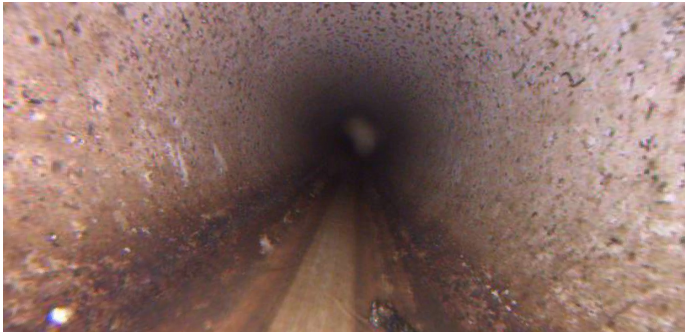
Code:	MWL
Description:	Water Level

Distance (ft):	.0
Structural Grade:	0
O&M Grade:	0
Clock Start/From:	
Clock To:	
1st Value:	
2nd Value:	
Value Percent:	5.000
Continuous Index:	
Within 8" of Joint:	NO
Remarks:

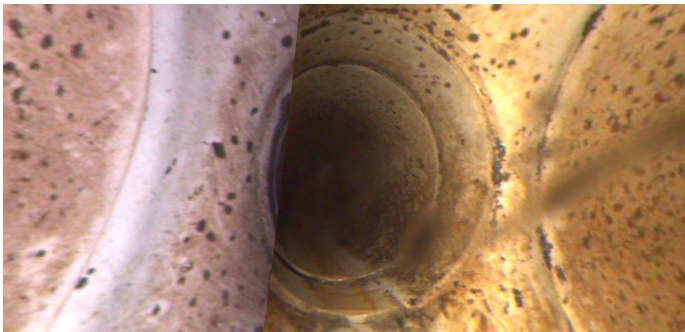
Code:	TF
Description:	Tap Factory

Distance (ft):	9.4
Structural Grade:	0
O&M Grade:	0
Clock Start/From:	2
Clock To:	
1st Value:	4.000
2nd Value:	
Value Percent:	
Continuous Index:	
Within 8" of Joint:	
Remarks:

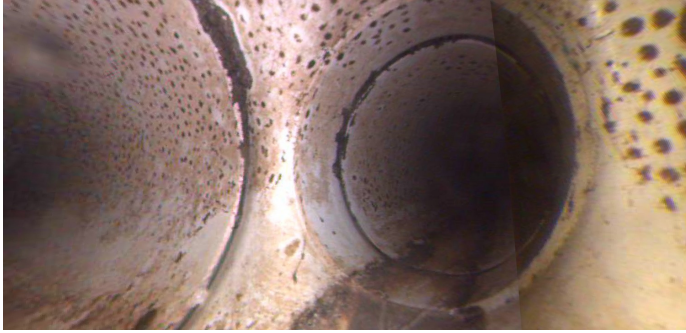
Code: **TF**
Description: **Tap Factory**

Distance (ft): **76.7**
Structural Grade: **0**
O&M Grade: **0**
Clock Start/From: **3**
Clock To:
1st Value: **4.000**
2nd Value:
Value Percent:
Continuous Index:
Within 8" of Joint:
Remarks:

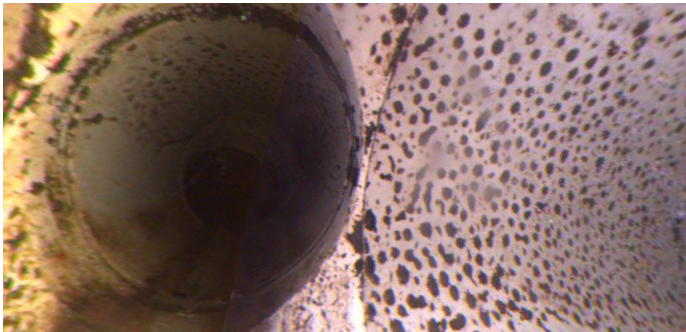
Code: **TF**
Description: **Tap Factory**

Distance (ft): **93.3**
Structural Grade: **0**
O&M Grade: **0**
Clock Start/From: **10**
Clock To:
1st Value: **4.000**
2nd Value:
Value Percent:
Continuous Index:
Within 8" of Joint:
Remarks:

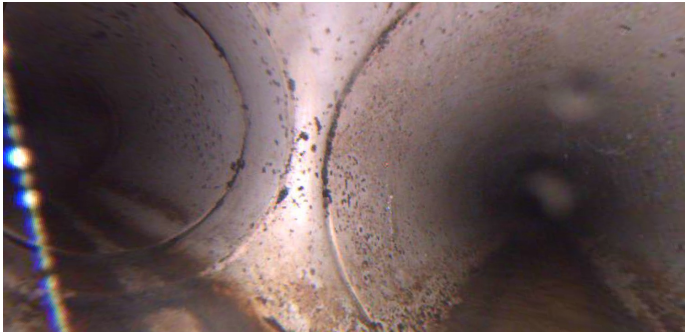
Code: **TFA**
Description: **Tap Factory Active**

Distance (ft): **130.1**
Structural Grade: **0**
O&M Grade: **0**
Clock Start/From: **9**
Clock To:
1st Value: **4.000**
2nd Value:
Value Percent:
Continuous Index:
Within 8" of Joint:
Remarks:

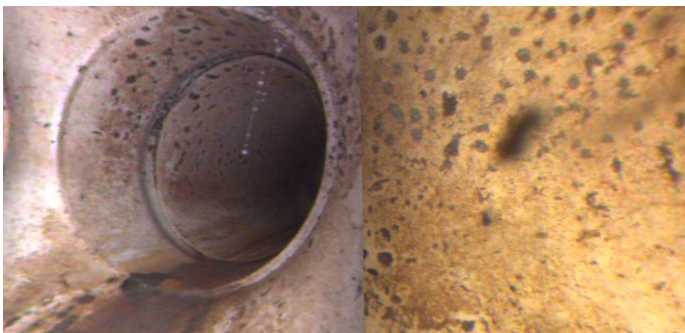
Code: **TF**
Description: **Tap Factory**

Distance (ft): **148.5**
Structural Grade: **0**
O&M Grade: **0**
Clock Start/From: **3**
Clock To:
1st Value: **4.000**
2nd Value:
Value Percent:
Continuous Index:
Within 8" of Joint:
Remarks:

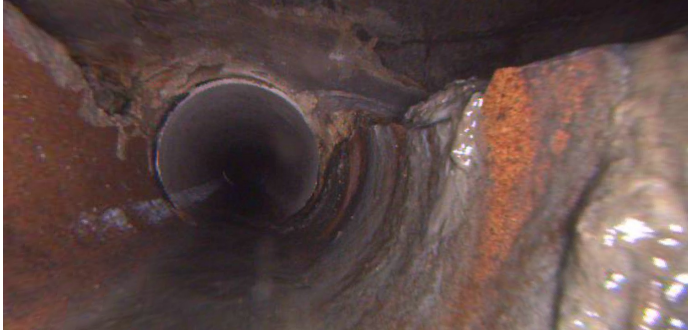
Code:	AMH
Description:	Manhole
Distance (ft):	193.0
Structural Grade:	0
O&M Grade:	0
Clock Start/From:	
Clock To:	
1st Value:	
2nd Value:	
Value Percent:	
Continuous Index:	
Within 8" of Joint:	NO
Remarks:	M-305-054
