Profile/Photo Observation Report

Street:	FOXCROFT STREET	Flow Control:	Not Controlled
City:	Hobart, IN	Year Renewed:	
Location:	Yard	Tape/Media #:	
Purpose:	Routine Assessment	Dia/Height:	10"
Use:	Sanitary	Material:	PVC
Drain Area:	NA	Lining:	
Category:	NA		
Comment:	Flow direction wrong

Location Details:		Direction of Survey:	Upstream
US MH:	M-305-054	DS MH:	M-305-055
		Total Length Surveyed (ft):	193.0

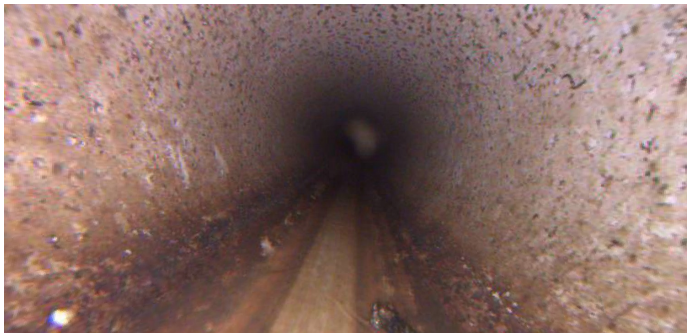
The diagram shows a vertical pipe with a downward-pointing red arrow labeled "Camera Direction". The pipe is labeled with "M-305-055" at the top and "M-305-054" at the bottom. Eight observation points are marked along the pipe, each corresponding to a row in the table below. The table has five columns: Position, Code, Observation, Video (sec), and Grade.

Position	Code	Observation	Video (sec)	Grade
.0	AMH	Manhole	10	NA
.0	MWL	Water Level	21	NA
9.4	TF	Tap Factory	53	NA
76.7	TF	Tap Factory	201	NA
93.3	TF	Tap Factory	247	NA
130.1	TFA	Tap Factory Active	333	NA
148.5	TF	Tap Factory	382	NA
193.0	AMH	Manhole	484	NA

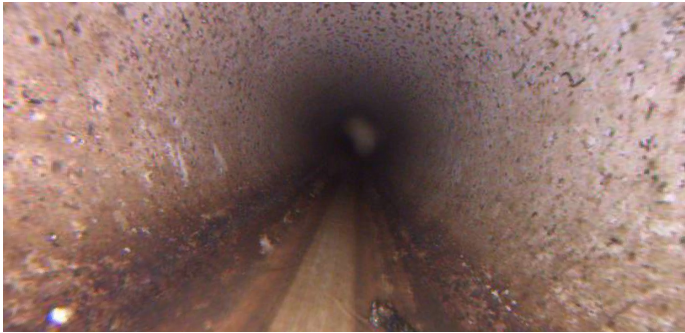
Code:	MWL
Description:	Water Level

Distance (ft):	.0
Structural Grade:	0
O&M Grade:	0
Clock Start/From:	
Clock To:	
1st Value:	
2nd Value:	
Value Percent:	5.000
Continuous Index:	
Within 8" of Joint:	NO
Remarks:

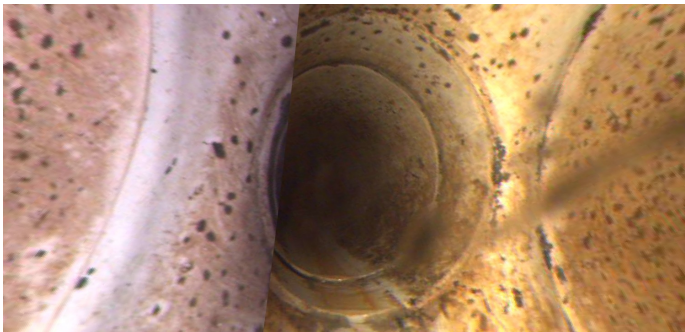
Code:	TF
Description:	Tap Factory

Distance (ft):	9.4
Structural Grade:	0
O&M Grade:	0
Clock Start/From:	2
Clock To:	
1st Value:	4.000
2nd Value:	
Value Percent:	
Continuous Index:	
Within 8" of Joint:	
Remarks:

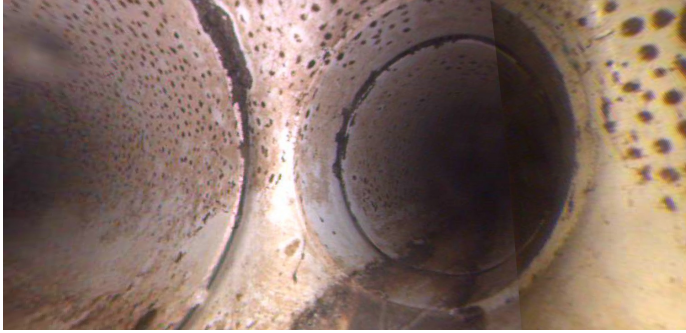
Code: **TF**
Description: **Tap Factory**

Distance (ft): **76.7**
Structural Grade: **0**
O&M Grade: **0**
Clock Start/From: **3**
Clock To:
1st Value: **4.000**
2nd Value:
Value Percent:
Continuous Index:
Within 8" of Joint:
Remarks:

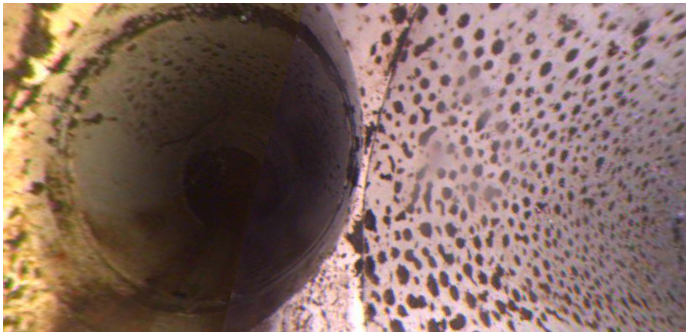
Code: **TF**
Description: **Tap Factory**

Distance (ft): **93.3**
Structural Grade: **0**
O&M Grade: **0**
Clock Start/From: **10**
Clock To:
1st Value: **4.000**
2nd Value:
Value Percent:
Continuous Index:
Within 8" of Joint:
Remarks:

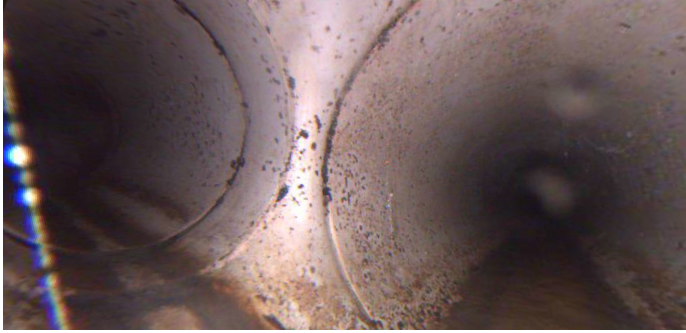
Code: **TFA**
Description: **Tap Factory Active**

Distance (ft): **130.1**
Structural Grade: **0**
O&M Grade: **0**
Clock Start/From: **9**
Clock To:
1st Value: **4.000**
2nd Value:
Value Percent:
Continuous Index:
Within 8" of Joint:
Remarks:

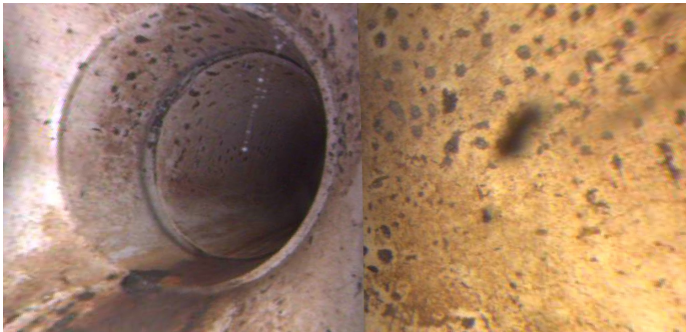
Code: **TF**
Description: **Tap Factory**

Distance (ft): **148.5**
Structural Grade: **0**
O&M Grade: **0**
Clock Start/From: **3**
Clock To:
1st Value: **4.000**
2nd Value:
Value Percent:
Continuous Index:
Within 8" of Joint:
Remarks:

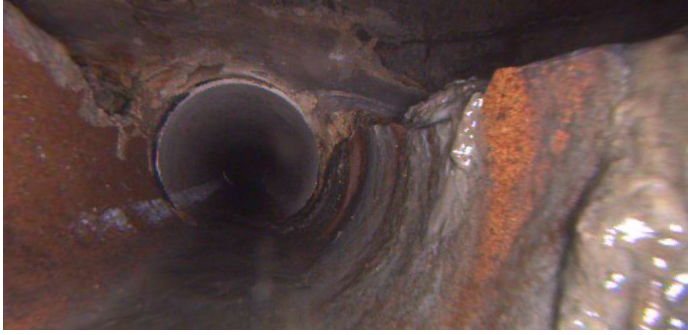
Code:	AMH
Description:	Manhole
Distance (ft):	193.0
Structural Grade:	0
O&M Grade:	0
Clock Start/From:	
Clock To:	
1st Value:	
2nd Value:	
Value Percent:	
Continuous Index:	
Within 8" of Joint:	NO
Remarks:	M-305-054
