Profile/Photo Observation Report

Street:	W 3RD ST	Flow Control:	Not Controlled
City:	Hobart, IN	Year Renewed:	
Location:	Yard	Tape/Media #:	
Purpose:	Routine Assessment	Dia/Height:	10"
Use:	Sanitary	Material:	PVC
Drain Area:	NA	Lining:	
Category:	NA		
Comment:	Flow direction wrong . MH_F at 183 ft map wrong		
Location Details:		Direction of Survey:	Downstream
US MH:	M-305-057	DS MH:	M-305-053
		Total Length Surveyed (ft):	182.6

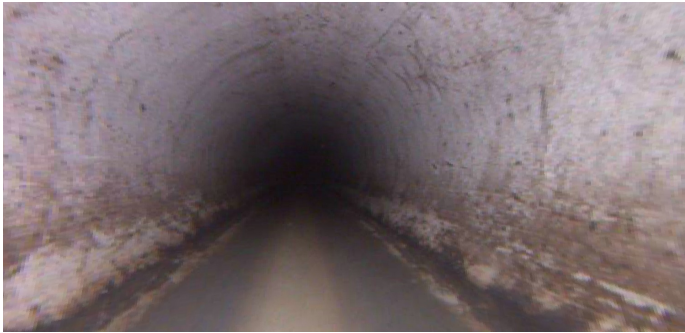
Code:	MWL
Description:	Water Level

Distance (ft):	.0
Structural Grade:	0
O&M Grade:	0
Clock Start/From:	
Clock To:	
1st Value:	
2nd Value:	
Value Percent:	5.000
Continuous Index:	
Within 8" of Joint:	NO
Remarks:

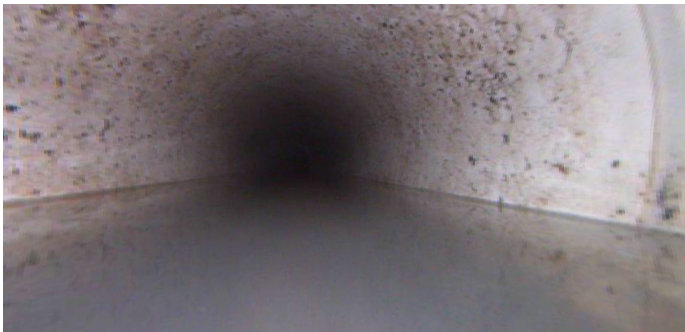
Code:	MWL
Description:	Water Level

Distance (ft):	85.8
Structural Grade:	0
O&M Grade:	0
Clock Start/From:	
Clock To:	
1st Value:	
2nd Value:	
Value Percent:	20.000
Continuous Index:	
Within 8" of Joint:	NO
Remarks:

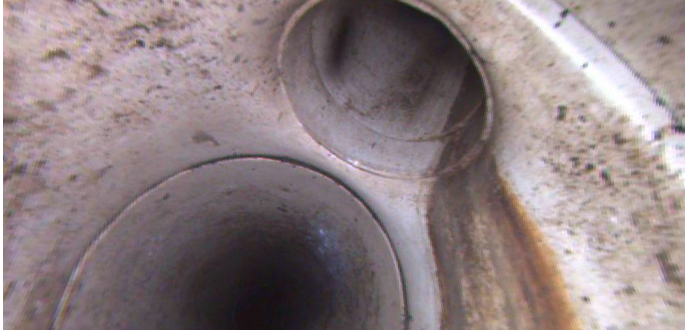
Code: **TF**
Description: **Tap Factory**

Distance (ft): **93.9**
Structural Grade: **0**
O&M Grade: **0**
Clock Start/From: **1**
Clock To:
1st Value: **4.000**
2nd Value:
Value Percent:
Continuous Index:
Within 8" of Joint: **YES**
Remarks:

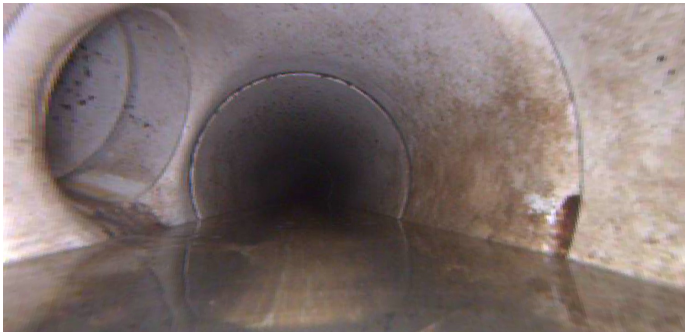
Code: **TF**
Description: **Tap Factory**

Distance (ft): **120.9**
Structural Grade: **0**
O&M Grade: **0**
Clock Start/From: **10**
Clock To:
1st Value: **4.000**
2nd Value:
Value Percent:
Continuous Index:
Within 8" of Joint: **YES**
Remarks:

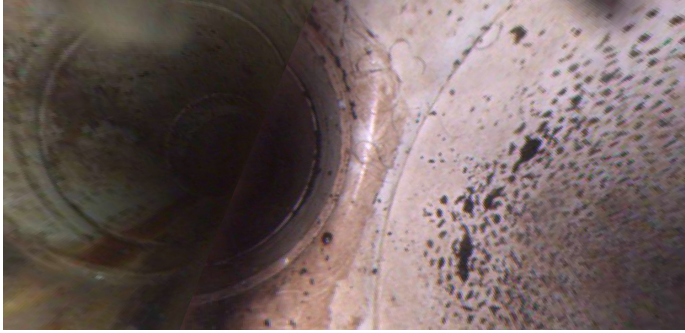
Code: **TF**
Description: **Tap Factory**

Distance (ft): **133.2**
Structural Grade: **0**
O&M Grade: **0**
Clock Start/From: **10**
Clock To:
1st Value: **4.000**
2nd Value:
Value Percent:
Continuous Index:
Within 8" of Joint: **YES**
Remarks:

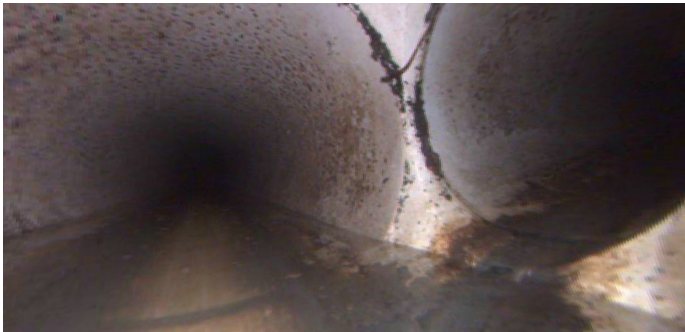
Code: **TF**
Description: **Tap Factory**

Distance (ft): **139.8**
Structural Grade: **0**
O&M Grade: **0**
Clock Start/From: **3**
Clock To:
1st Value: **4.000**
2nd Value:
Value Percent:
Continuous Index:
Within 8" of Joint: **YES**
Remarks:

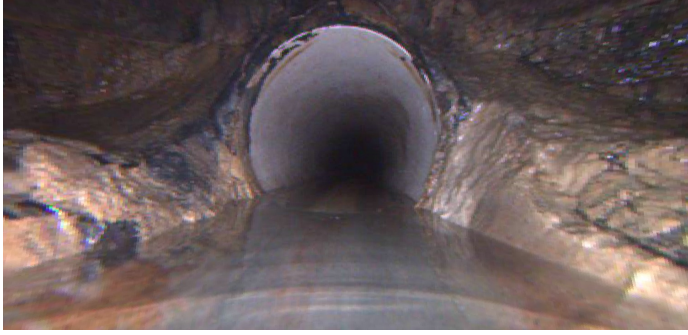
Code:	AMH
Description:	Manhole
Distance (ft):	180.9
Structural Grade:	0
O&M Grade:	0
Clock Start/From:	
Clock To:	
1st Value:	
2nd Value:	
Value Percent:	
Continuous Index:	
Within 8" of Joint:	NO
Remarks:	M-305-053
