Profile/Photo Observation Report

Street:	FOXCROFT STREET	Flow Control:	Not Controlled
City:	Hobart, IN	Year Renewed:	
Location:	Yard	Tape/Media #:	
Purpose:	Routine Assessment	Dia/Height:	10"
Use:	Sanitary	Material:	PVC
Drain Area:	NA	Lining:	
Category:	NA		
Comment:	Flow direction wrong . MH_F at 183 ft map wrong		
Location Details:		Direction of Survey:	Downstream
US MH:	M-305-057	DS MH:	M-305-053
		Total Length Surveyed (ft):	182.6

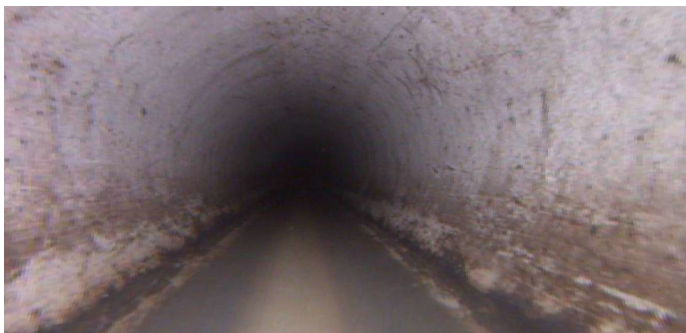
Code: **AMH**
Description: **Manhole**

Distance (ft): **.0**
Structural Grade: **0**
O&M Grade: **0**
Clock Start/From:
Clock To:
1st Value:
2nd Value:
Value Percent:
Continuous Index:
Within 8" of Joint: **NO**
Remarks: **M-305-057**

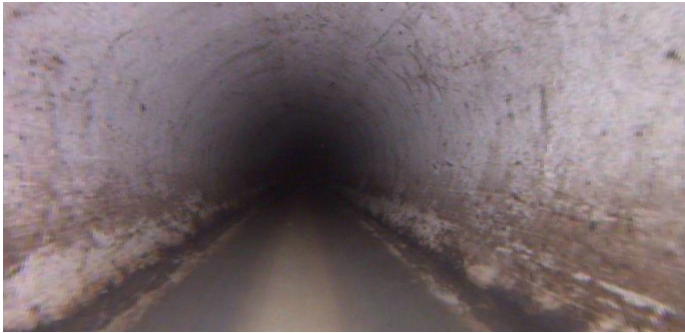
Code:	MWL
Description:	Water Level

Distance (ft):	.0
Structural Grade:	0
O&M Grade:	0
Clock Start/From:	
Clock To:	
1st Value:	
2nd Value:	
Value Percent:	5.000
Continuous Index:	
Within 8" of Joint:	NO
Remarks:

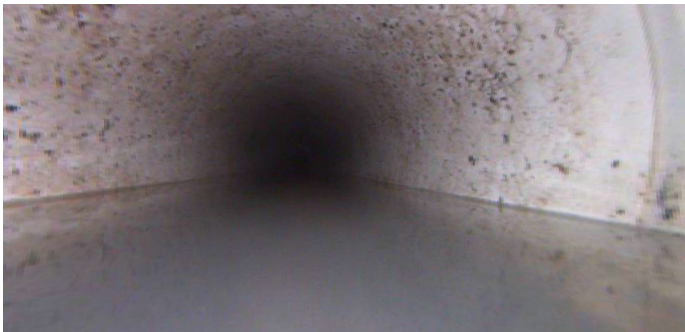
Code:	MWL
Description:	Water Level

Distance (ft):	85.8
Structural Grade:	0
O&M Grade:	0
Clock Start/From:	
Clock To:	
1st Value:	
2nd Value:	
Value Percent:	20.000
Continuous Index:	
Within 8" of Joint:	NO
Remarks:

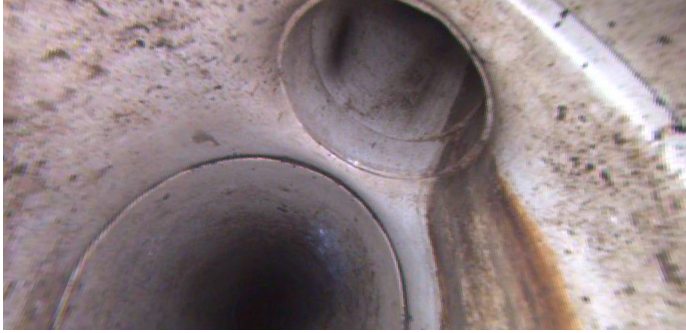
Code: **TF**
Description: **Tap Factory**

Distance (ft): **93.9**
Structural Grade: **0**
O&M Grade: **0**
Clock Start/From: **1**
Clock To:
1st Value: **4.000**
2nd Value:
Value Percent:
Continuous Index:
Within 8" of Joint: **YES**
Remarks:

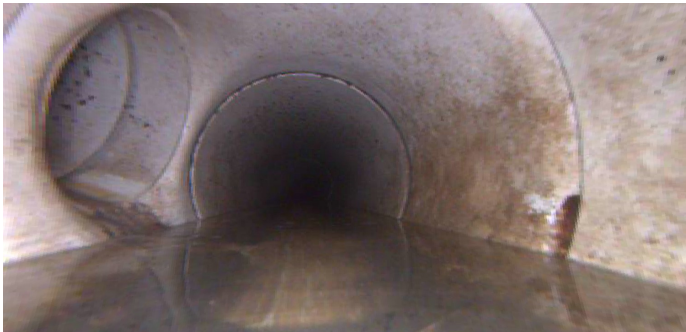
Code: **TF**
Description: **Tap Factory**

Distance (ft): **120.9**
Structural Grade: **0**
O&M Grade: **0**
Clock Start/From: **10**
Clock To:
1st Value: **4.000**
2nd Value:
Value Percent:
Continuous Index:
Within 8" of Joint: **YES**
Remarks:

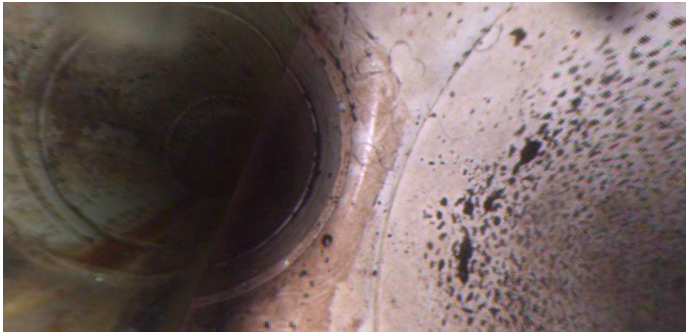
Code: **TF**
Description: **Tap Factory**

Distance (ft): **133.2**
Structural Grade: **0**
O&M Grade: **0**
Clock Start/From: **10**
Clock To:
1st Value: **4.000**
2nd Value:
Value Percent:
Continuous Index:
Within 8" of Joint: **YES**
Remarks:

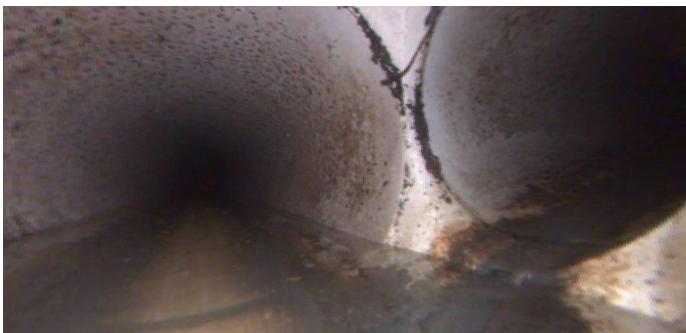
Code: **TF**
Description: **Tap Factory**

Distance (ft): **139.8**
Structural Grade: **0**
O&M Grade: **0**
Clock Start/From: **3**
Clock To:
1st Value: **4.000**
2nd Value:
Value Percent:
Continuous Index:
Within 8" of Joint: **YES**
Remarks:

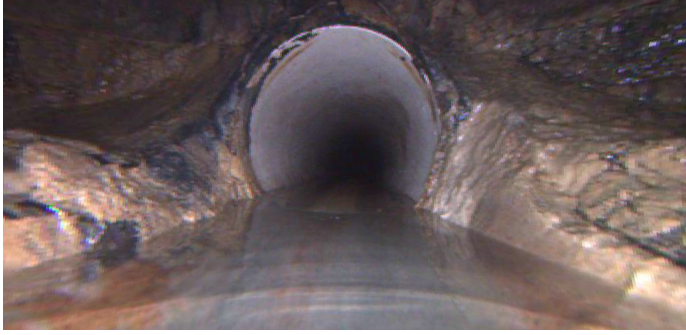
Code:	AMH
Description:	Manhole
Distance (ft):	180.9
Structural Grade:	0
O&M Grade:	0
Clock Start/From:	
Clock To:	
1st Value:	
2nd Value:	
Value Percent:	
Continuous Index:	
Within 8" of Joint:	NO
Remarks:	M-305-053
