## Profile/Photo Observation Report

Street:	<b>FOXCROFT STREET</b>	Flow Control:	<b>Not Controlled</b>
City:	<b>Hobart, IN</b>	Year Renewed:	
Location:	<b>Light Highway</b>	Tape/Media #:	
Purpose:	<b>Routine Assessment</b>	Dia/Height:	<b>8"</b>
Use:	<b>Sanitary</b>	Material:	<b>PVC</b>
Drain Area:	<b>NA</b>	Lining:	
Category:	<b>NA</b>		
Comment:	<b>Flow direction wrong</b>

Location Details:		Direction of Survey:	<b>Upstream</b>
US MH:	<b>M-308-010</b>	DS MH:	<b>M-308-011</b>
		Total Length Surveyed (ft):	<b>345.7</b>

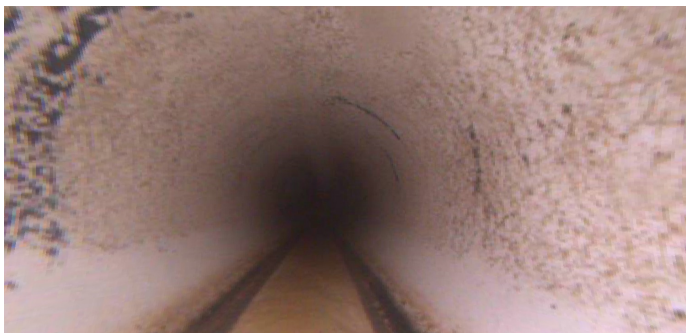
Code: **AMH**  
Description: **Manhole**

Distance (ft): **.0**  
Structural Grade: **0**  
O&M Grade: **0**  
Clock Start/From:  
Clock To:  
1st Value:  
2nd Value:  
Value Percent:  
Continuous Index:  
Within 8" of Joint: **NO**  
Remarks: **M-308-011**

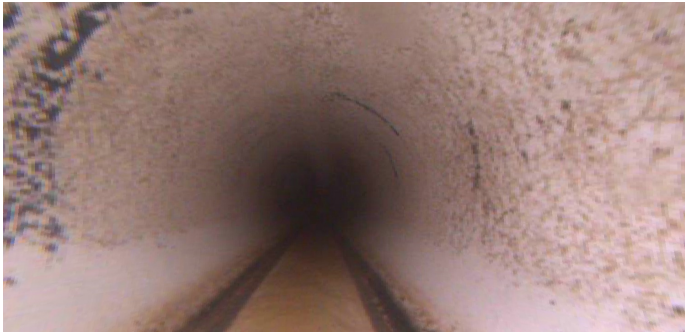
Code:	<b>MWL</b>
Description:	<b>Water Level</b>

Distance (ft):	<b>.0</b>
Structural Grade:	<b>0</b>
O&M Grade:	<b>0</b>
Clock Start/From:	
Clock To:	
1st Value:	
2nd Value:	
Value Percent:	<b>5.000</b>
Continuous Index:	
Within 8" of Joint:	<b>NO</b>
Remarks:

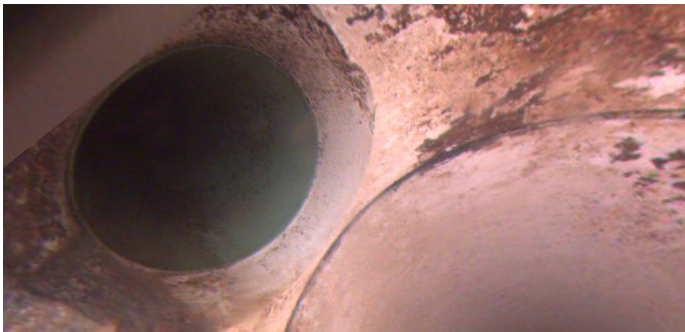
Code:	<b>TF</b>
Description:	<b>Tap Factory</b>

Distance (ft):	<b>71.2</b>
Structural Grade:	<b>0</b>
O&M Grade:	<b>0</b>
Clock Start/From:	<b>2</b>
Clock To:	
1st Value:	<b>4.000</b>
2nd Value:	
Value Percent:	
Continuous Index:	
Within 8" of Joint:	
Remarks:

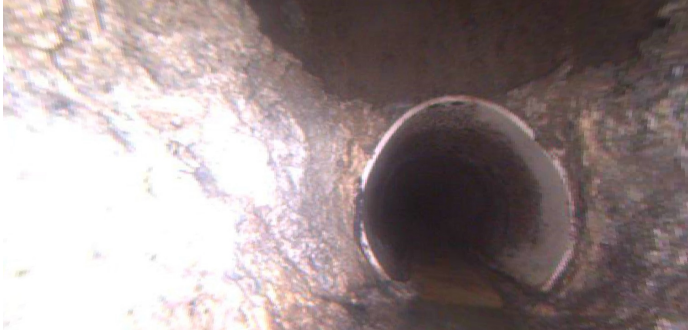
Code:	<b>AMH</b>
Description:	<b>Manhole</b>
Distance (ft):	<b>345.7</b>
Structural Grade:	<b>0</b>
O&M Grade:	<b>0</b>
Clock Start/From:	
Clock To:	
1st Value:	
2nd Value:	
Value Percent:	
Continuous Index:	
Within 8" of Joint:	<b>NO</b>
Remarks:	<b>M-308-010</b>
