Profile/Photo Observation Report

Date:	03/21/2018	Weather:		Coding:	PACP 6.0
Pipe Length (ft):	235.8	Owner:	NA	Pre Clean:	No Pre-Cleaning
P.O.#:		Surveyor:	Selasie Honu	PSR:	P-308-019-011
Customer:		Clean Date:	01/01/1900	Shape:	C

Street:	DIAMOND DR	Flow Control:	Not Controlled
City:	Hobart, IN	Year Renewed:	
Location:	Light Highway	Tape/Media #:	
Purpose:	Routine Assessment	Dia/Height:	8"
Use:	Sanitary	Material:	PVC
Drain Area:	NA	Lining:	
Category:	NA		
Comment:	Flow direction wrong		
Location Details:		Direction of Survey:	Upstream
US MH:	M-308-011	DS MH:	M-308-019
		Total Length Surveyed (ft):	230.6

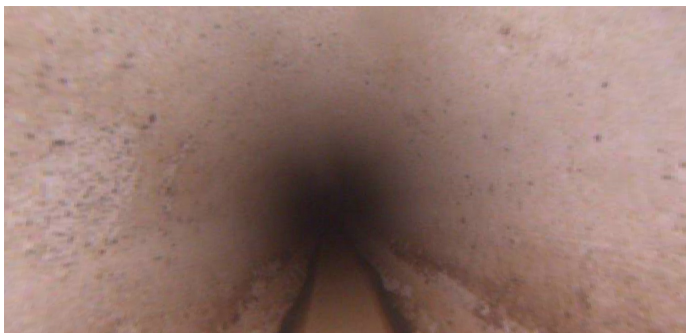
Code: **AMH**
Description: **Manhole**

Distance (ft): **.0**
Structural Grade: **0**
O&M Grade: **0**
Clock Start/From:
Clock To:
1st Value:
2nd Value:
Value Percent:
Continuous Index:
Within 8" of Joint: **NO**
Remarks: **M-308-019**

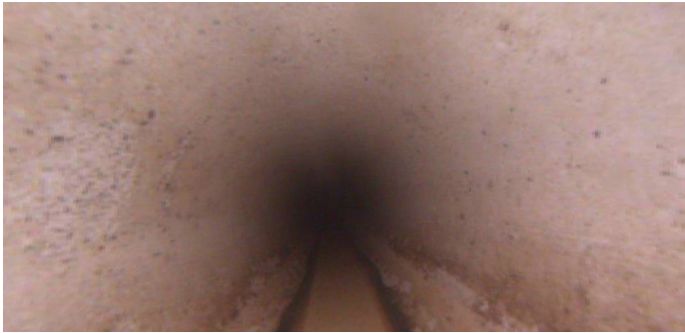
Code:	MWL
Description:	Water Level

Distance (ft):	.0
Structural Grade:	0
O&M Grade:	0
Clock Start/From:	
Clock To:	
1st Value:	
2nd Value:	
Value Percent:	5.000
Continuous Index:	
Within 8" of Joint:	NO
Remarks:

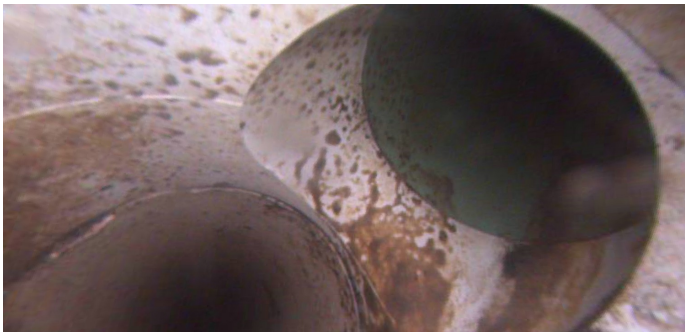
Code:	TF
Description:	Tap Factory

Distance (ft):	12.0
Structural Grade:	0
O&M Grade:	0
Clock Start/From:	2
Clock To:	
1st Value:	4.000
2nd Value:	
Value Percent:	
Continuous Index:	
Within 8" of Joint:	
Remarks:

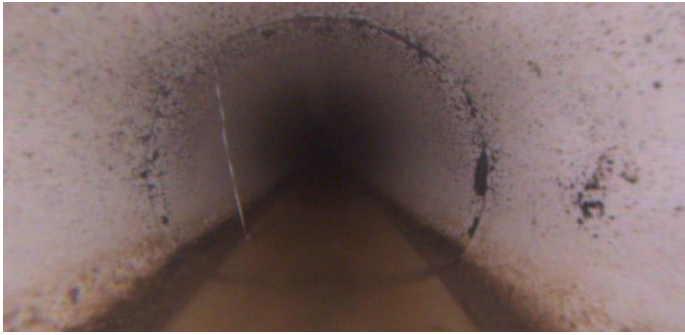
Code: **RFJ**
Description: **Roots Fine Joint**

Distance (ft): **37.2**
Structural Grade: **0**
O&M Grade: **1**
Clock Start/From: **11**
Clock To:
1st Value:
2nd Value:
Value Percent:
Continuous Index:
Within 8" of Joint: **YES**
Remarks:

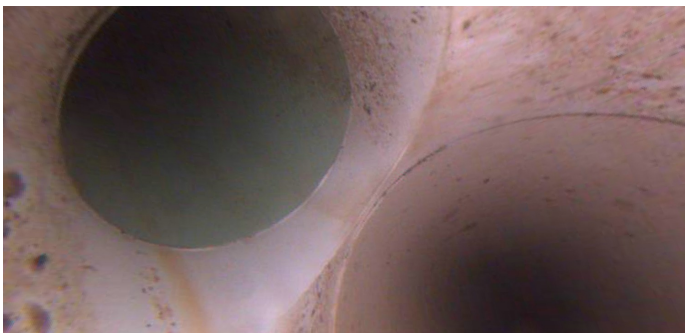
Code: **TF**
Description: **Tap Factory**

Distance (ft): **88.7**
Structural Grade: **0**
O&M Grade: **0**
Clock Start/From: **2**
Clock To:
1st Value: **4.000**
2nd Value:
Value Percent:
Continuous Index:
Within 8" of Joint:
Remarks:

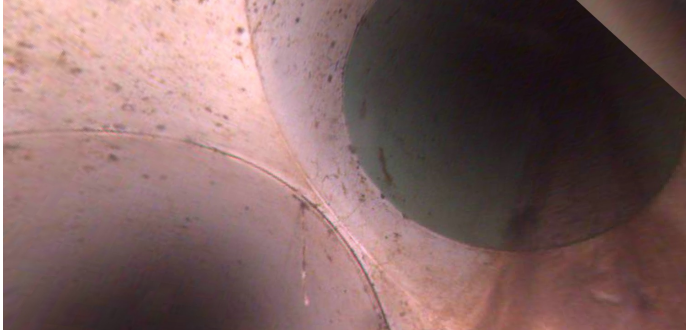
Code: **TF**
Description: **Tap Factory**

Distance (ft): **101.8**
Structural Grade: **0**
O&M Grade: **0**
Clock Start/From: **10**
Clock To:
1st Value: **4.000**
2nd Value:
Value Percent:
Continuous Index:
Within 8" of Joint:
Remarks:

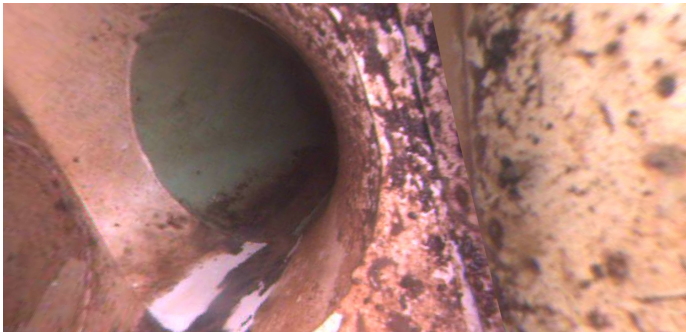
Code: **TF**
Description: **Tap Factory**

Distance (ft): **203.7**
Structural Grade: **0**
O&M Grade: **0**
Clock Start/From: **10**
Clock To:
1st Value: **4.000**
2nd Value:
Value Percent:
Continuous Index:
Within 8" of Joint:
Remarks:

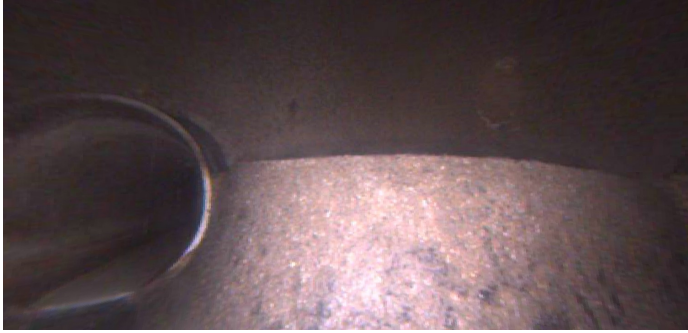
Code:	AMH
Description:	Manhole
Distance (ft):	230.6
Structural Grade:	0
O&M Grade:	0
Clock Start/From:	
Clock To:	
1st Value:	
2nd Value:	
Value Percent:	
Continuous Index:	
Within 8" of Joint:	NO
Remarks:	M-308-011
