Profile/Photo Observation Report

Street:	FOXCROFT STREET	Flow Control:	Not Controlled
City:	Hobart, IN	Year Renewed:	
Location:	Light Highway	Tape/Media #:	
Purpose:	Routine Assessment	Dia/Height:	8"
Use:	Sanitary	Material:	PVC
Drain Area:	NA	Lining:	
Category:	NA		
Comment:	Flow direction wrong

Location Details:		Direction of Survey:	Upstream
US MH:	M-308-011	DS MH:	M-308-019
		Total Length Surveyed (ft):	230.6

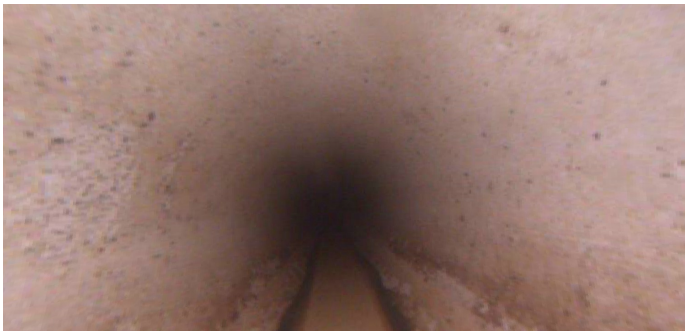
Code: **AMH**
Description: **Manhole**

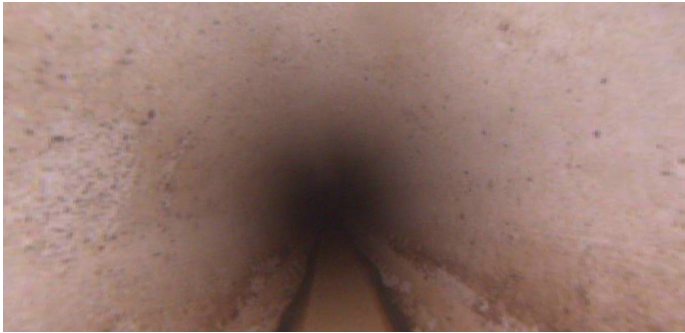
Code:	MWL
Description:	Water Level

Distance (ft):	.0
Structural Grade:	0
O&M Grade:	0
Clock Start/From:	
Clock To:	
1st Value:	
2nd Value:	
Value Percent:	5.000
Continuous Index:	
Within 8" of Joint:	NO
Remarks:

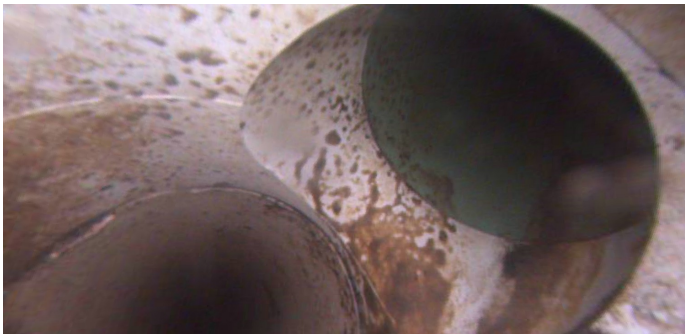
Code:	TF
Description:	Tap Factory

Distance (ft):	12.0
Structural Grade:	0
O&M Grade:	0
Clock Start/From:	2
Clock To:	
1st Value:	4.000
2nd Value:	
Value Percent:	
Continuous Index:	
Within 8" of Joint:	
Remarks:

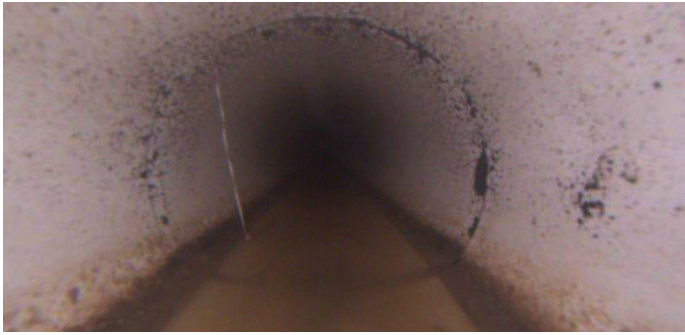
Code: **RFJ**
Description: **Roots Fine Joint**

Distance (ft): **37.2**
Structural Grade: **0**
O&M Grade: **1**
Clock Start/From: **11**
Clock To:
1st Value:
2nd Value:
Value Percent:
Continuous Index:
Within 8" of Joint: **YES**
Remarks:

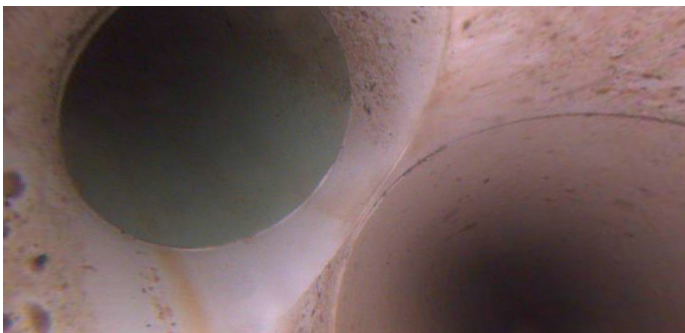
Code: **TF**
Description: **Tap Factory**

Distance (ft): **88.7**
Structural Grade: **0**
O&M Grade: **0**
Clock Start/From: **2**
Clock To:
1st Value: **4.000**
2nd Value:
Value Percent:
Continuous Index:
Within 8" of Joint:
Remarks:

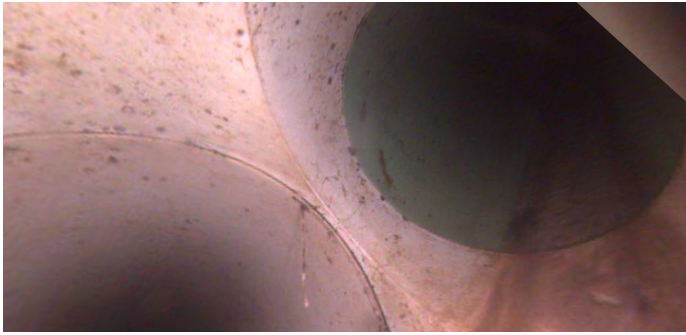
Code: **TF**
Description: **Tap Factory**

Distance (ft): **101.8**
Structural Grade: **0**
O&M Grade: **0**
Clock Start/From: **10**
Clock To:
1st Value: **4.000**
2nd Value:
Value Percent:
Continuous Index:
Within 8" of Joint:
Remarks:

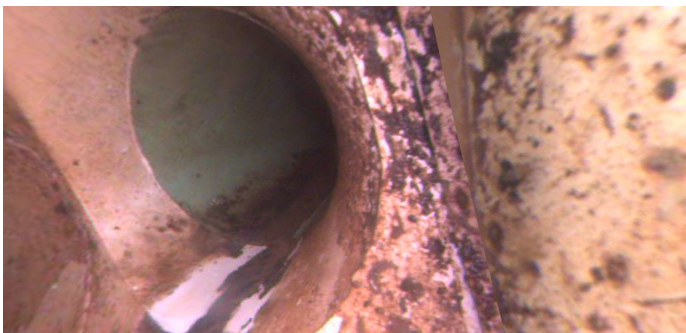
Code: **TF**
Description: **Tap Factory**

Distance (ft): **203.7**
Structural Grade: **0**
O&M Grade: **0**
Clock Start/From: **10**
Clock To:
1st Value: **4.000**
2nd Value:
Value Percent:
Continuous Index:
Within 8" of Joint:
Remarks:

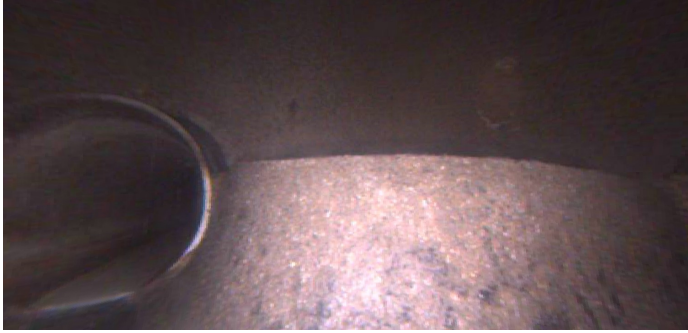
Code:	AMH
Description:	Manhole
Distance (ft):	230.6
Structural Grade:	0
O&M Grade:	0
Clock Start/From:	
Clock To:	
1st Value:	
2nd Value:	
Value Percent:	
Continuous Index:	
Within 8" of Joint:	NO
Remarks:	M-308-011
