Profile/Photo Observation Report

Street:	AMBER DR	Flow Control:	Not Controlled
City:	Hobart, IN	Year Renewed:	
Location:	Light Highway	Tape/Media #:	
Purpose:	Routine Assessment	Dia/Height:	10"
Use:	Sanitary	Material:	PVC
Drain Area:	NA	Lining:	
Category:	NA		
Comment:

Location Details:		Direction of Survey:	Downstream
US MH:	M-308-013	DS MH:	M-308-012
		Total Length Surveyed (ft):	171.6

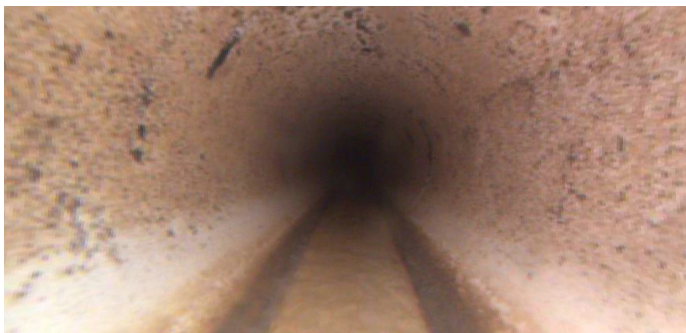
Code: **AMH**
Description: **Manhole**

Distance (ft): **.0**
Structural Grade: **0**
O&M Grade: **0**
Clock Start/From:
Clock To:
1st Value:
2nd Value:
Value Percent:
Continuous Index:
Within 8" of Joint: **NO**
Remarks: **M-308-013**

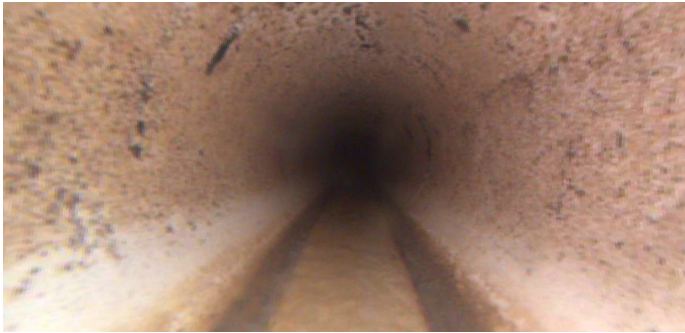
Code:	MWL
Description:	Water Level

Distance (ft):	.0
Structural Grade:	0
O&M Grade:	0
Clock Start/From:	
Clock To:	
1st Value:	
2nd Value:	
Value Percent:	5.000
Continuous Index:	
Within 8" of Joint:	NO
Remarks:

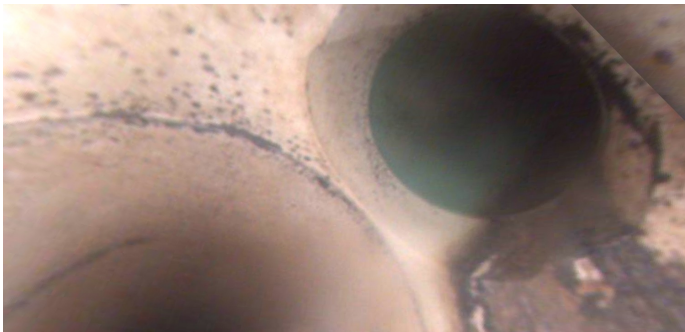
Code:	TF
Description:	Tap Factory

Distance (ft):	20.0
Structural Grade:	0
O&M Grade:	0
Clock Start/From:	10
Clock To:	
1st Value:	4.000
2nd Value:	
Value Percent:	
Continuous Index:	
Within 8" of Joint:	
Remarks:

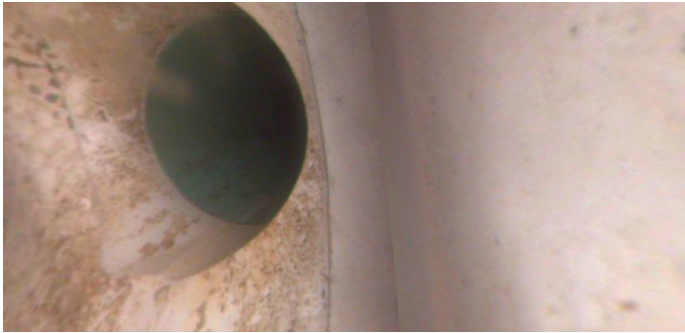
Code: **TF**
Description: **Tap Factory**

Distance (ft): **60.5**
Structural Grade: **0**
O&M Grade: **0**
Clock Start/From: **2**
Clock To:
1st Value: **4.000**
2nd Value:
Value Percent:
Continuous Index:
Within 8" of Joint:
Remarks:

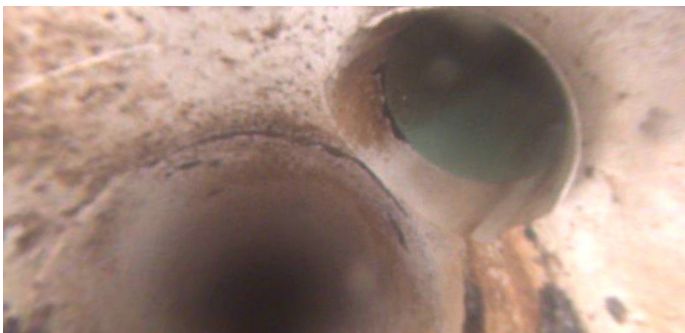
Code: **TF**
Description: **Tap Factory**

Distance (ft): **130.0**
Structural Grade: **0**
O&M Grade: **0**
Clock Start/From: **10**
Clock To:
1st Value: **4.000**
2nd Value:
Value Percent:
Continuous Index:
Within 8" of Joint:
Remarks:

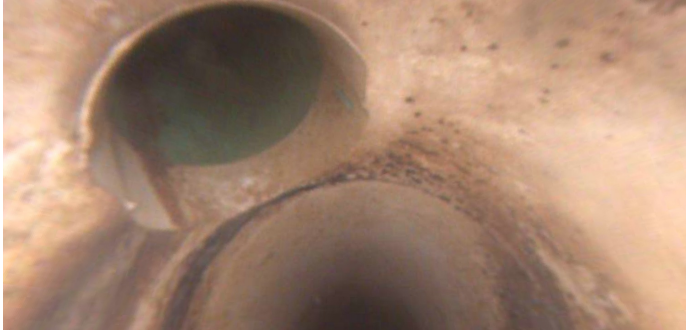
Code: **TF**
Description: **Tap Factory**

Distance (ft): **143.8**
Structural Grade: **0**
O&M Grade: **0**
Clock Start/From: **1**
Clock To:
1st Value: **4.000**
2nd Value:
Value Percent:
Continuous Index:
Within 8" of Joint:
Remarks:

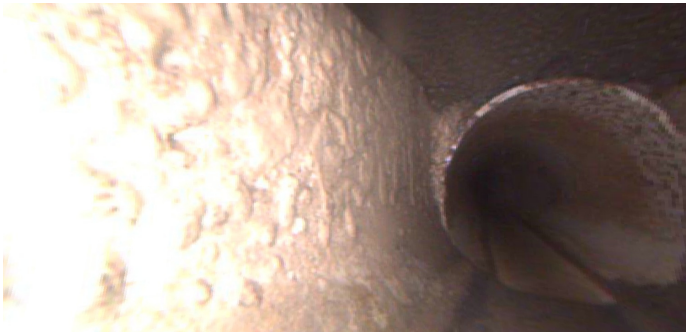
Code: **AMH**
Description: **Manhole**

Distance (ft): **171.6**
Structural Grade: **0**
O&M Grade: **0**
Clock Start/From:
Clock To:
1st Value:
2nd Value:
Value Percent:
Continuous Index:
Within 8" of Joint: **NO**
Remarks: **M-308-012**
