Profile/Photo Observation Report

Date:	03/21/2018	Weather:		Coding:	PACP 6.0
Pipe Length (ft):	314.2	Owner:	NA	Pre Clean:	No Pre-Cleaning
P.O.#:		Surveyor:	Selasie Honu	PSR:	P-308-014-013
Customer:		Clean Date:	01/01/1900	Shape:	C

Street:	AMBER DR	Flow Control:	Not Controlled
City:	Hobart, IN	Year Renewed:	
Location:	Light Highway	Tape/Media #:	
Purpose:	Routine Assessment	Dia/Height:	10"
Use:	Sanitary	Material:	PVC
Drain Area:	NA	Lining:	
Category:	NA		
Comment:			
Location Details:		Direction of Survey:	Upstream
US MH:	M-308-014	DS MH:	M-308-013
		Total Length Surveyed (ft):	302.7

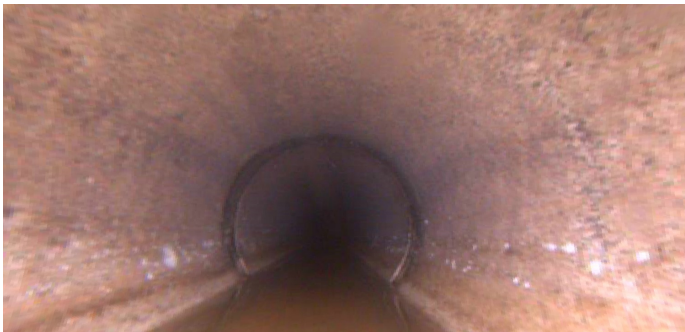
Code:	RFJ
Description:	Roots Fine Joint

Distance (ft):	10.8
Structural Grade:	0
O&M Grade:	1
Clock Start/From:	12
Clock To:	
1st Value:	
2nd Value:	
Value Percent:	
Continuous Index:	
Within 8" of Joint:	YES
Remarks:

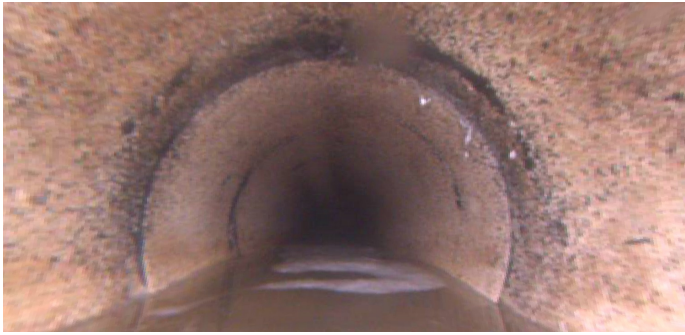
Code: **RFJ**
Description: **Roots Fine Joint**

Distance (ft): **24.2**
Structural Grade: **0**
O&M Grade: **1**
Clock Start/From: **12**
Clock To: **3**
1st Value:
2nd Value:
Value Percent:
Continuous Index:
Within 8" of Joint: **YES**
Remarks:

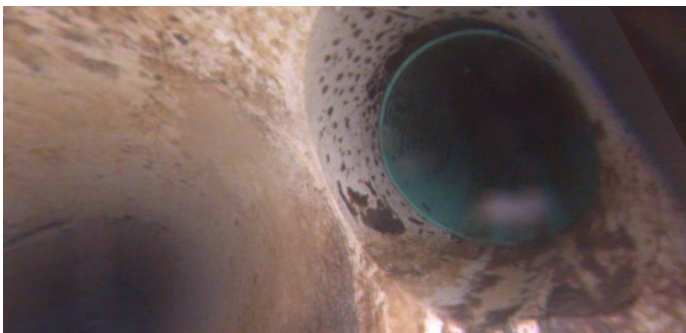
Code: **TF**
Description: **Tap Factory**

Distance (ft): **101.9**
Structural Grade: **0**
O&M Grade: **0**
Clock Start/From: **2**
Clock To:
1st Value: **4.000**
2nd Value:
Value Percent:
Continuous Index:
Within 8" of Joint:
Remarks:

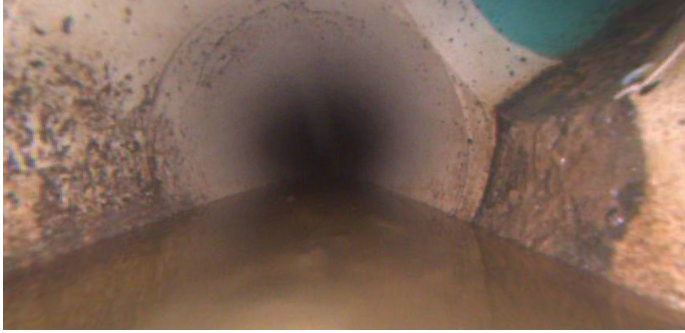
Code: **MWL**
Description: **Water Level**

Distance (ft): **281.2**
Structural Grade: **0**
O&M Grade: **0**
Clock Start/From:
Clock To:
1st Value:
2nd Value:
Value Percent: **30.000**
Continuous Index:
Within 8" of Joint: **NO**
Remarks:

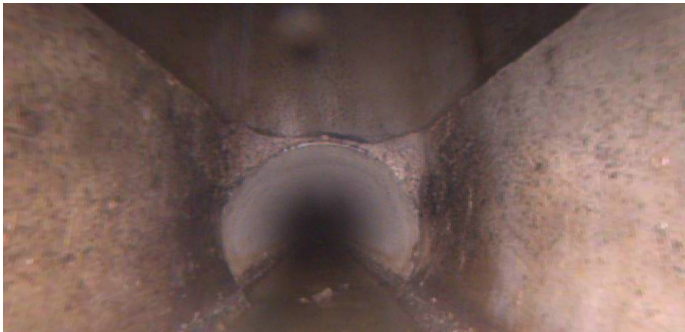
Code: **AMH**
Description: **Manhole**

Distance (ft): **302.7**
Structural Grade: **0**
O&M Grade: **0**
Clock Start/From:
Clock To:
1st Value:
2nd Value:
Value Percent:
Continuous Index:
Within 8" of Joint: **NO**
Remarks: **M-308-014**
