## Profile/Photo Observation Report

Date:	<b>03/21/2018</b>	Weather:		Coding:	<b>PACP 6.0</b>
Pipe Length (ft):	<b>314.2</b>	Owner:	<b>NA</b>	Pre Clean:	<b>No Pre-Cleaning</b>
P.O.#:		Surveyor:	<b>Selasie Honu</b>	PSR:	<b>P-308-014-013</b>
Customer:		Clean Date:	<b>01/01/1900</b>	Shape:	<b>C</b>

Street:	<b>FOXCROFT STREET</b>	Flow Control:	<b>Not Controlled</b>
City:	<b>Hobart, IN</b>	Year Renewed:	
Location:	<b>Light Highway</b>	Tape/Media #:	
Purpose:	<b>Routine Assessment</b>	Dia/Height:	<b>10"</b>
Use:	<b>Sanitary</b>	Material:	<b>PVC</b>
Drain Area:	<b>NA</b>	Lining:	
Category:	<b>NA</b>		
Comment:

Location Details:		Direction of Survey:	<b>Upstream</b>
US MH:	<b>M-308-014</b>	DS MH:	<b>M-308-013</b>
		Total Length Surveyed (ft):	<b>302.7</b>

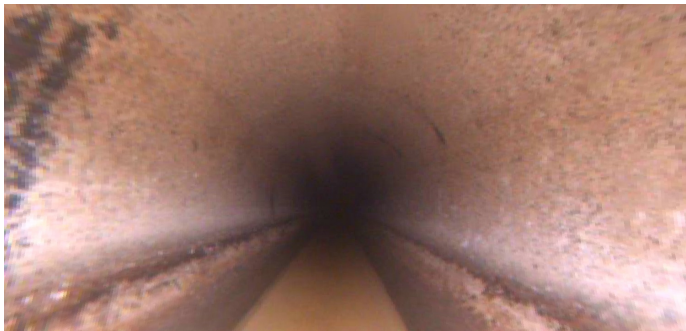
Code: **AMH**  
Description: **Manhole**

Distance (ft): **.0**  
Structural Grade: **0**  
O&M Grade: **0**  
Clock Start/From:  
Clock To:  
1st Value:  
2nd Value:  
Value Percent:  
Continuous Index:  
Within 8" of Joint: **NO**  
Remarks: **M-308-013**

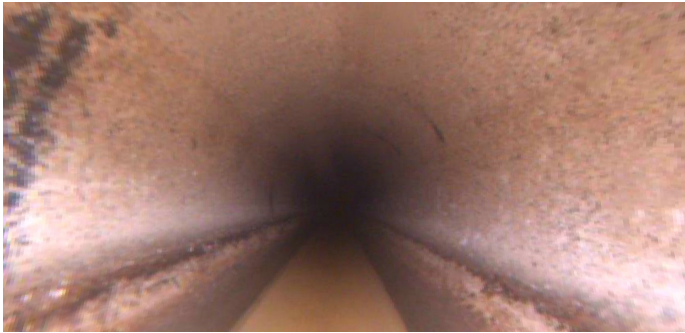
Code:	<b>MWL</b>
Description:	<b>Water Level</b>

Distance (ft):	<b>.0</b>
Structural Grade:	<b>0</b>
O&M Grade:	<b>0</b>
Clock Start/From:	
Clock To:	
1st Value:	
2nd Value:	
Value Percent:	<b>5.000</b>
Continuous Index:	
Within 8" of Joint:	<b>NO</b>
Remarks:

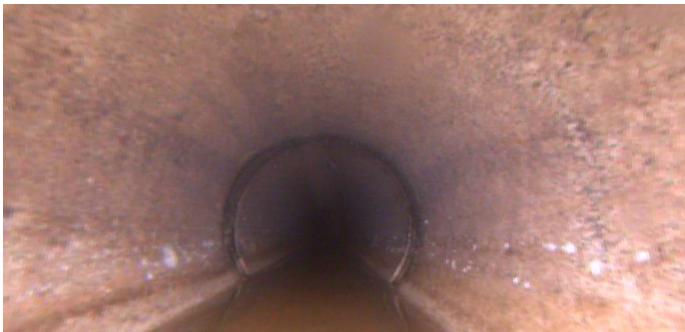
Code:	<b>RFJ</b>
Description:	<b>Roots Fine Joint</b>

Distance (ft):	<b>10.8</b>
Structural Grade:	<b>0</b>
O&M Grade:	<b>1</b>
Clock Start/From:	<b>12</b>
Clock To:	
1st Value:	
2nd Value:	
Value Percent:	
Continuous Index:	
Within 8" of Joint:	<b>YES</b>
Remarks:

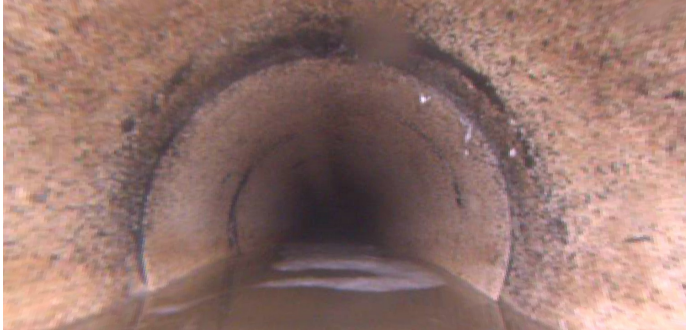
Code: **RFJ**  
Description: **Roots Fine Joint**

Distance (ft): **24.2**  
Structural Grade: **0**  
O&M Grade: **1**  
Clock Start/From: **12**  
Clock To: **3**  
1st Value:  
2nd Value:  
Value Percent:  
Continuous Index:  
Within 8" of Joint: **YES**  
Remarks:

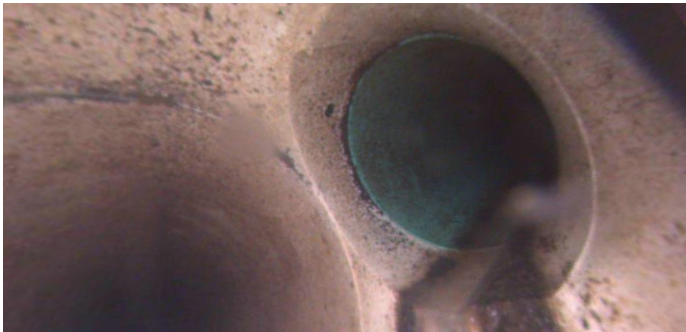
Code: **TF**  
Description: **Tap Factory**

Distance (ft): **37.4**  
Structural Grade: **0**  
O&M Grade: **0**  
Clock Start/From: **2**  
Clock To:  
1st Value: **4.000**  
2nd Value:  
Value Percent:  
Continuous Index:  
Within 8" of Joint:  
Remarks:

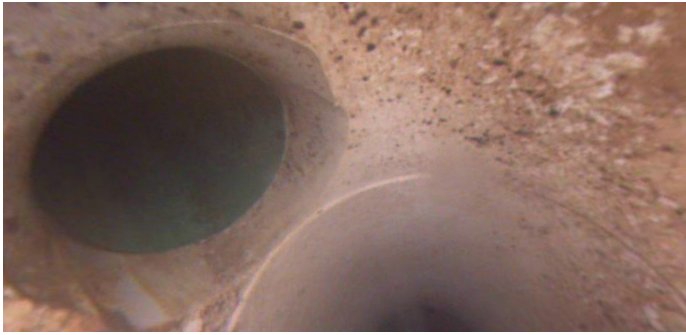
Code: **TF**  
Description: **Tap Factory**

Distance (ft): **75.8**  
Structural Grade: **0**  
O&M Grade: **0**  
Clock Start/From: **10**  
Clock To:  
1st Value: **4.000**  
2nd Value:  
Value Percent:  
Continuous Index:  
Within 8" of Joint:  
Remarks:

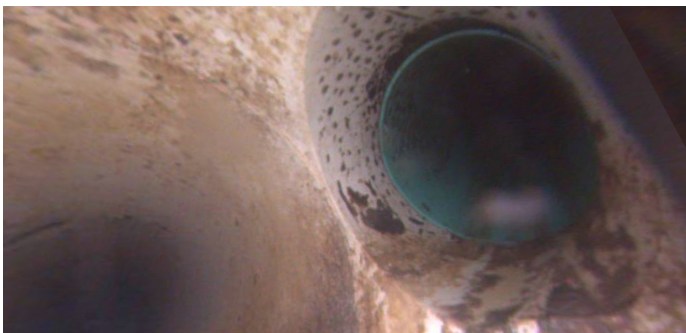
Code: **TF**  
Description: **Tap Factory**

Distance (ft): **101.9**  
Structural Grade: **0**  
O&M Grade: **0**  
Clock Start/From: **2**  
Clock To:  
1st Value: **4.000**  
2nd Value:  
Value Percent:  
Continuous Index:  
Within 8" of Joint:  
Remarks:

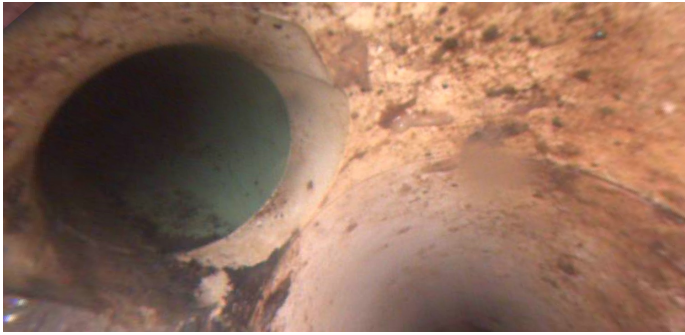
Code: **TF**  
Description: **Tap Factory**

Distance (ft): **153.3**  
Structural Grade: **0**  
O&M Grade: **0**  
Clock Start/From: **10**  
Clock To:  
1st Value: **4.000**  
2nd Value:  
Value Percent:  
Continuous Index:  
Within 8" of Joint:  
Remarks:

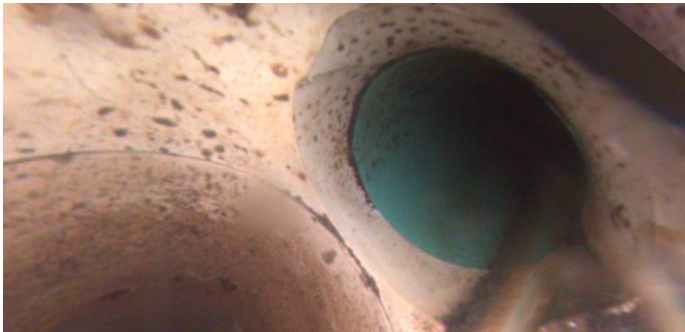
Code: **TF**  
Description: **Tap Factory**

Distance (ft): **204.3**  
Structural Grade: **0**  
O&M Grade: **0**  
Clock Start/From: **2**  
Clock To:  
1st Value: **4.000**  
2nd Value:  
Value Percent:  
Continuous Index:  
Within 8" of Joint:  
Remarks:

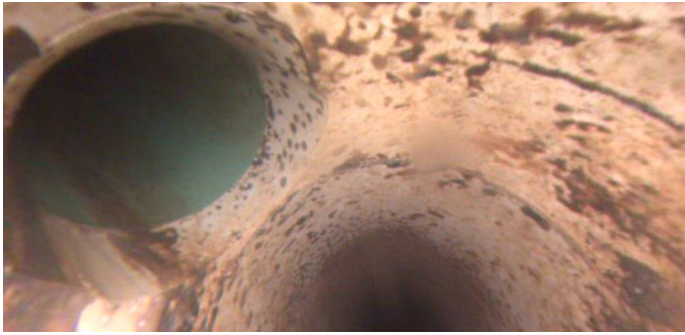
Code: **TF**  
Description: **Tap Factory**

Distance (ft): **242.9**  
Structural Grade: **0**  
O&M Grade: **0**  
Clock Start/From: **10**  
Clock To:  
1st Value: **4.000**  
2nd Value:  
Value Percent:  
Continuous Index:  
Within 8" of Joint:  
Remarks:

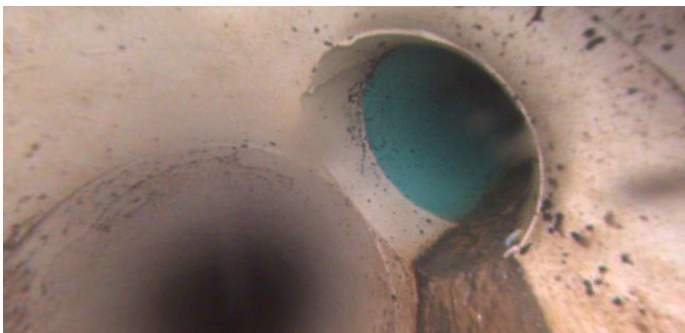
Code: **TF**  
Description: **Tap Factory**

Distance (ft): **281.2**  
Structural Grade: **0**  
O&M Grade: **0**  
Clock Start/From: **2**  
Clock To:  
1st Value: **4.000**  
2nd Value:  
Value Percent:  
Continuous Index:  
Within 8" of Joint:  
Remarks:

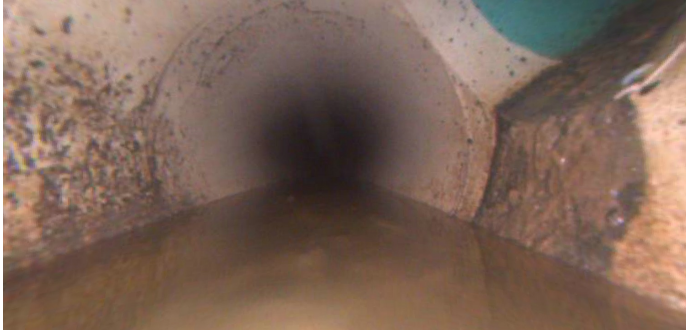
Code: **MWL**  
Description: **Water Level**

Distance (ft): **281.2**  
Structural Grade: **0**  
O&M Grade: **0**  
Clock Start/From:  
Clock To:  
1st Value:  
2nd Value:  
Value Percent: **30.000**  
Continuous Index:  
Within 8" of Joint: **NO**  
Remarks:

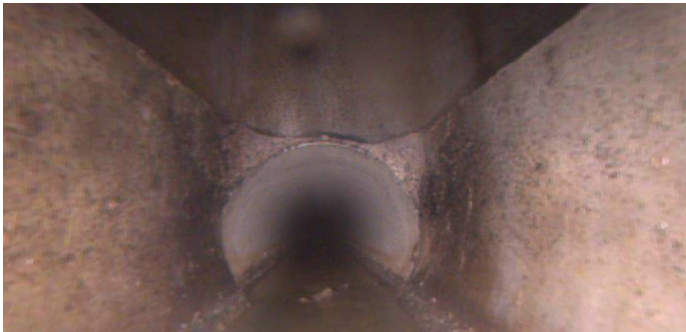
Code: **AMH**  
Description: **Manhole**

Distance (ft): **302.7**  
Structural Grade: **0**  
O&M Grade: **0**  
Clock Start/From:  
Clock To:  
1st Value:  
2nd Value:  
Value Percent:  
Continuous Index:  
Within 8" of Joint: **NO**  
Remarks: **M-308-014**
