Profile/Photo Observation Report

Street:	FOXCROFT STREET	Flow Control:	Not Controlled
City:	Hobart, IN	Year Renewed:	
Location:	Light Highway	Tape/Media #:	
Purpose:	Routine Assessment	Dia/Height:	8"
Use:	Sanitary	Material:	PVC
Drain Area:	NA	Lining:	
Category:	NA		
Comment:	P_C at 122 ft nothing visible rocks in the tracks \nFlow direction wrong		
Location Details:		Direction of Survey:	Upstream
US MH:	M-308-016	DS MH:	M-308-015
		Total Length Surveyed (ft):	123.5

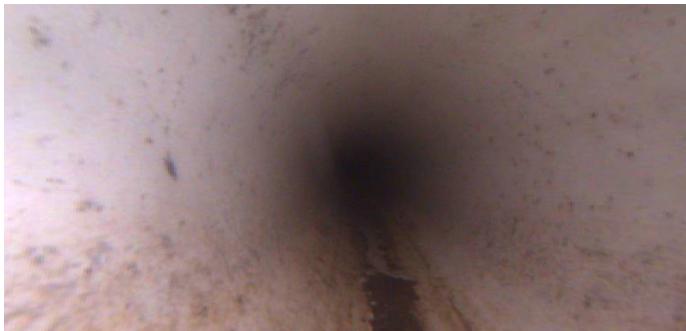
Code: **AMH**
Description: **Manhole**

Distance (ft): **.0**
Structural Grade: **0**
O&M Grade: **0**
Clock Start/From:
Clock To:
1st Value:
2nd Value:
Value Percent:
Continuous Index:
Within 8" of Joint: **NO**
Remarks: **M-308-015**

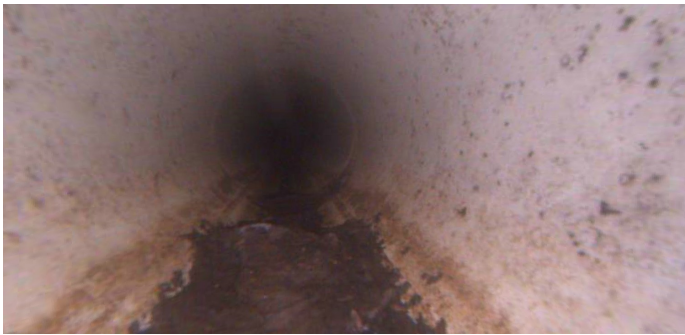
Code:	DSF
Description:	Deposits Settled Fine

Distance (ft):	4.7
Structural Grade:	0
O&M Grade:	2
Clock Start/From:	6
Clock To:	
1st Value:	
2nd Value:	
Value Percent:	5.000
Continuous Index:	
Within 8" of Joint:	NO
Remarks:

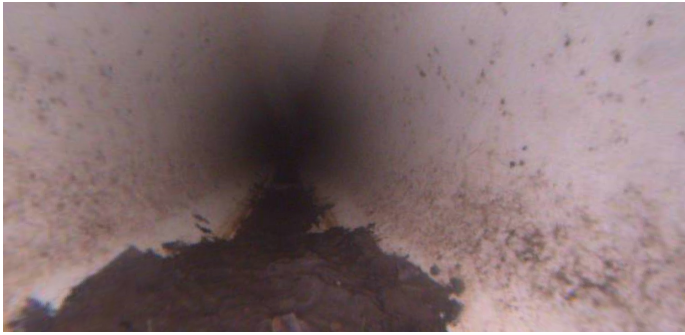
Code: **DSF**
Description: **Deposits Settled Fine**

Distance (ft): **12.6**
Structural Grade: **0**
O&M Grade: **2**
Clock Start/From: **6**
Clock To:
1st Value:
2nd Value:
Value Percent: **5.000**
Continuous Index:
Within 8" of Joint: **NO**
Remarks:

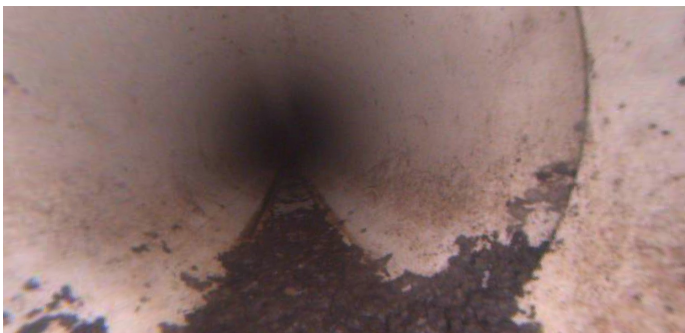
Code: **DSF**
Description: **Deposits Settled Fine**

Distance (ft): **18.8**
Structural Grade: **0**
O&M Grade: **2**
Clock Start/From: **6**
Clock To:
1st Value:
2nd Value:
Value Percent: **5.000**
Continuous Index:
Within 8" of Joint: **NO**
Remarks:

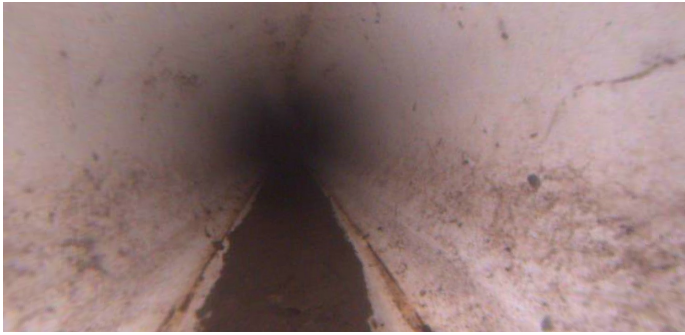
Code: **DSF**
Description: **Deposits Settled Fine**

Distance (ft): **27.7**
Structural Grade: **0**
O&M Grade: **2**
Clock Start/From: **6**
Clock To:
1st Value:
2nd Value:
Value Percent: **5.000**
Continuous Index: **S01**
Within 8" of Joint: **NO**
Remarks:

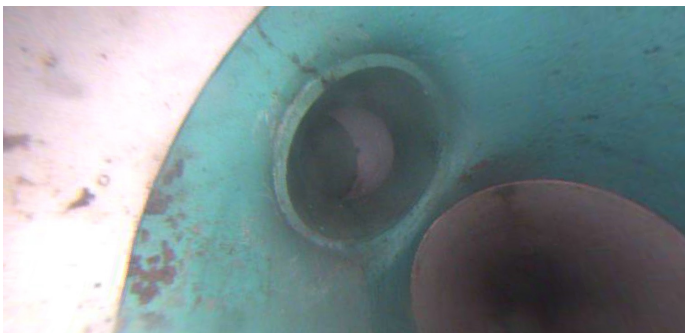
Code: **TF**
Description: **Tap Factory**

Distance (ft): **33.1**
Structural Grade: **0**
O&M Grade: **0**
Clock Start/From: **2**
Clock To:
1st Value: **4.000**
2nd Value:
Value Percent:
Continuous Index:
Within 8" of Joint:
Remarks:

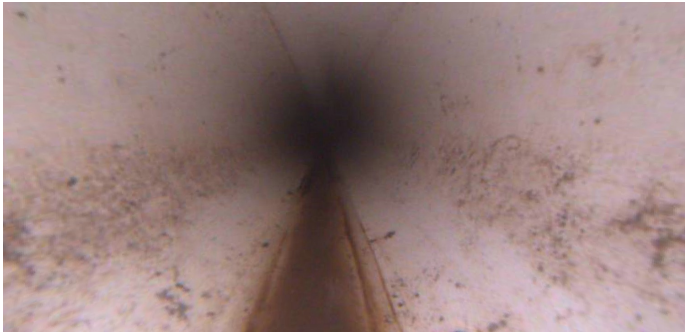
Code: **DSF**
Description: **Deposits Settled Fine**

Distance (ft): **35.8**
Structural Grade: **0**
O&M Grade: **2**
Clock Start/From: **6**
Clock To:
1st Value:
2nd Value:
Value Percent: **5.000**
Continuous Index: **F01**
Within 8" of Joint: **NO**
Remarks:

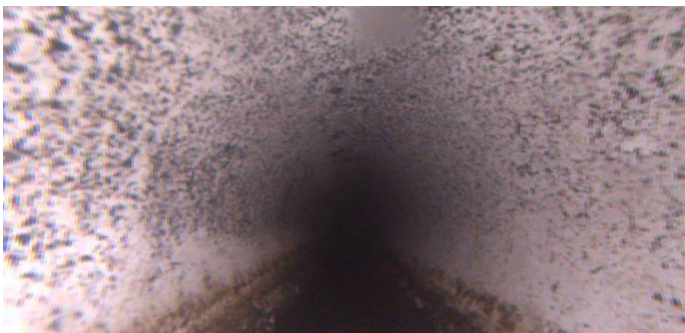
Code: **MSA**
Description: **Abandoned Survey**

Distance (ft): **123.5**
Structural Grade: **0**
O&M Grade: **0**
Clock Start/From:
Clock To:
1st Value:
2nd Value:
Value Percent:
Continuous Index:
Within 8" of Joint: **NO**
Remarks: **DSF**
